**A25 (Dryhill Lane to the Surrey Border)
Route Study**

Client: Kent Highway Services, West Kent Division

April 2008

Project Number B0820600
Jacobs, Miller House, Lower Stone Street, Maidstone, Kent, ME 15 6GB

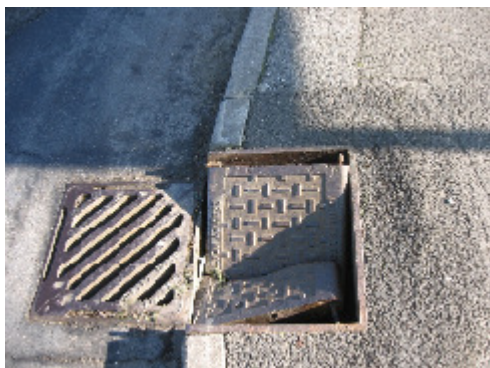
In the junction mouth of Dryhill Lane the kerb entry gully is blocked with debris and has a broken cover, the road surface has cracks appearing and at the entry onto the main carriageway the road is in a poor condition with the surface sunken and road surface breaking up. Visibility in both directions from Dryhill Lane is good.

Photo 1 - Kerb entry gully cover broken

The Dryhill Lane junction mouth should be repaired and the kerb entry gully cleaned and the broken cover replaced.

- The gully should be cleaned and the cover replaced (1.5.1)
- The junction mouth should be repaired (1.5.2).
- The 'Neighbourhood Watch' sign should be removed and the 'Hydrant' sign relocated (1.5.3).

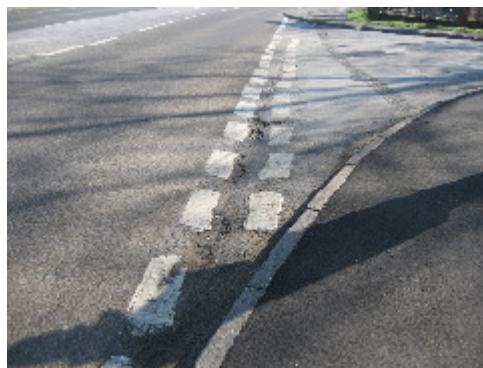
Photo 2 -Junction interface sunken and breaking up

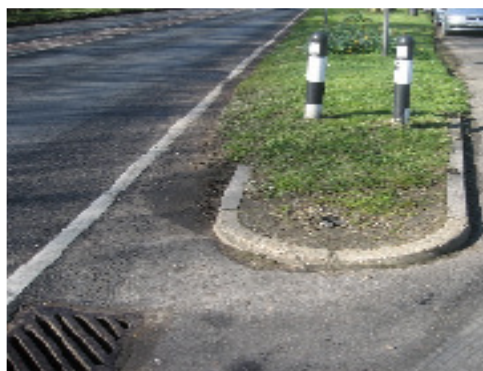
At the eastern entry to the service road there is a road marker post missing and a damaged marker post with its reflective white bands peeling and missing.

Photo 6 - Road marker post missing

The missing and damaged road markers should be replaced and existing ones require cleaning to enhance the conspicuity of the road entrance / exit.

- The footpath should be repaired (1.5.9).
- Repairs to the west bound carriageway opposite house number 18 should be carried out (1.6.0).
- The gully should be cleaned (1.6.1).
- Replace missing and damaged road marker posts (1.6.2).

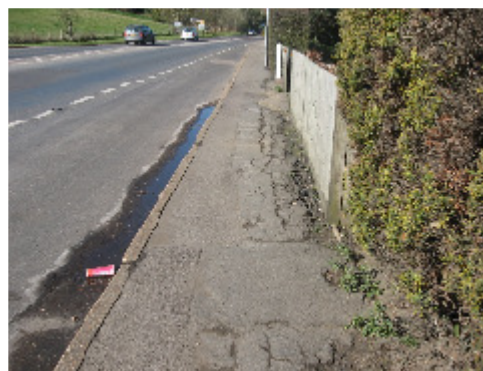
The footpath outside house numbers 18 - 22 Main Road Sundridge is deteriorating with previous remedial work cracking and breaking away. There is evidence of ponding on the southern side of the main carriageway opposite house number 18.

Photo 7 - The footpath is deteriorating

The repairs are required to the footpath outside House numbers 18 -22 Main Road Sundridge to improve pedestrian safety and the main carriageway opposite house number 18 should be repaired.

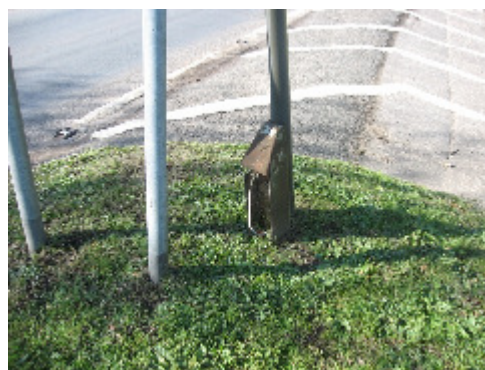
At the western entry to the service road the 'Service Road only' sign wide base post has the panel cover missing at the base of the post, exposing the electrical wiring. The post is misaligned.

Photo 9 - The panel cover is missing

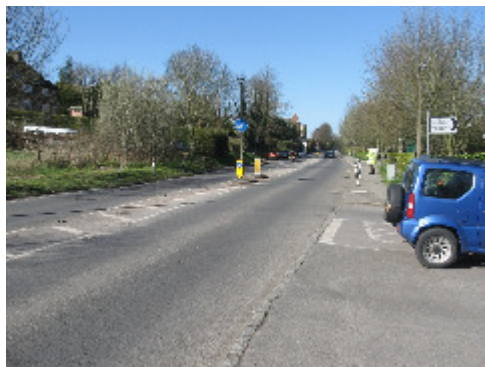
The Flecta bollards at the second pedestrian crossing located approximately 15metres west adjacent to the entrance to 84-88 Main Road are covered with grime and their reflective quality severely diminished. There are gravel spillages at both pedestrian crossings. The gullies over this section are blocked with debris.

Photo 12 - Flecta Bollards coated in grime

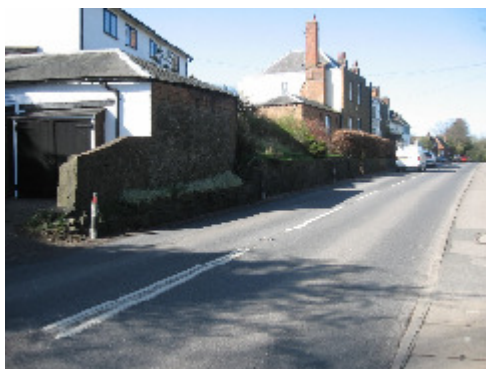
The road marker posts outside house number 27 Main Road on the west bound edge of the carriageway are coated with grime, with some reflectors and reflective bands missing which is severely diminishing their reflective quality.

Photo 13 - Road marker posts coated in grime

The road marker posts outside house number 27 Main Road should be replaced to clearly demarcate the carriageway edge.

- Replace road markers on the west bound carriageway (1.7.4).
- Cut back the vegetation encroaching onto the footpath (1.7.5)
- The Kee Klamp steel and concrete fence should be replaced with a panelled wooden fence (1.7.6).
- Repair carriageway road surface (1.7.7).
- Clean gullies over this section (1.7.8)

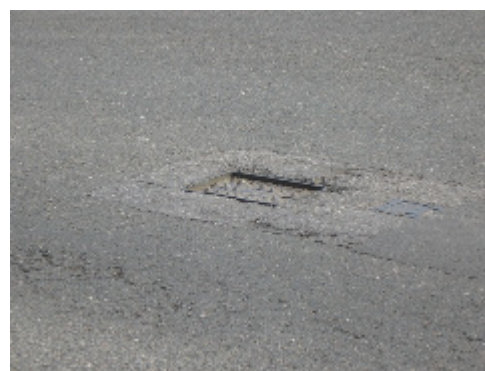
Photo 16 - Road surface is deteriorating

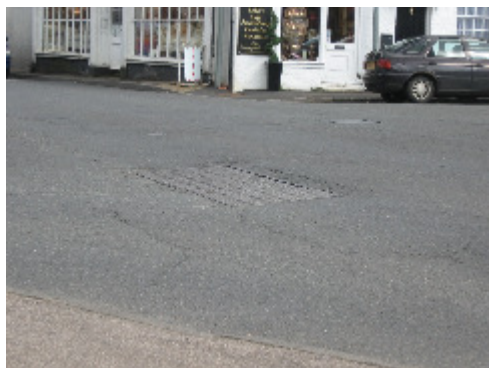
Photo 17 - Road surface is deteriorating

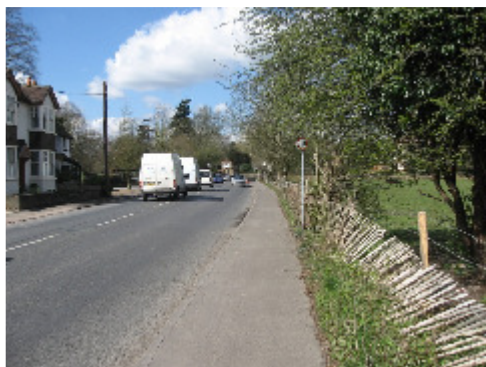
A 30mph speed limit repeater sign opposite house number 233 Main Road is partly obscured by an overhanging tree branch.

Photo 21 - The wooden fence is in a
poor condition and 30mph speed limit
sign partly obscured by vegetation

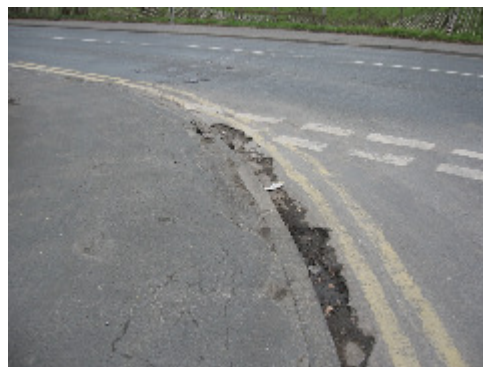
Photo 23 - Junction interface deteriorating

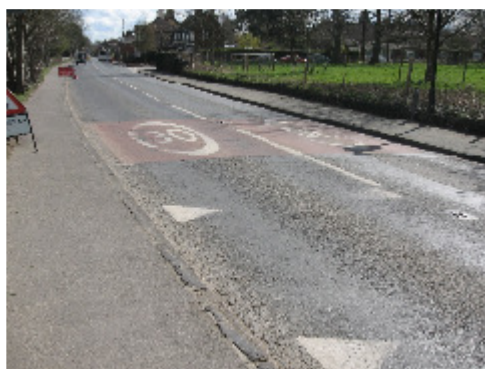
The 30mph speed limit road markings, HFS and 'Dragon's teeth' at the 30mph speed limit gateway are worn and faded with no carriageway edge road markings over this section. There is a 'Neighbourhood Watch' sign secured to the gateway post.

Photo 24 - Road markings are worn

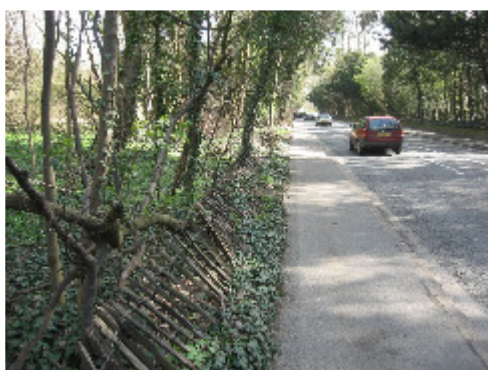
Photo 25 - Wooden fence is in a poor condition

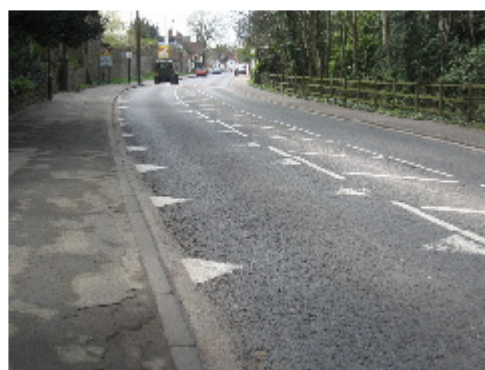
Photo 26 - Footpath is deteriorating

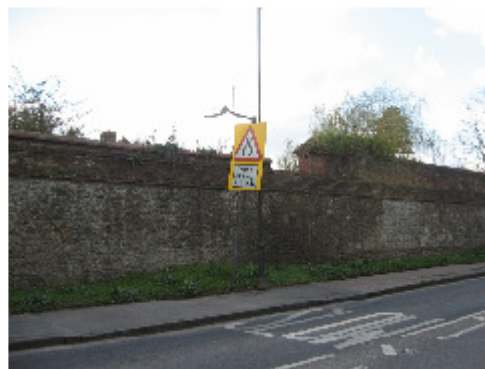
Photo 28 - Dislodged sign and worn 'Slow' road marking

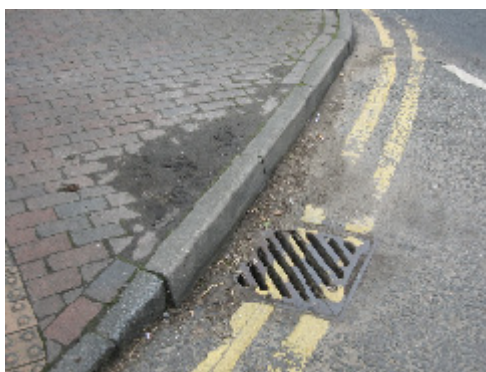
The double yellow lines on the 'Brasted Place' junction mouth are worn and faded and the gullies in the junction mouth are blocked with debris. There is a redundant post located adjacent to 'Brasted Place' and outside the 'White Hart Inn' Public House.

Photo 29 - Yellow lines are worn and gully is blocked

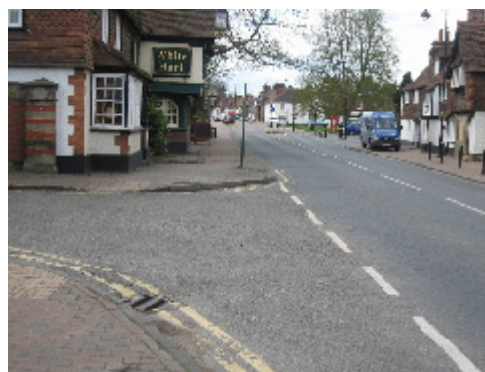
Photo 30 - There is a redundant pole

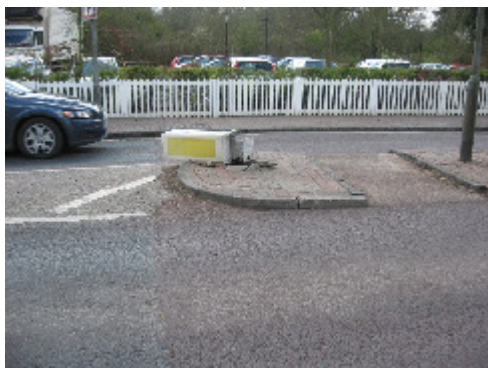
Photo 31 - Dislodged illuminating bollard

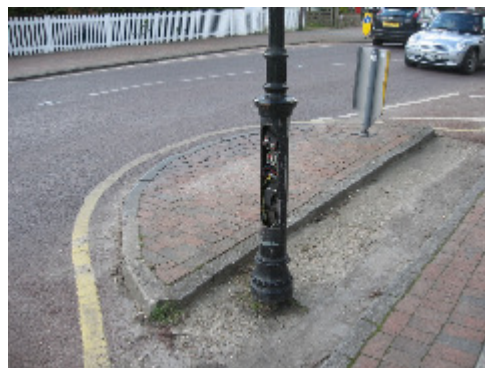
Photo 32 - Missing lamp column door

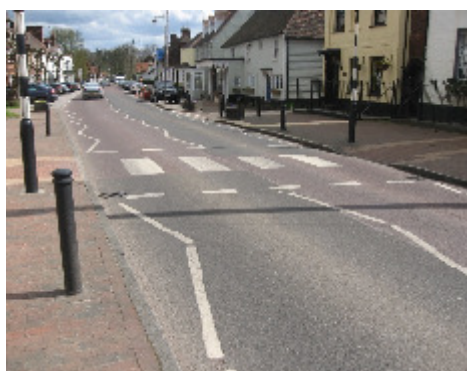
The pedestrian crossing road markings outside 'Fine Antiques' and the 'Slow' road markings outside 'The Mount House' are worn and faded.

Photo 33 - Road markings are worn

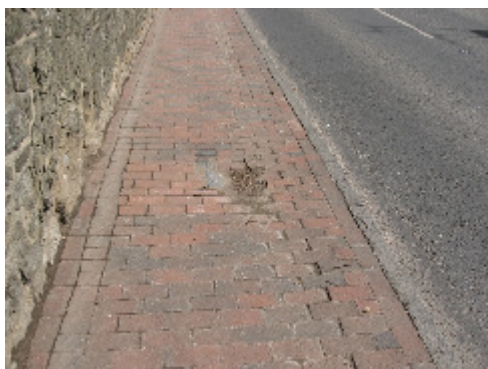
Photo 34 - Footpath has sunken

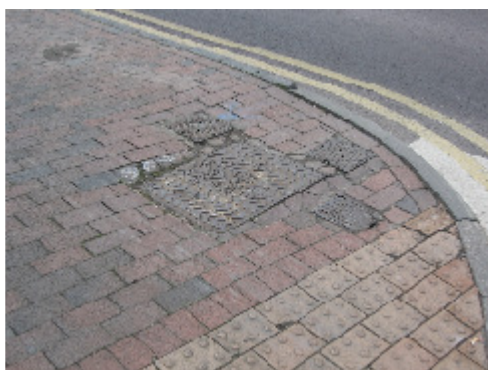
Photo 36 - Sunken utility covers

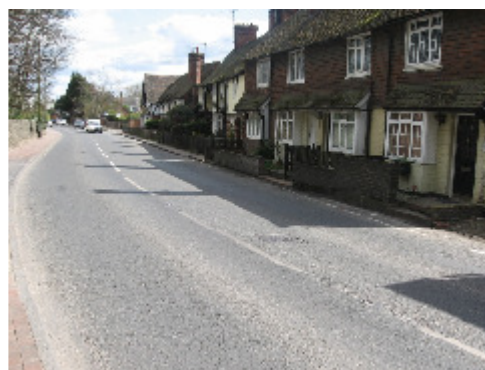
Photo 37 - Road markings are worn

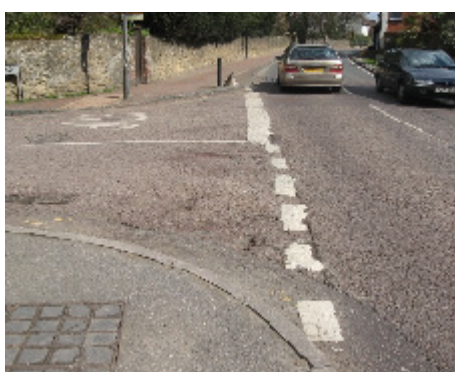
Photo 38- Junction mouth is in a poor condition

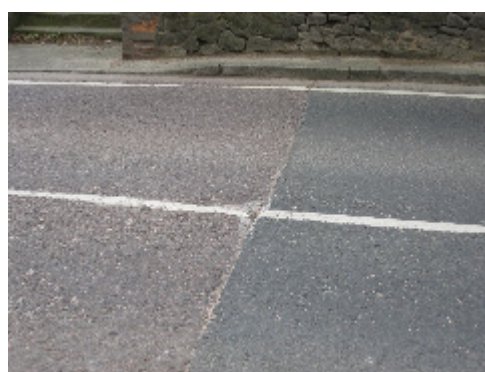
Photo 39 - Pothole in carriageway

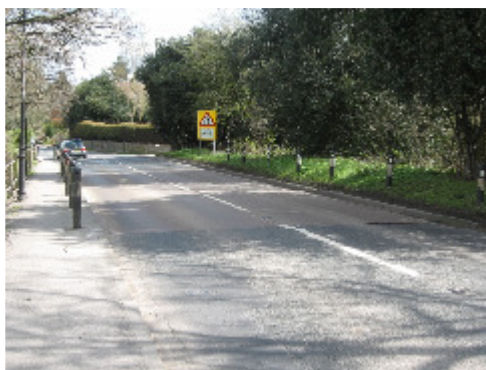
Photo 40 - Road marker posts are coated in grime

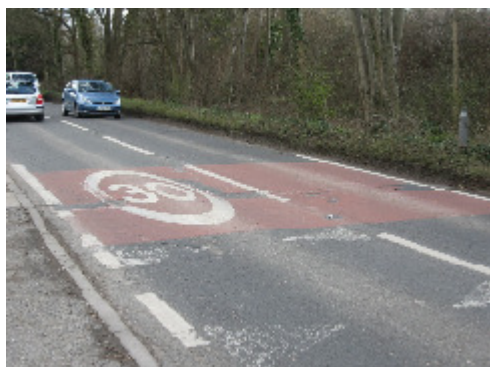
Photo 42- HFS broken away and road markings are worn

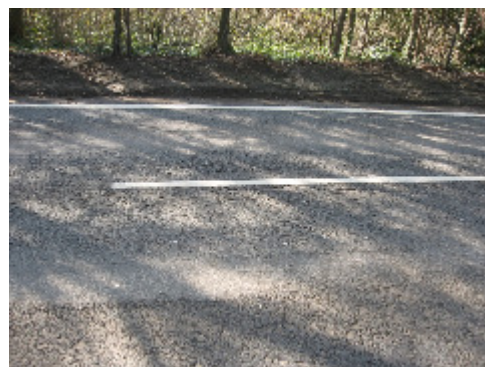
Photo 43 - Road surface deteriorating

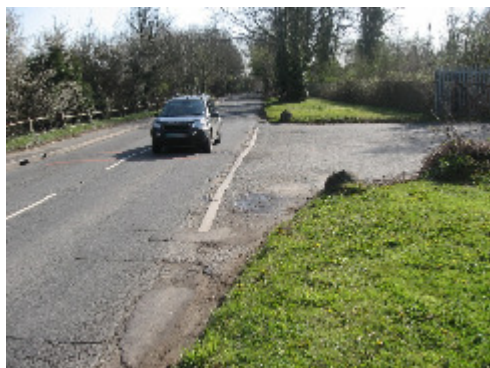
Photo 44 - Junction interface is in a poor condition

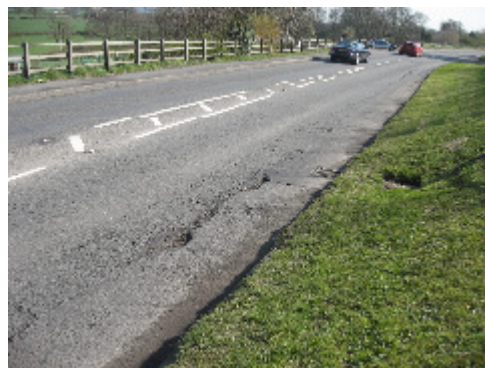
Photo 45 - Carriageway deteriorating

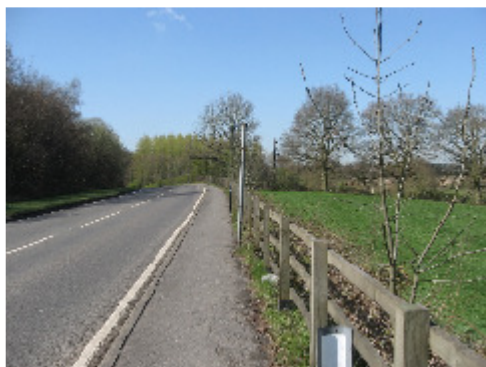
There are sections of the footpath which are uneven between the pedestrian crossing and the ‘Public footpath’ and could constitute a trip hazard.

Photo 46 - Footpath uneven and an unsigned post

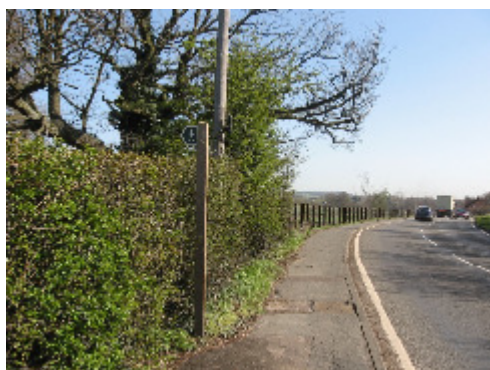
Photo 47 - Footpath broken away at 'Post Office Telephones' utility cover

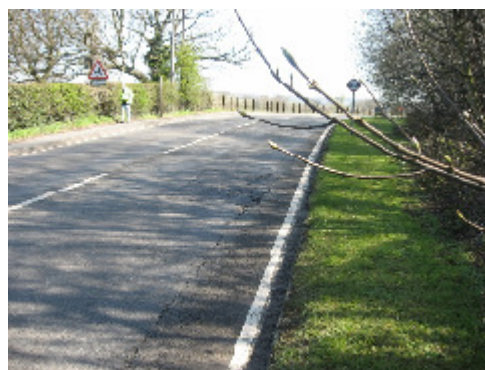
Photo 48 - Carriageway deteriorating

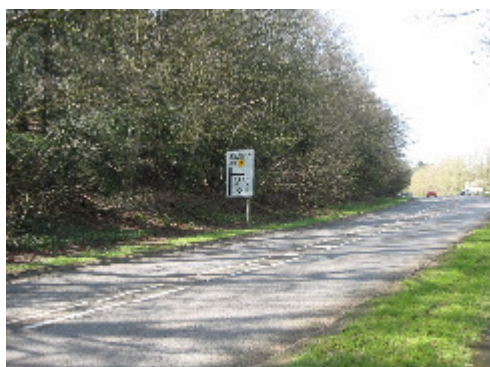
Photo 51 - Partly obscured sign

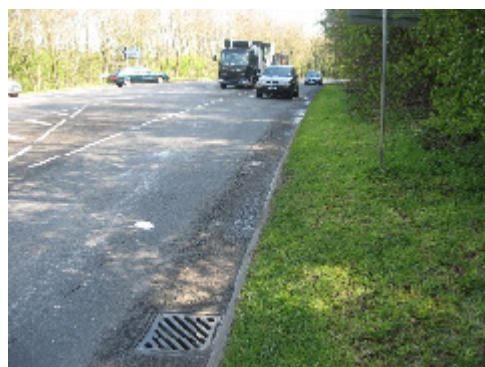
At the junction mouth for the A233 there is evidence of rutting and opposite the junction mouth a gulley has sunken and carriageway is cracking and carriageway edge is deteriorating.

Photo 52 - Carriageway edge is deteriorating

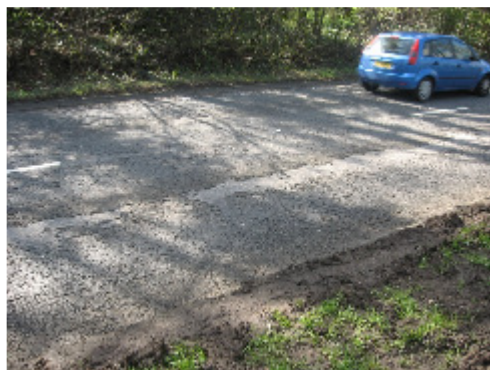
Photo 53 - Road surface is deteriorating

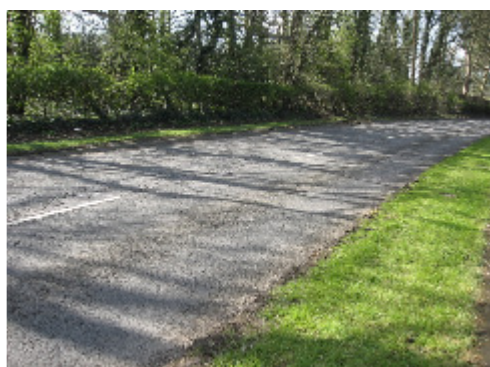
The west bound carriageway edge from approximately 300metres from ‘Dunsdale House’ is deteriorating to the 30mph speed limit eastern gateway in Westerham.

Photo 55 - Carriageway is deteriorating

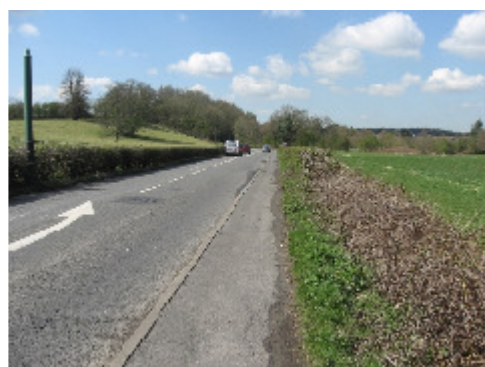
Photo 56 - Footpath verge subsiding

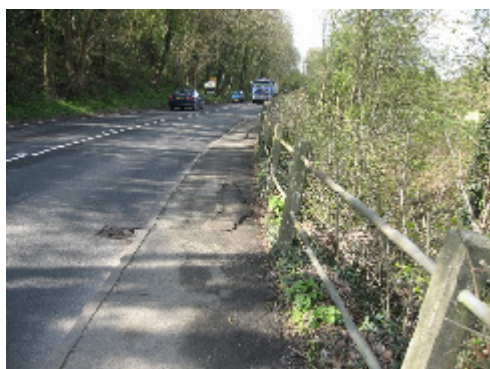
Photo 57 - Footpath is subsiding

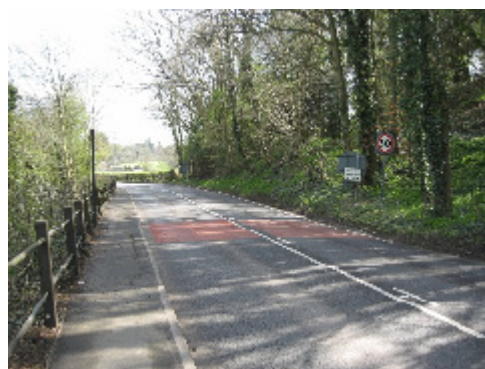
The HFS adjacent to the 30/50mph terminal speed limit gateway feature on the eastern approach to Westerham is breaking up and worn.

Photo 58 - HFS is breaking up and worn

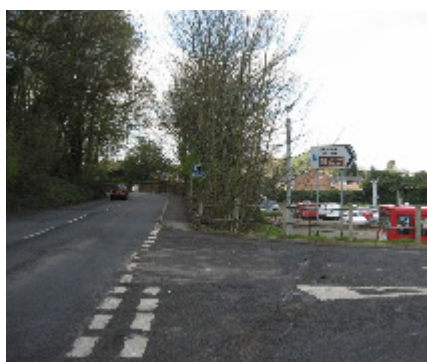
Photo 59 - Junction mouth deteriorating

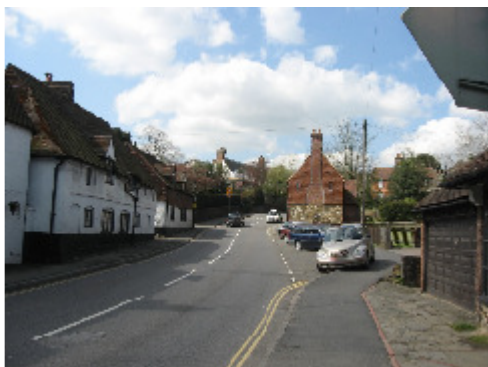
A gully is blocked at the junction with Mill Street.
The white demarcation lines at the lay-by up Vicarage Hill are worn and a section unpainted.
There is an illegal 'Astor Place' sign secured to the telegraph pole in conjunction with tourism signs.
There are non compliant AAT signs located outside and opposite 'Old Mill Leat' and 'Vicarage Cottage'.

Photo 62 - Lay-by lines are worn and a section unpainted

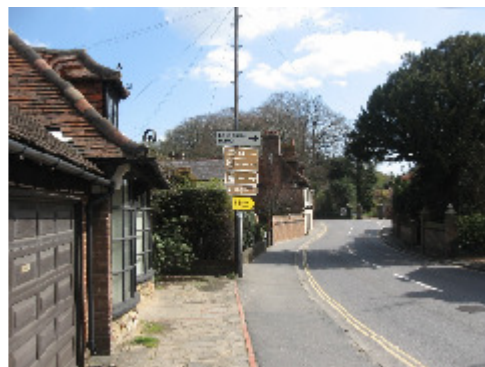
Photo 63 - An illegal sign with tourism signs

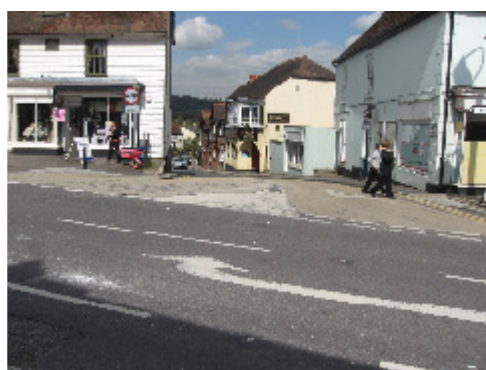
There is no 'road narrows on both sides ahead' sign prior to the entrance to Vicarage Hill.
The pedestrian crossing floodlights at the 'Westerham Green' bus stop are defective.
The carriageway edge outside the 'Orvis' shop has sunken and the HFS road markings on the junction mouth with London Road are worn.

Photo 64 - HFS and road markings are worn

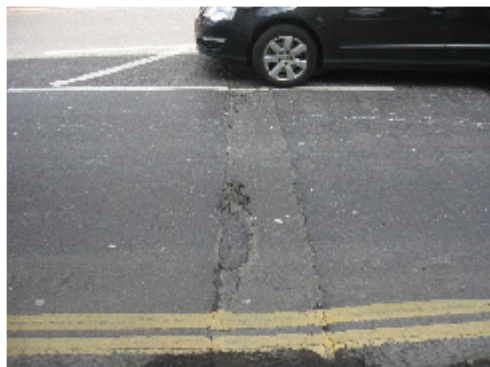
Photo 65 - Carriageway deteriorating

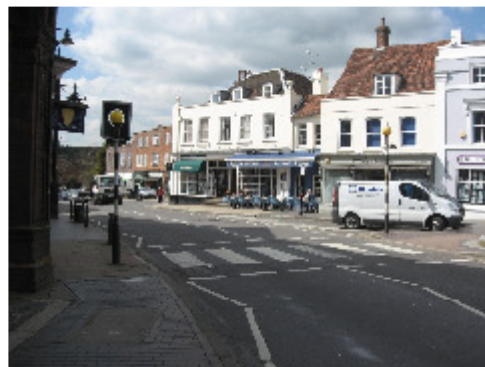
The pedestrian crossing road markings are worn and one floodlight missing.

Photo 66 - Road markings are worn

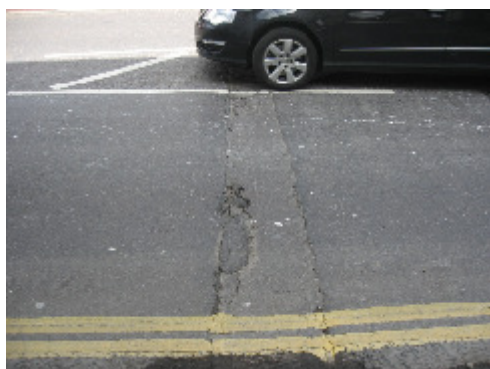
Photo 67 - Carriageway deteriorating

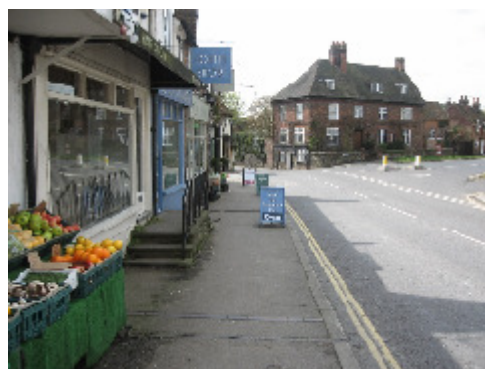
Shop advertising boards (A boards) placed on the footpath are partially obstructing pedestrian access between the Coffee Shop and Barbers.

Photo 68 - A boards on footpath

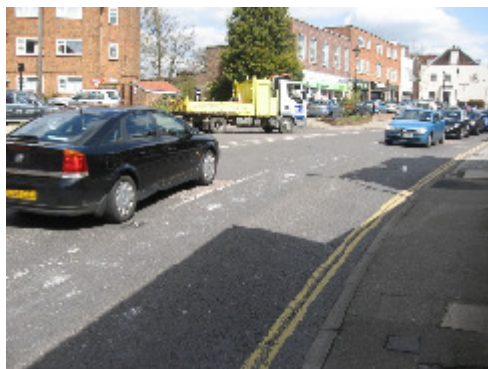
The carriageway central road markings opposite the B2024 junction down to 'Squerryes Mede' junction are worn.

Photo 69 - Carriageway centre line is worn

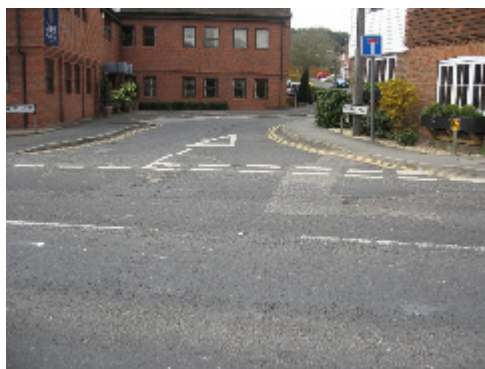
The carriageway at the 'Squerryes Mede' junction has utility covers and the road surface is sinking.

Photo 70 - Carriageway has sunken and junction mouth deteriorating

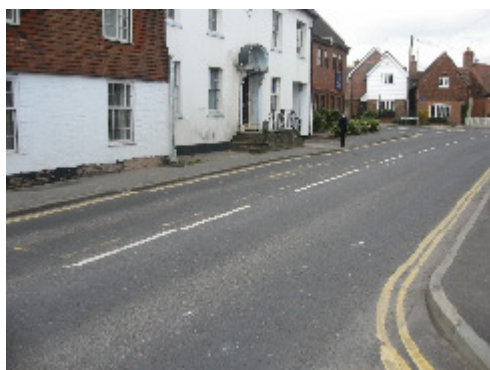
Photo 71 - Bus road markings are worn

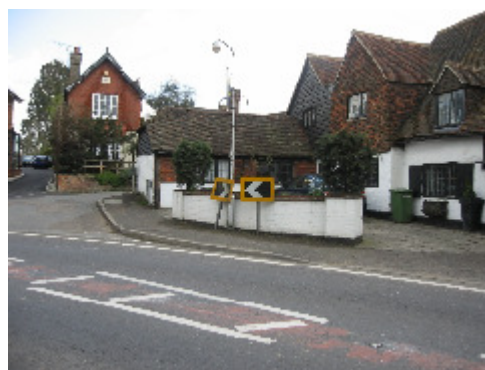
Photo 72 - Chevron signs are coated in grime and one has been dislodged

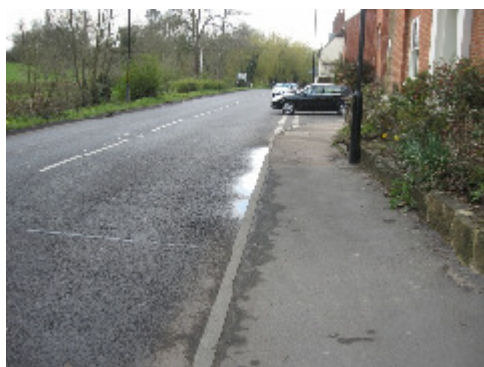
There is ponding both sides of the junction mouth with Black Eagle Close. The western lamp column adjacent to Black Eagle Close has an illegal sign secured to it. The steel and concrete post fence at the 'Kinara' car park is in poor condition.

Photo 73 - Ponding in carriageway

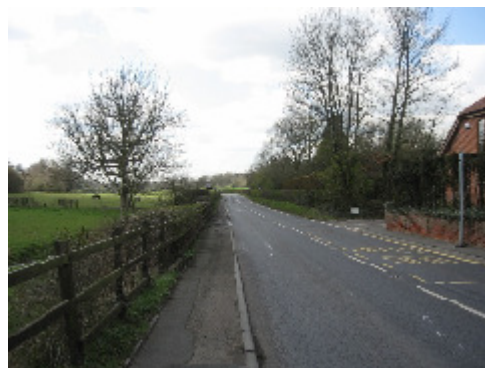
Photo 75 - Footpath is in a poor condition

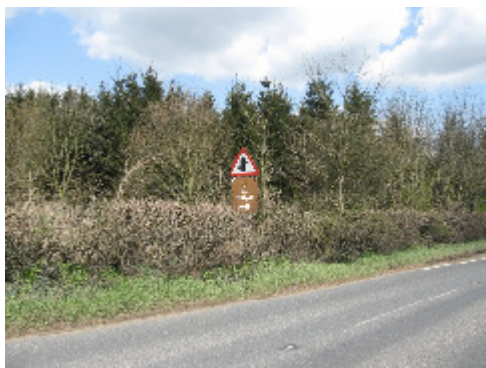
Photo 77 - No carriageway edge road markings and an outdated tourist sign

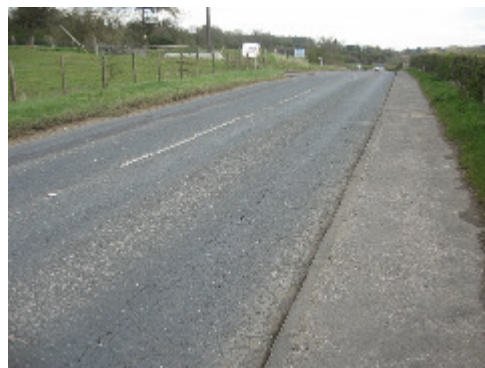
Photo 78 - Carriageway cracking and evidence of deterioration

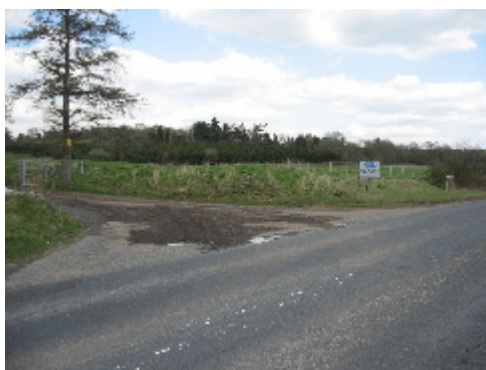
Photo 79 - Junction mouth is in a poor condition

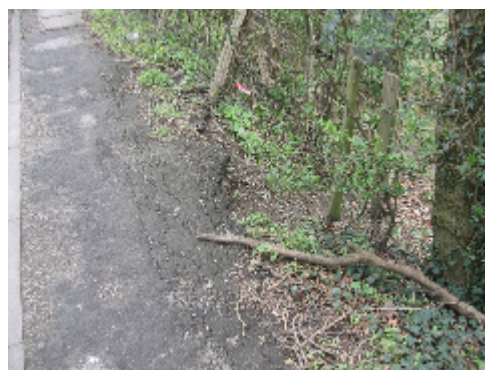
Photo 80 - Footpath subsiding
