Four Winds –

SURVEY AND STRUCTURAL REPORT

THE EXCAVATIONS AND FOUNDATIONS

FOUR WINDS, FARLEY COMMON

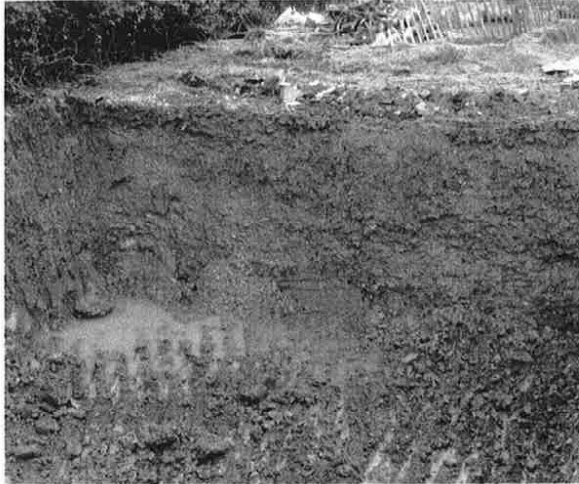
This picture shows the water that continuously appeared in the south eastern corner of the excavation nearest the Well in our neighbours adjoining property.

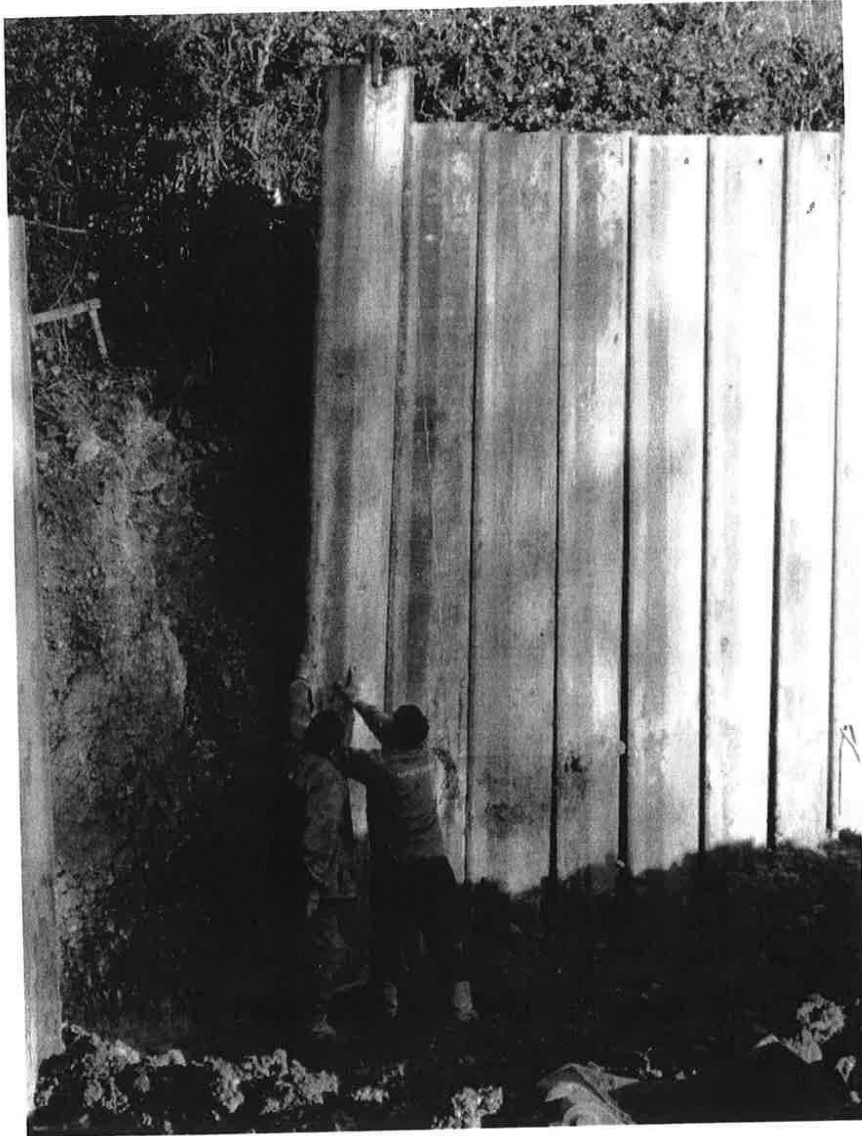
Sheet piles being put in place and hammered down.

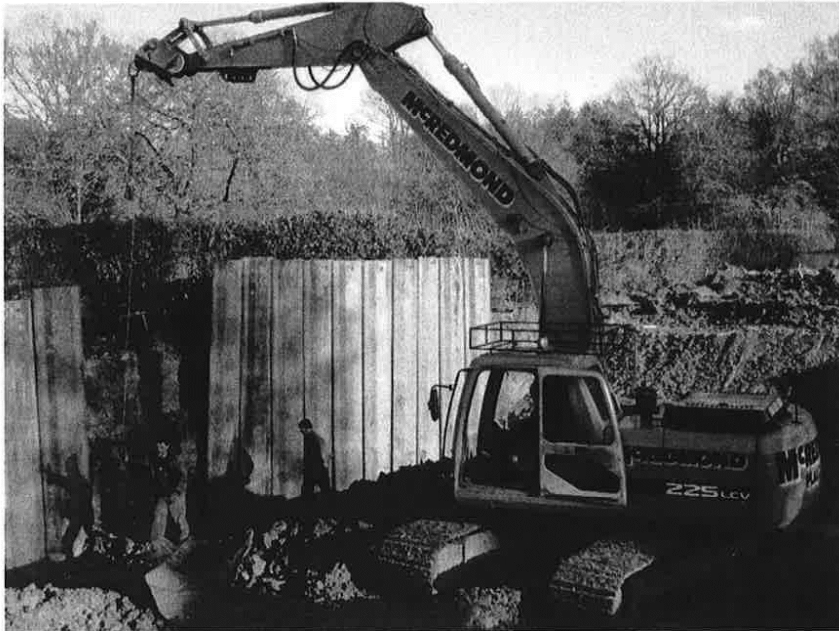
The line of sheet piles against our neighbours eastern boundary which subsequently had to be re “planted”

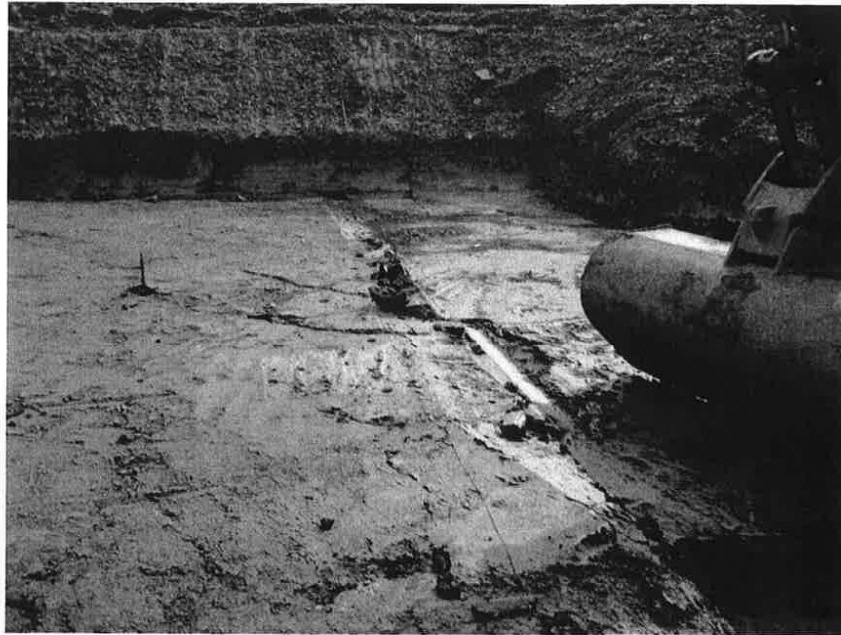
This picture shows the Black gault clay at the slightly lower level as opposed to the red / flinty clay on the sides. You can see that we went down to the points where we encountered the black clay.

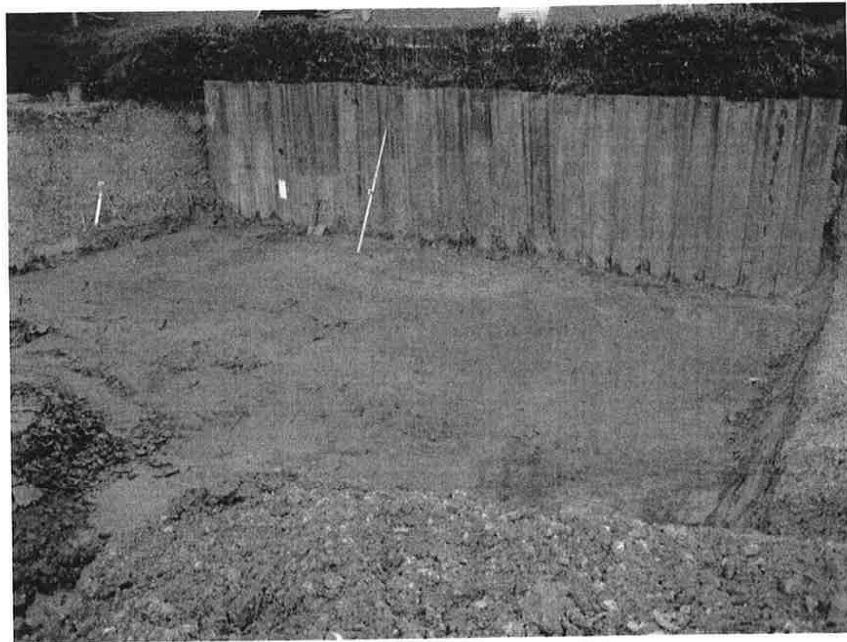
This picture shows you the eastern boundary and its piling. You can also see the water in the right corner, and this is after little or no rain for more than a month.

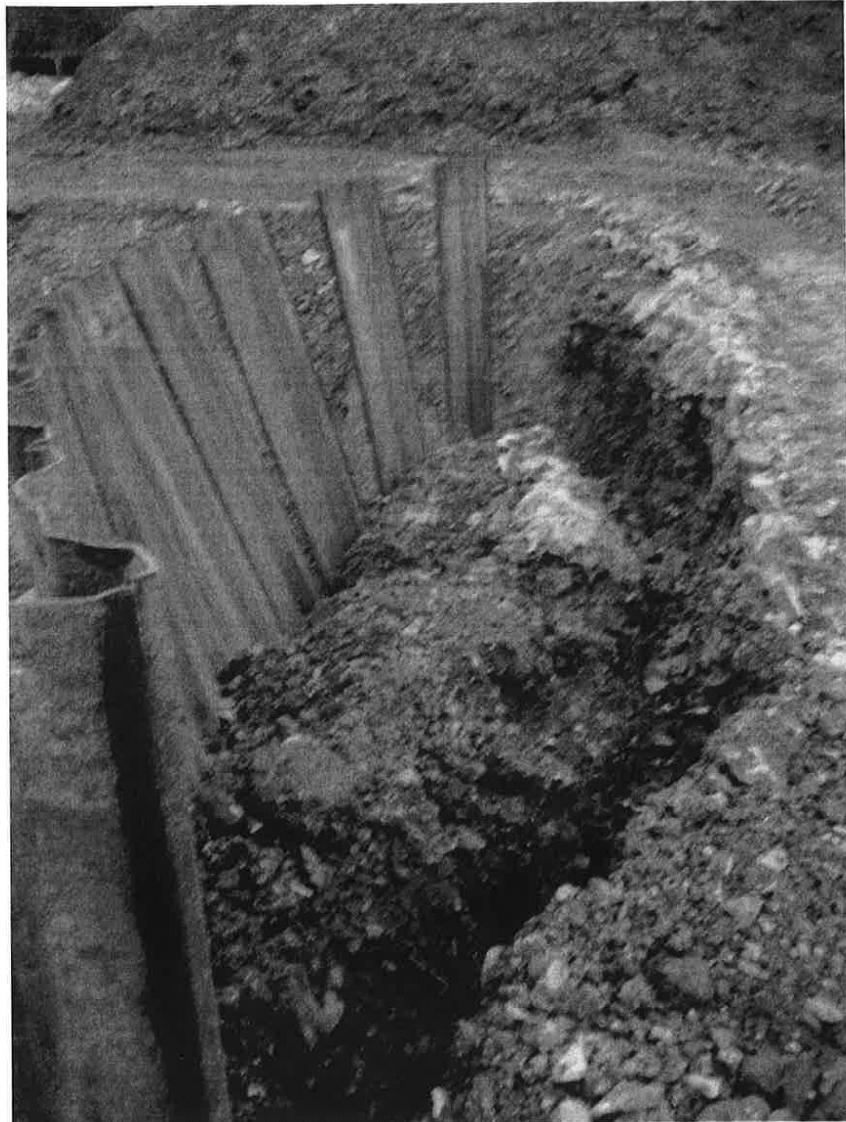
Opps there go the piles just a few hours after the Digger had been taking away necessitating its return at vast expense to put them in again and sort out the collapsed ground.

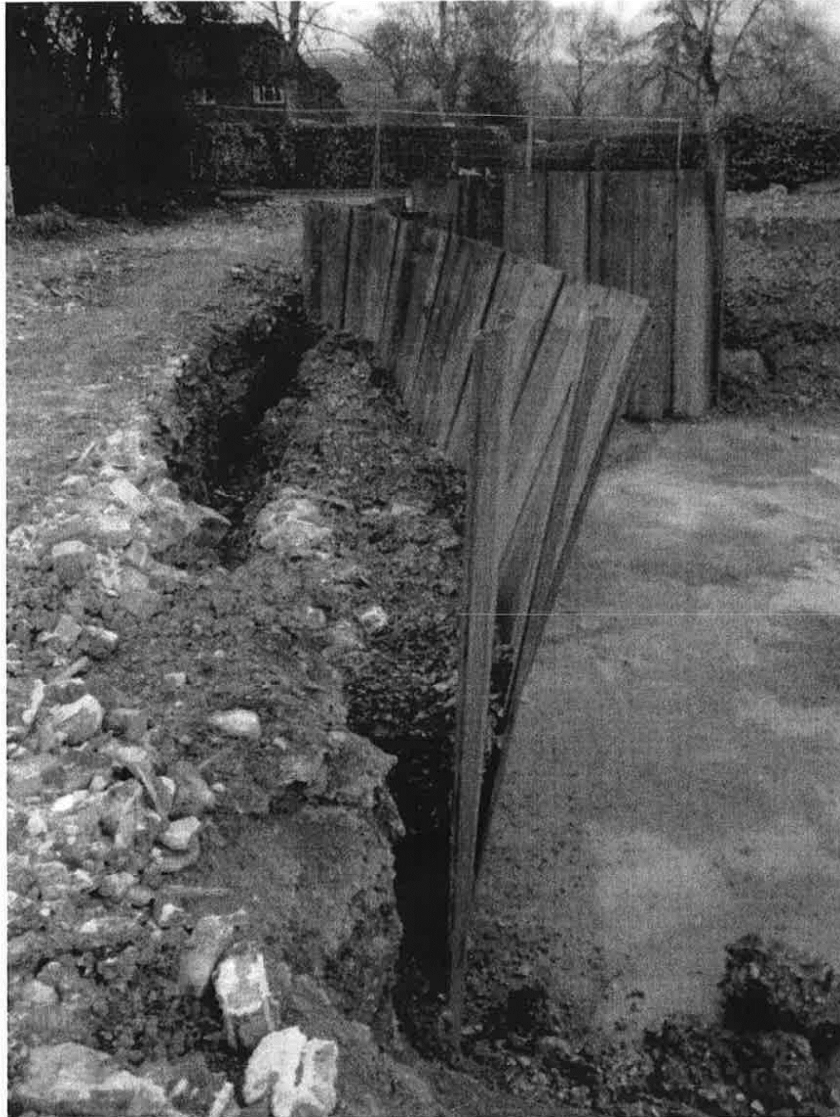
This picture is of the ground to the Western boundary, but the same thing happened to the eastern boundary piling, though for some reason I don't have a picture for this.

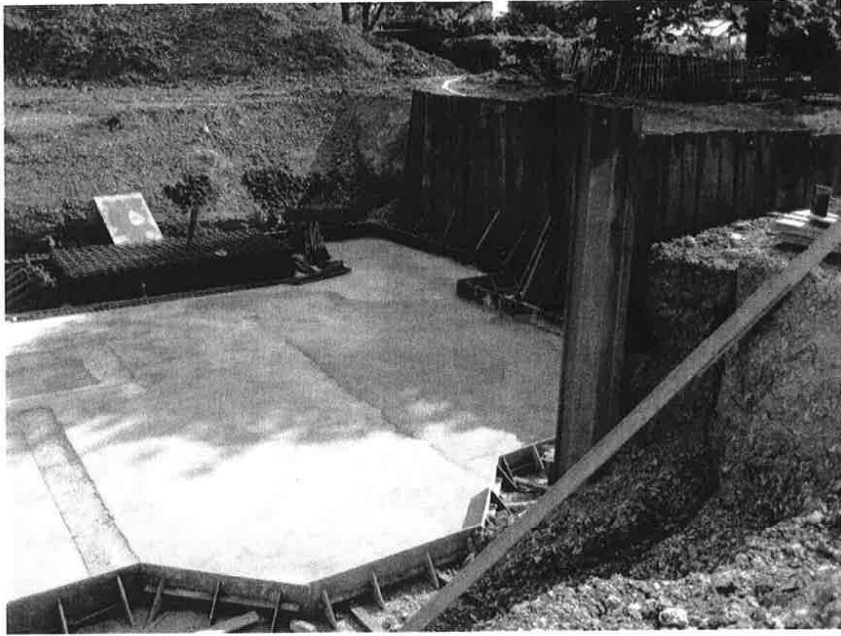
The screed slab area. You can also see just behind the sheet piling how great chunks of ground would just “sheer” off. You can also see this happening at the other end of the sheet piling where there is the beginning of a mound of earth appearing. This happened a lot.

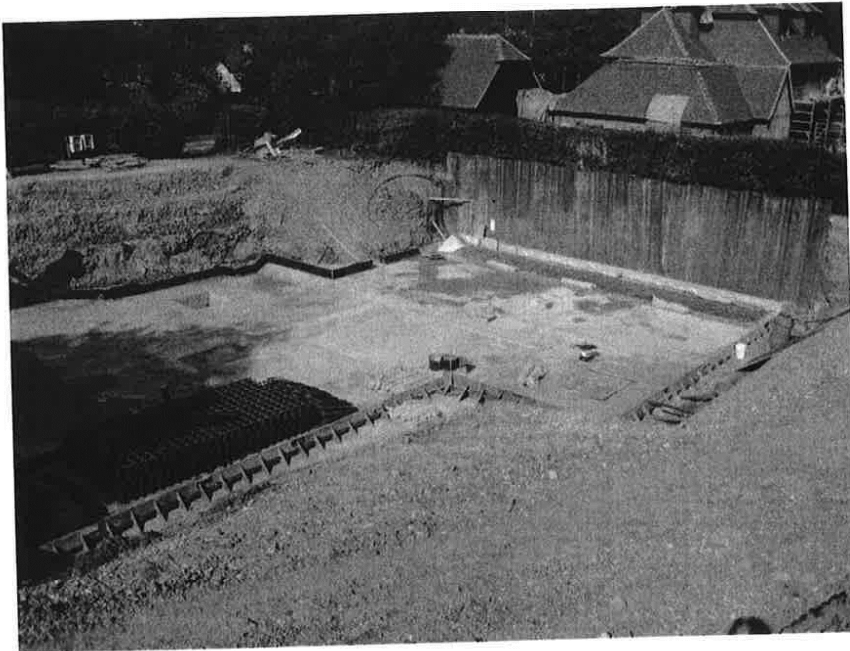
The slab area in preparation for the bentonite material that forms the waterproofing membrane. You can see the first couple of sections.

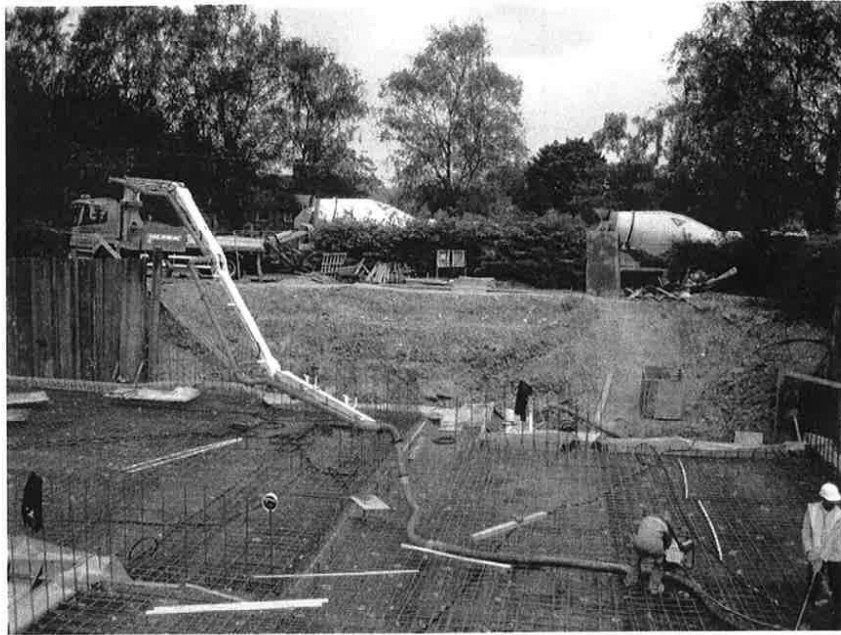
Just at the beginning of pouring the slab..... that's the SINGLE slab..... atleast that's how it looks to me!

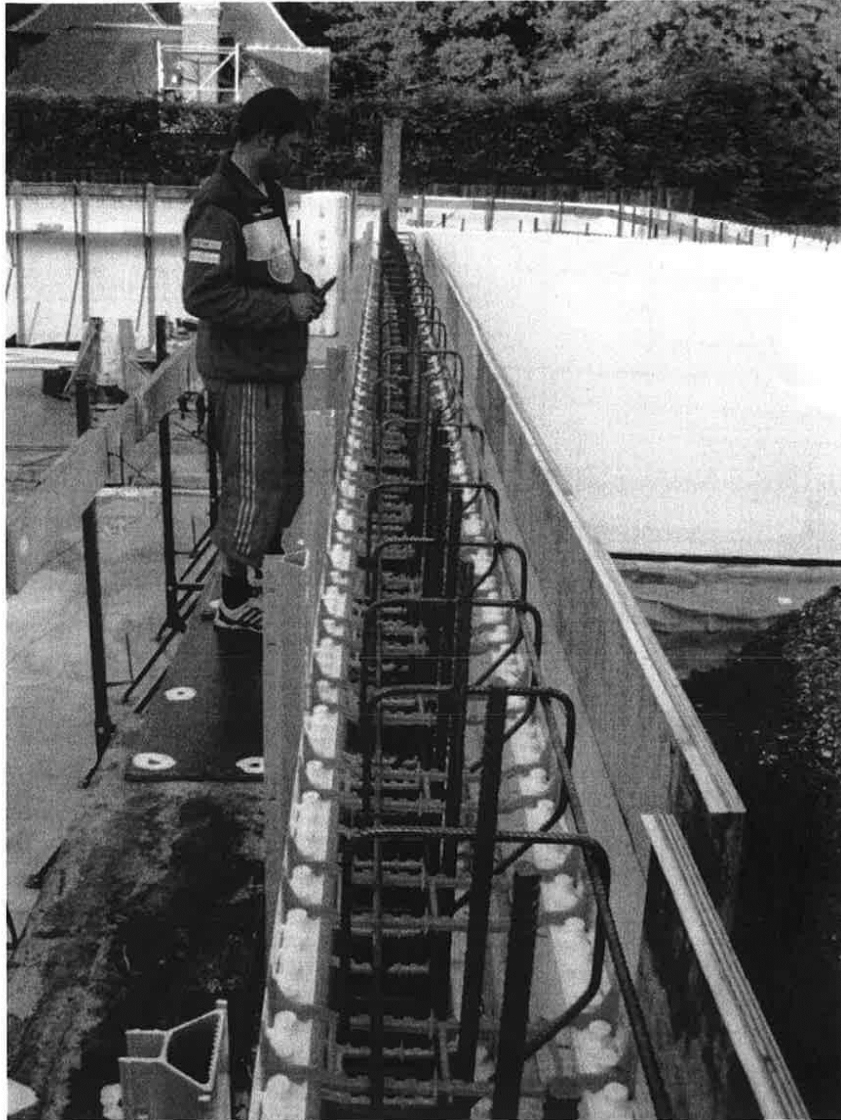
There is some steel in those walls to reassure you.... You can also see the water in the outside corner of the building around the bottom of the slab. By then we had a pump hooked up to pump it out continuously.

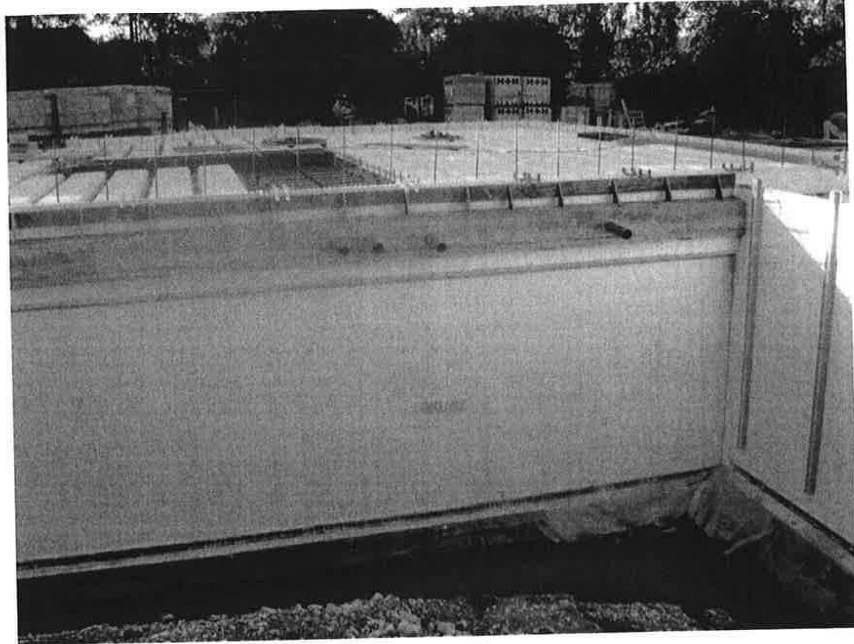
Water.
