Kent Pedestrian Guard Railing Assessment

Sevenoaks – Report for Consultation

Client: Kent Highway Services
 Project: Kent Guard Railing Assessment Job No: B1555300
 Document Title: Sevenoaks Guard Railing Assessment

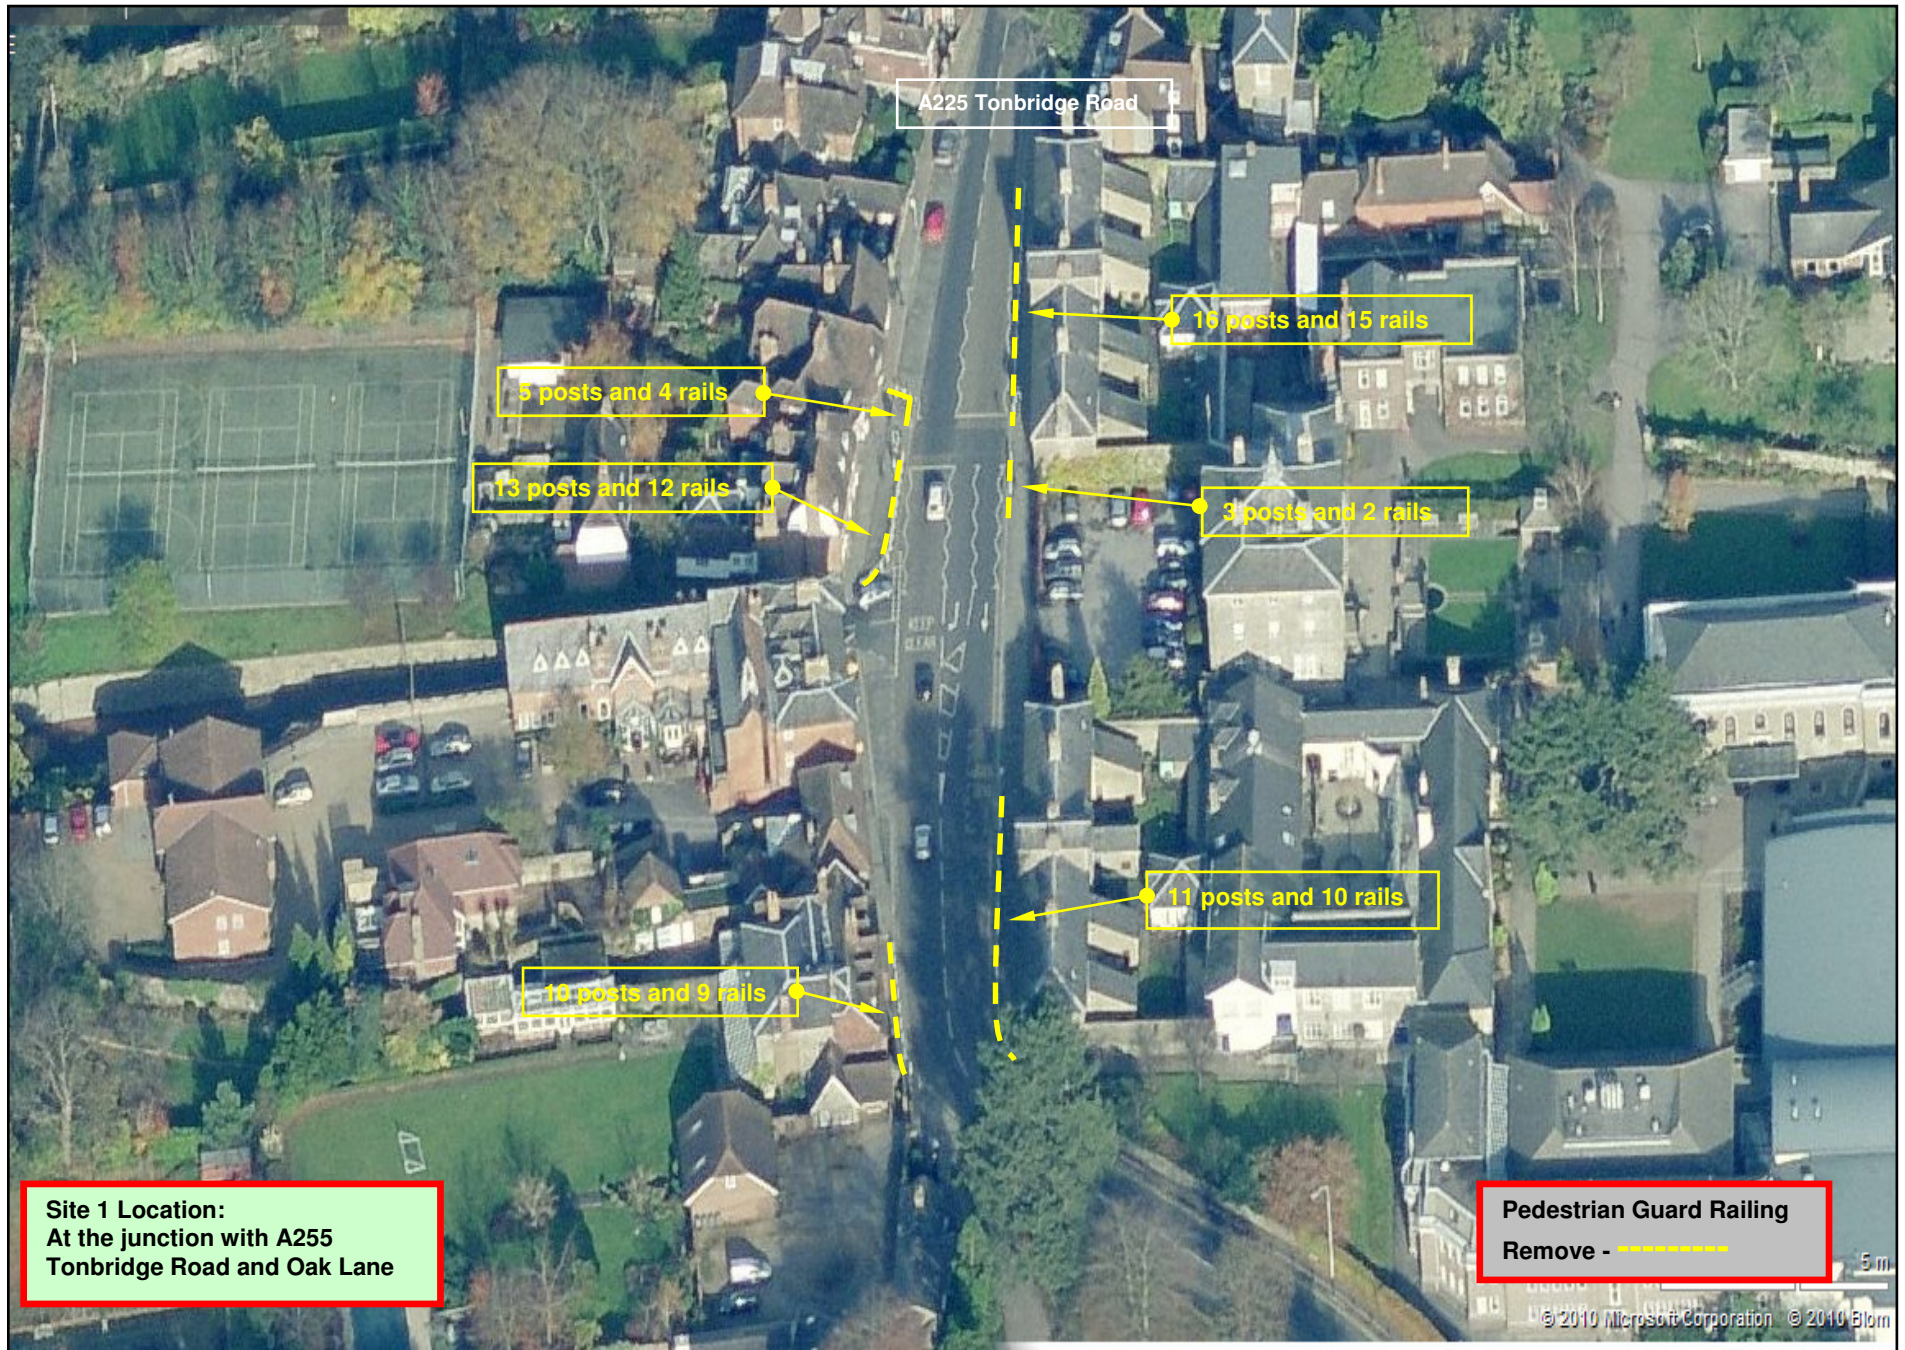
Illustrated Diagram of site 1

The guard railings are located outside the Sevenoaks School and the junction with Oak Lane. During peak times there is a high volume of vehicular traffic and the Pelican Crossing at the site has a high volume of pedestrian movement, in particular school children.

The post and railing type of panel installed offers little benefit as a guide or protective device for either pedestrians or vehicles.

The general condition of the post and railings are fair.

Site 1 Location:
At the junction with A255
Tonbridge Road and Oak Lane

- **It is recommended to remove the post and railing at site 1.**

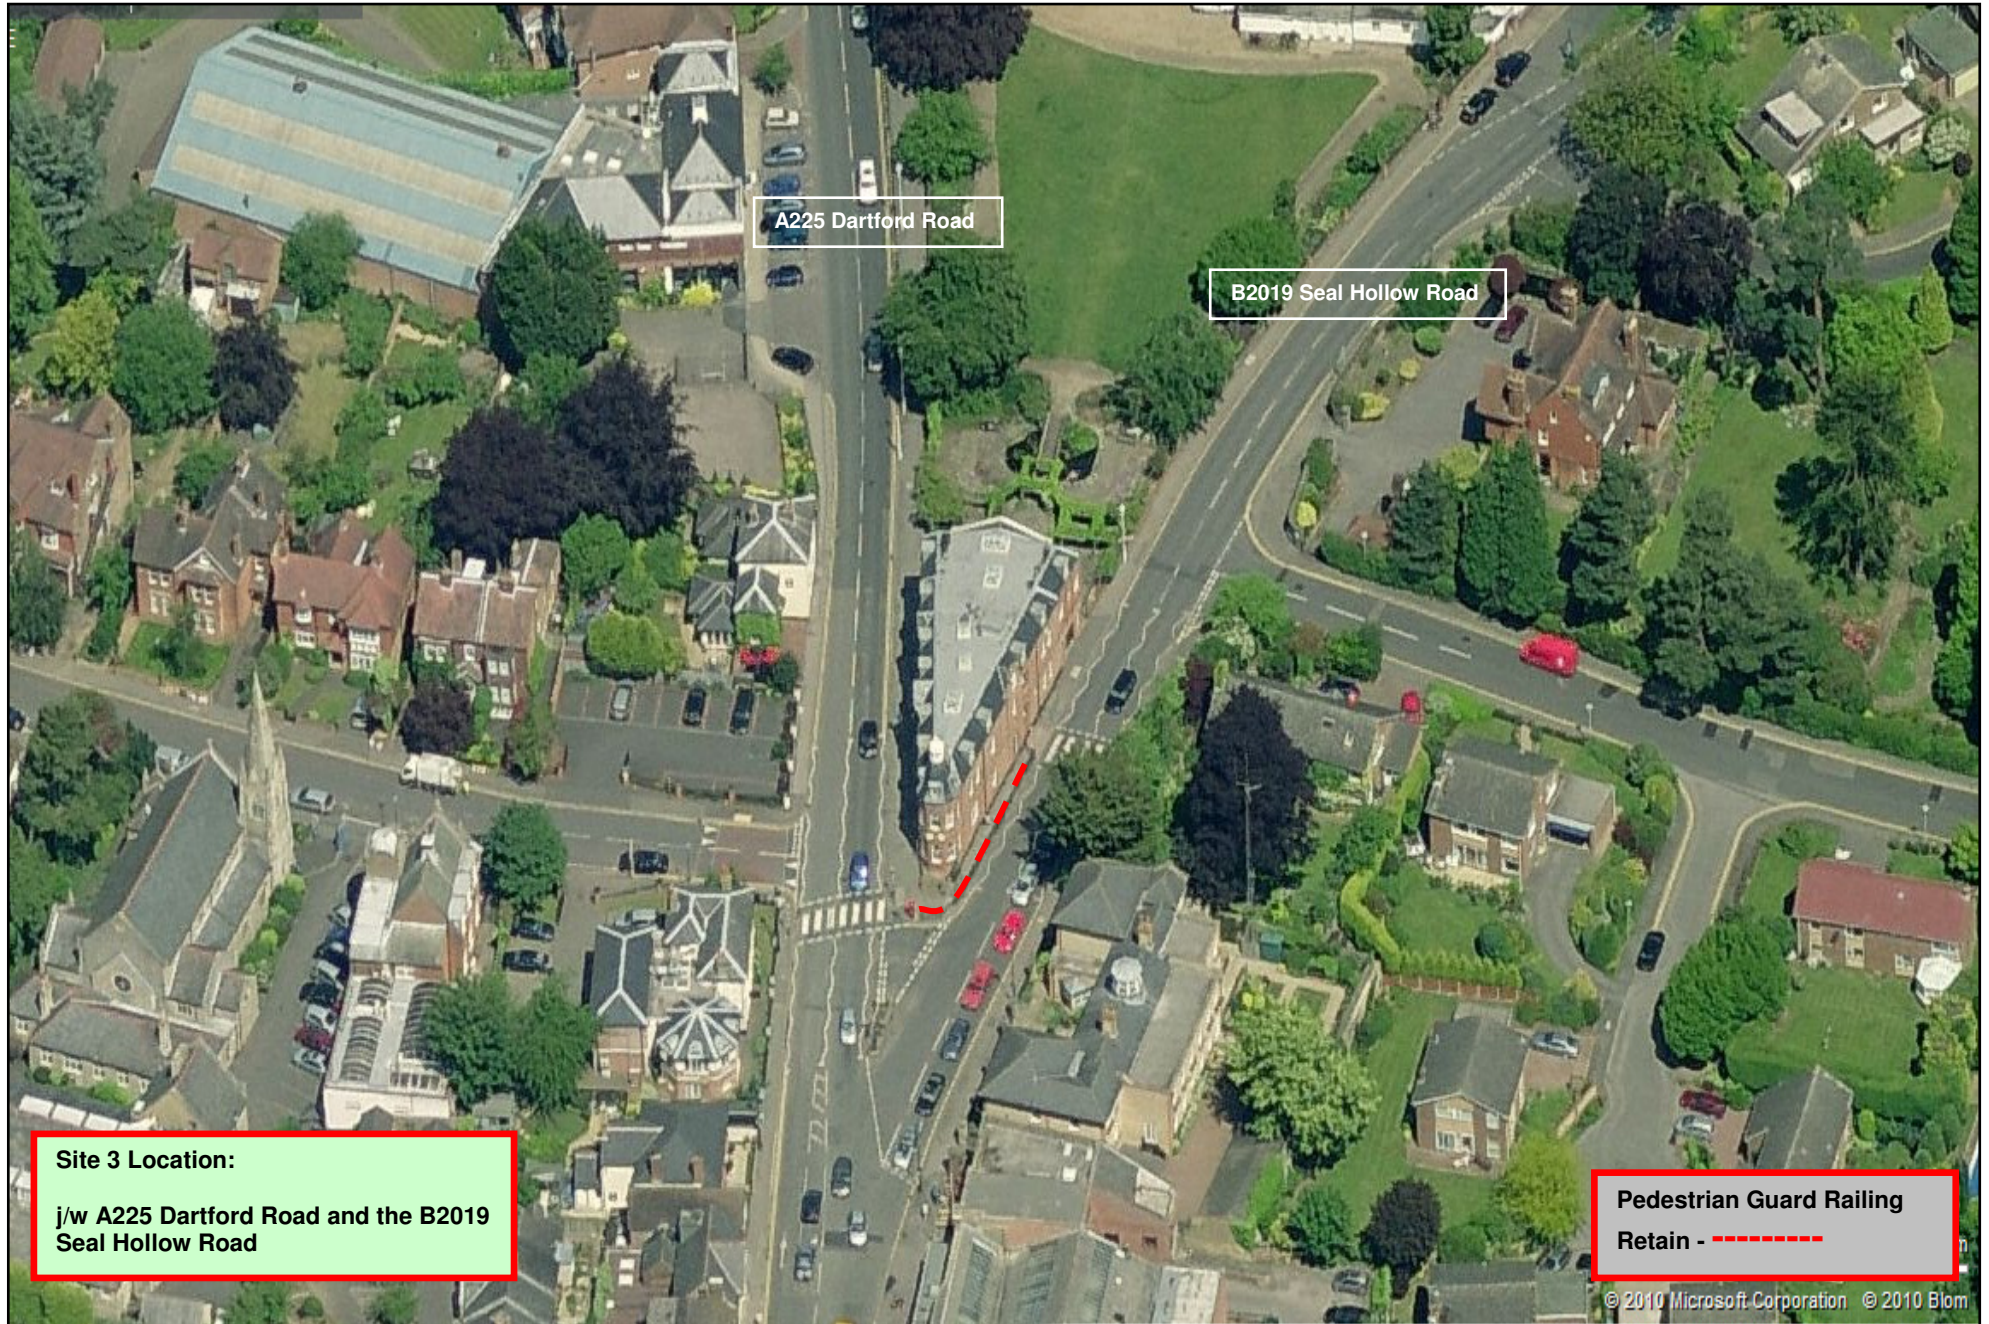
Illustrated Diagram of site 3

The pedestrian guard railing is located at a complex junction and links two Zebra Crossings, one located at the junction with A225 Dartford Road and the other approximately 15metres away on the B2019 Seal Hollow Road.

The guard railings guide pedestrians from the A225 Dartford Road footway away from the northern and southern exit and entry points of Seal Hollow Road to a safe point at the Zebra Crossing on Seal Hollow Road and visa versa. The site has a high volume of vehicular traffic and a moderate volume of pedestrian movement.

Site 3 Location:
j/w A225 Dartford Road and the B2019 Seal Hollow Road

- **It is recommended to retain the pedestrian guard railing at site 3.**

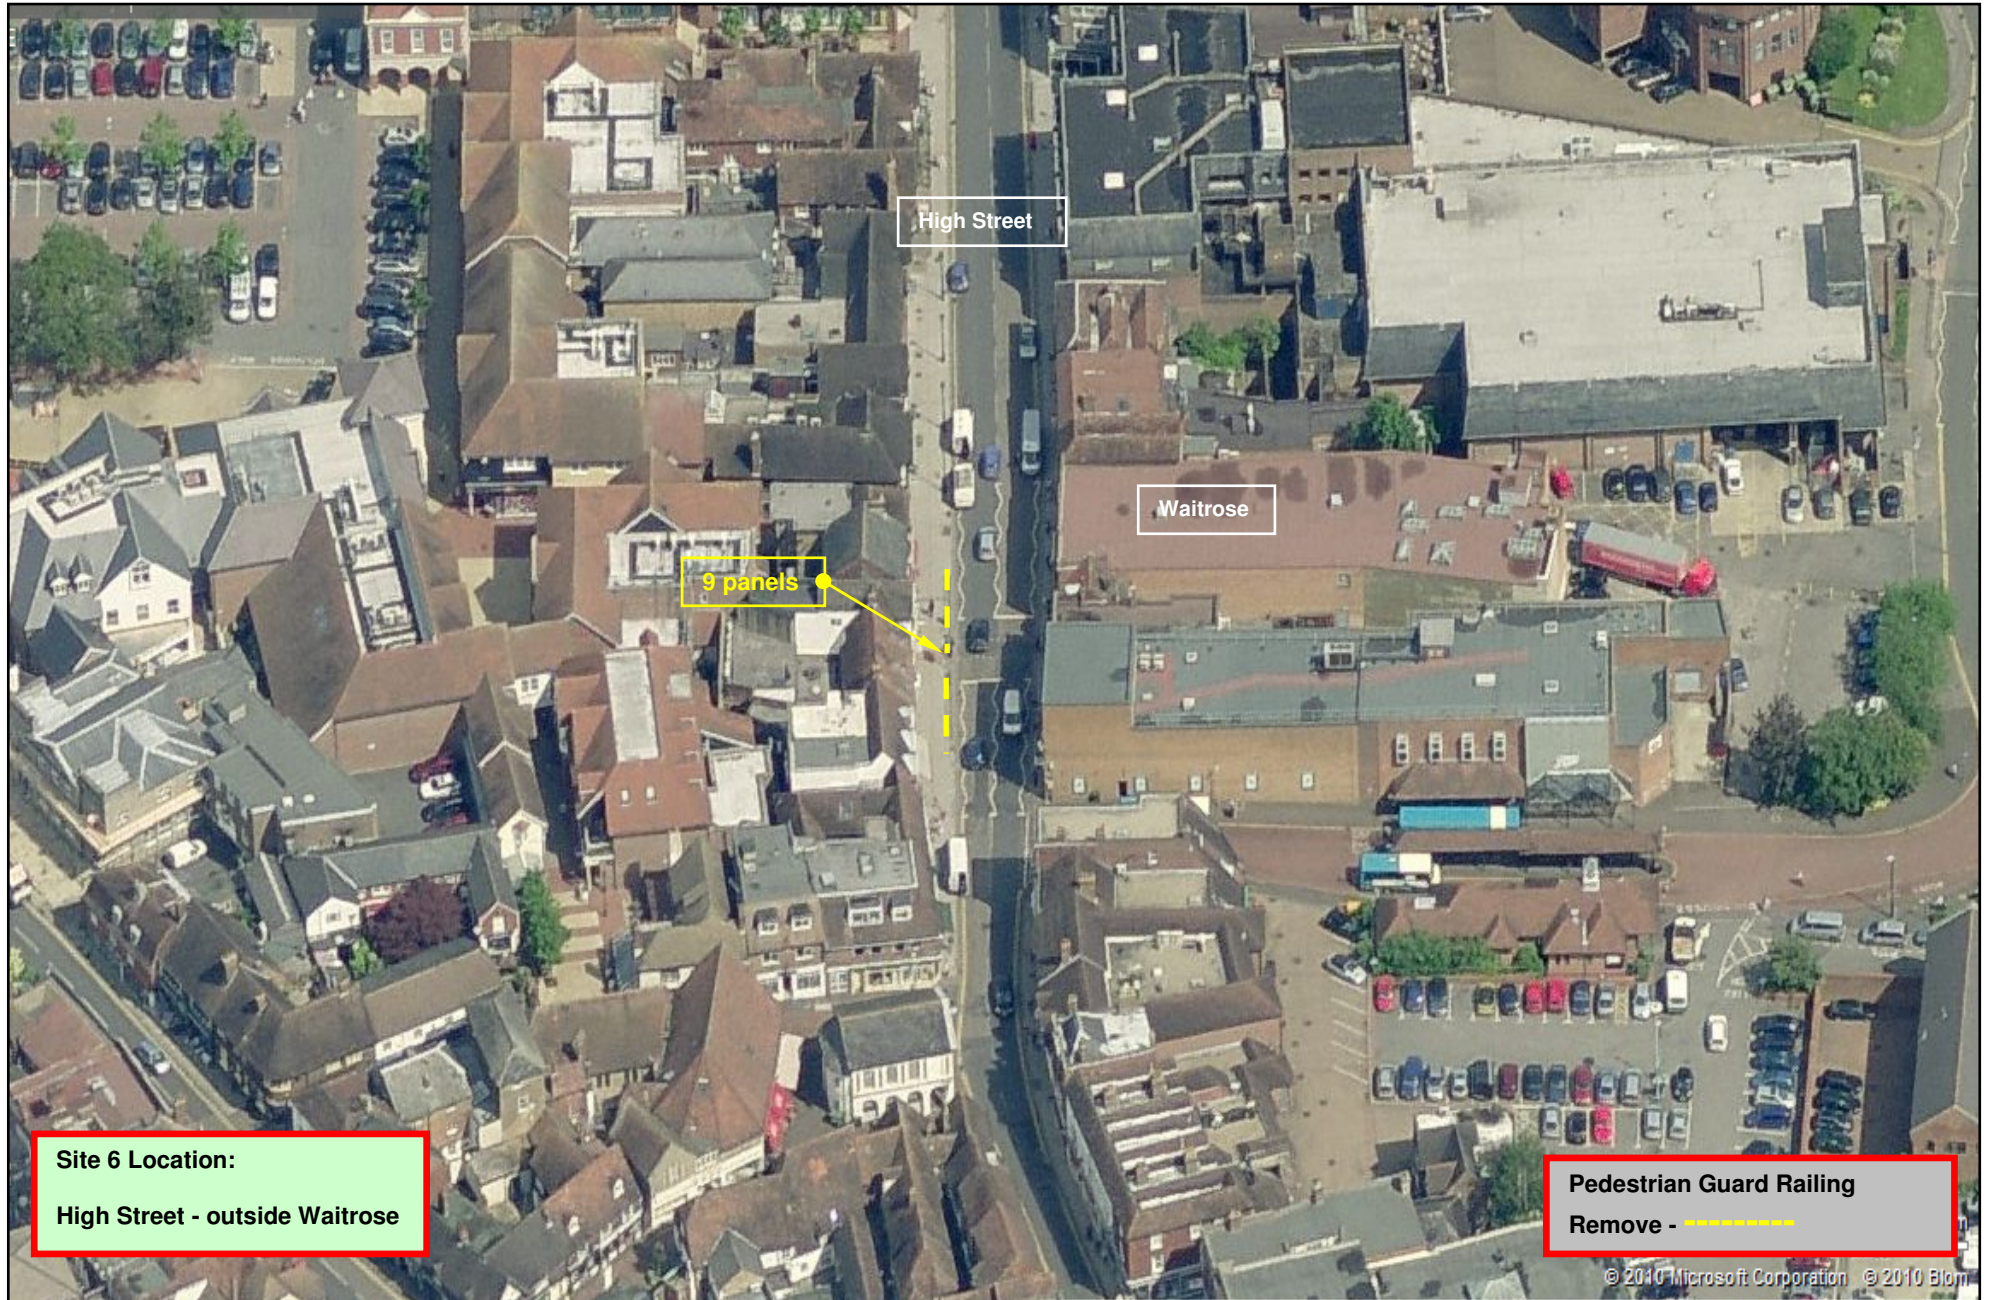
Illustrated Diagram of site 6

There are 9 pedestrian guard railing panels located on the western side footway at the Pelican Crossing and no guard railings on the eastern side, the 9 railings offer no benefit as a guide or protective device, as pedestrians were observed crossing the road all along the High Street.

Site 6 Location:
High Street - outside Waitrose

- **It is recommended to remove the pedestrian guard railing at site 6.**

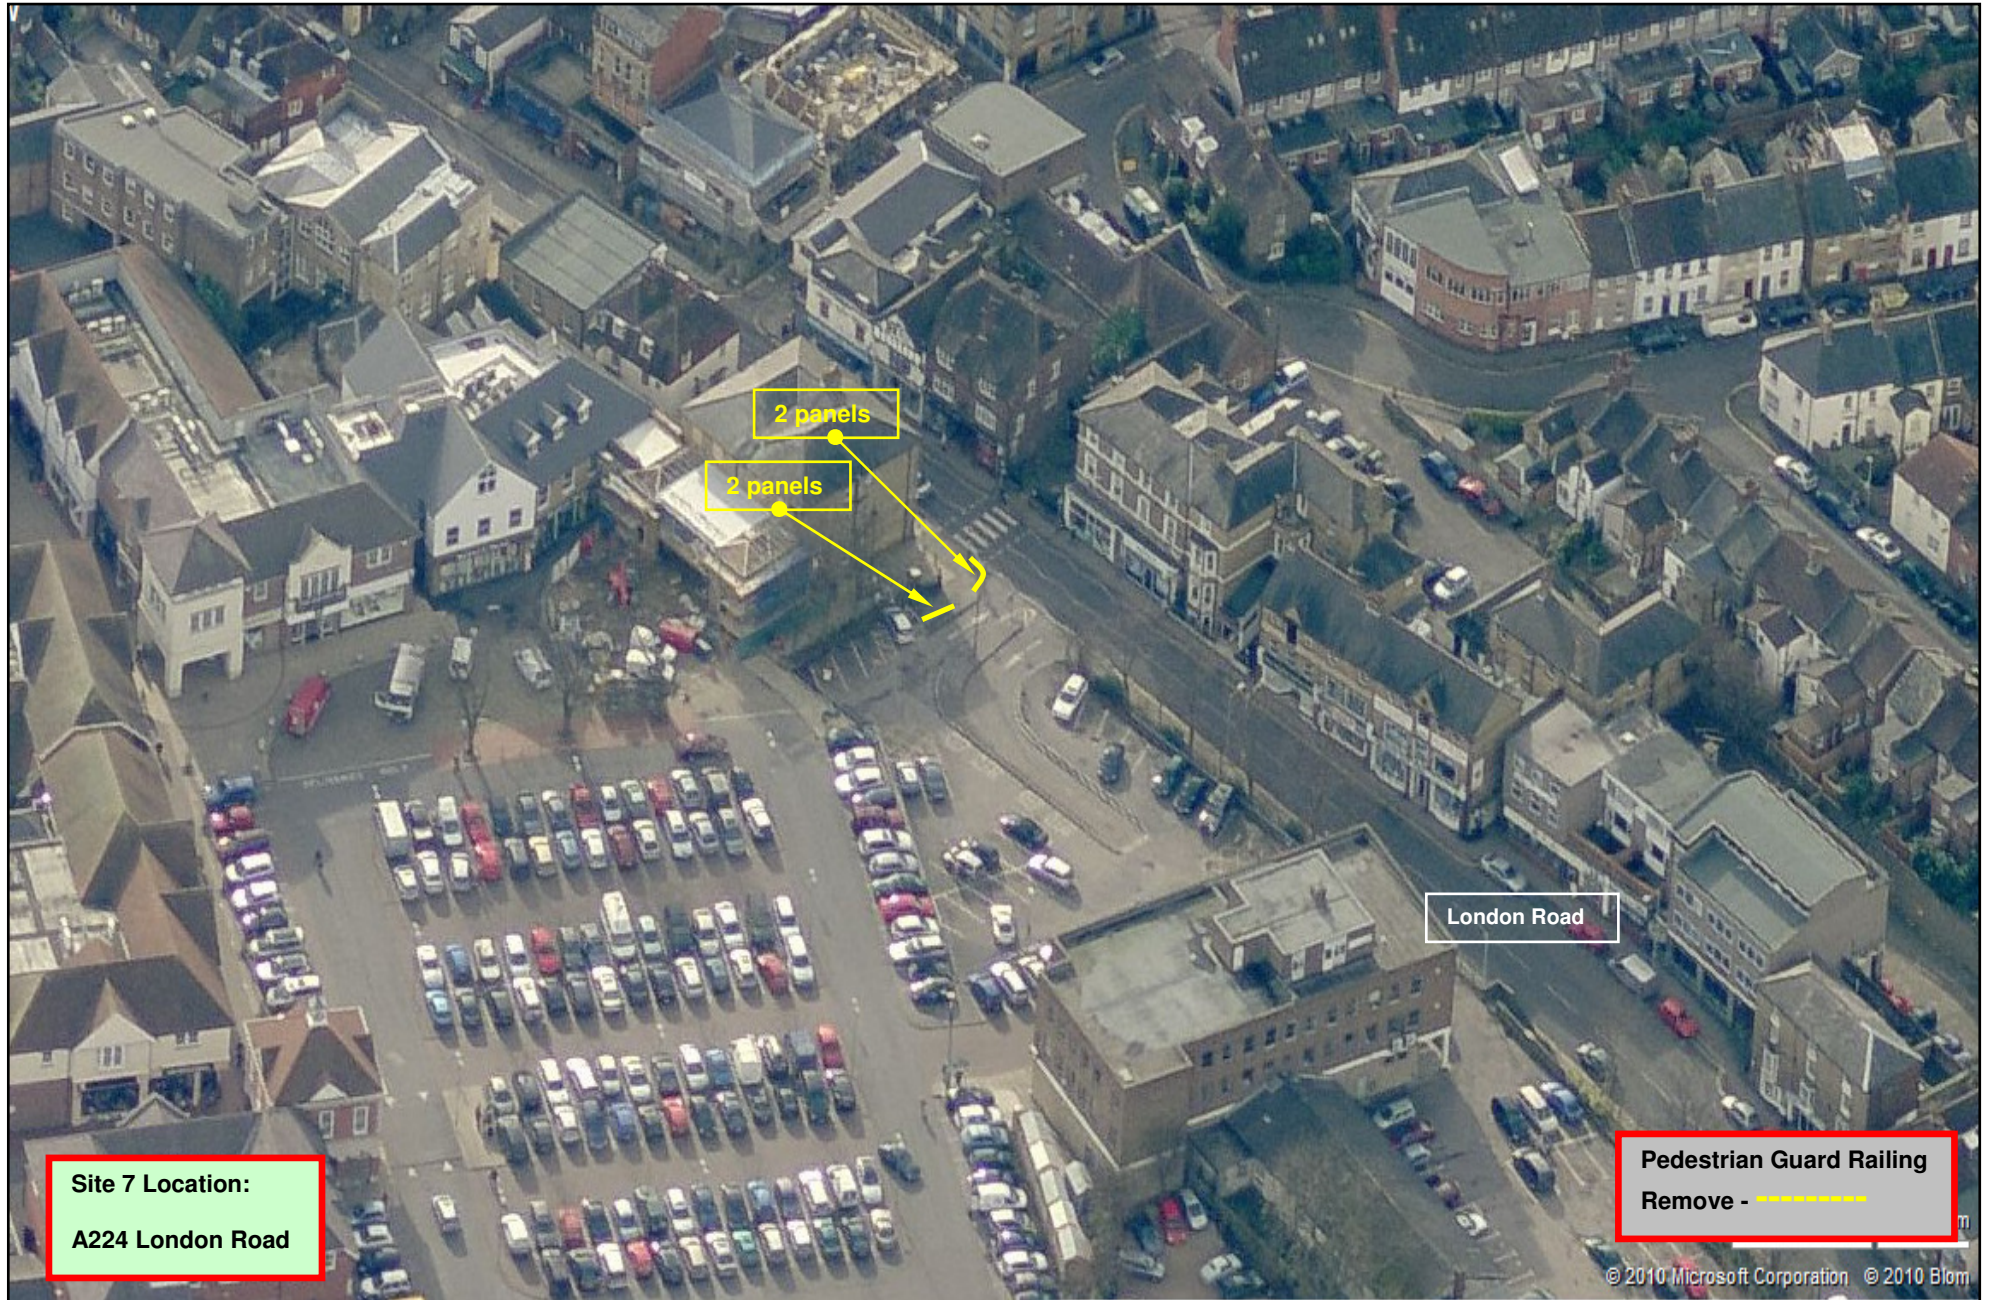
Illustrated Diagram of site 7

There are 2 pedestrian guard railing panels located on the eastern side footway at the Zebra Crossing and no guard railings on the western side. There are also 2 panels located immediately inside the entrance to the car park which offer no benefit as a guide or protective device.

Site 7 Location:
A224 London Road

- **It is recommended to remove the pedestrian guard railing at site 7.**

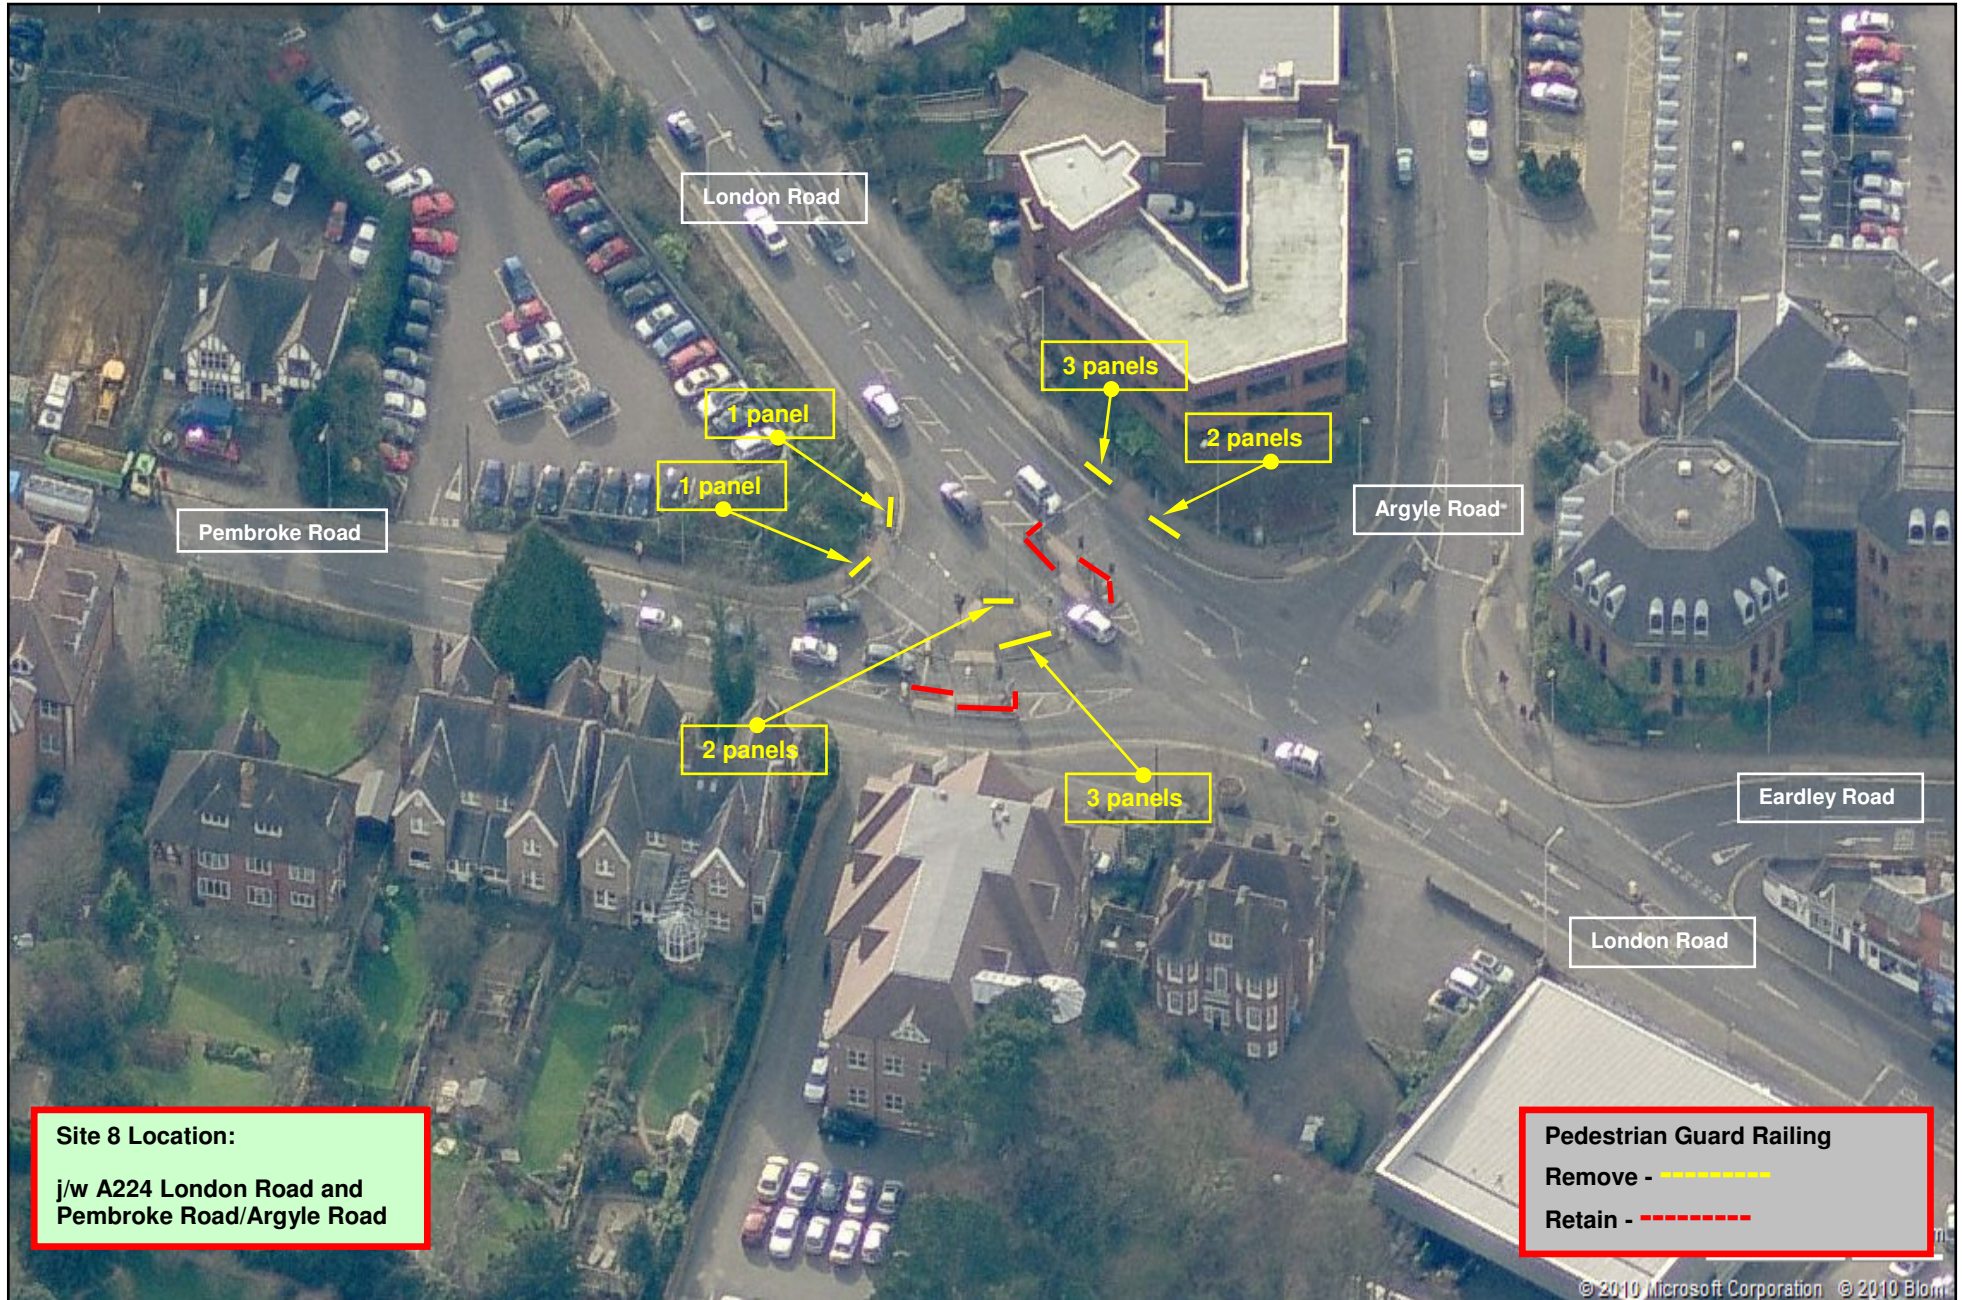
Illustrated Diagram of site 8

The site is located at a large busy crossroad junction with moderate pedestrian movements. The junction has three refuge island crossing points of which two are controlled, with the centre island guard railings and the footway railings offering little benefit as a guide or protective device.

- **It is recommended to remove the pedestrian guard railing at site 8.**
