**OTFORD PALACE
OTFORD, KENT
CONSERVATION STATEMENT**

Drury McPherson Partnership
Historic environment policy and practice

FINAL DRAFT: FEBRUARY 2018

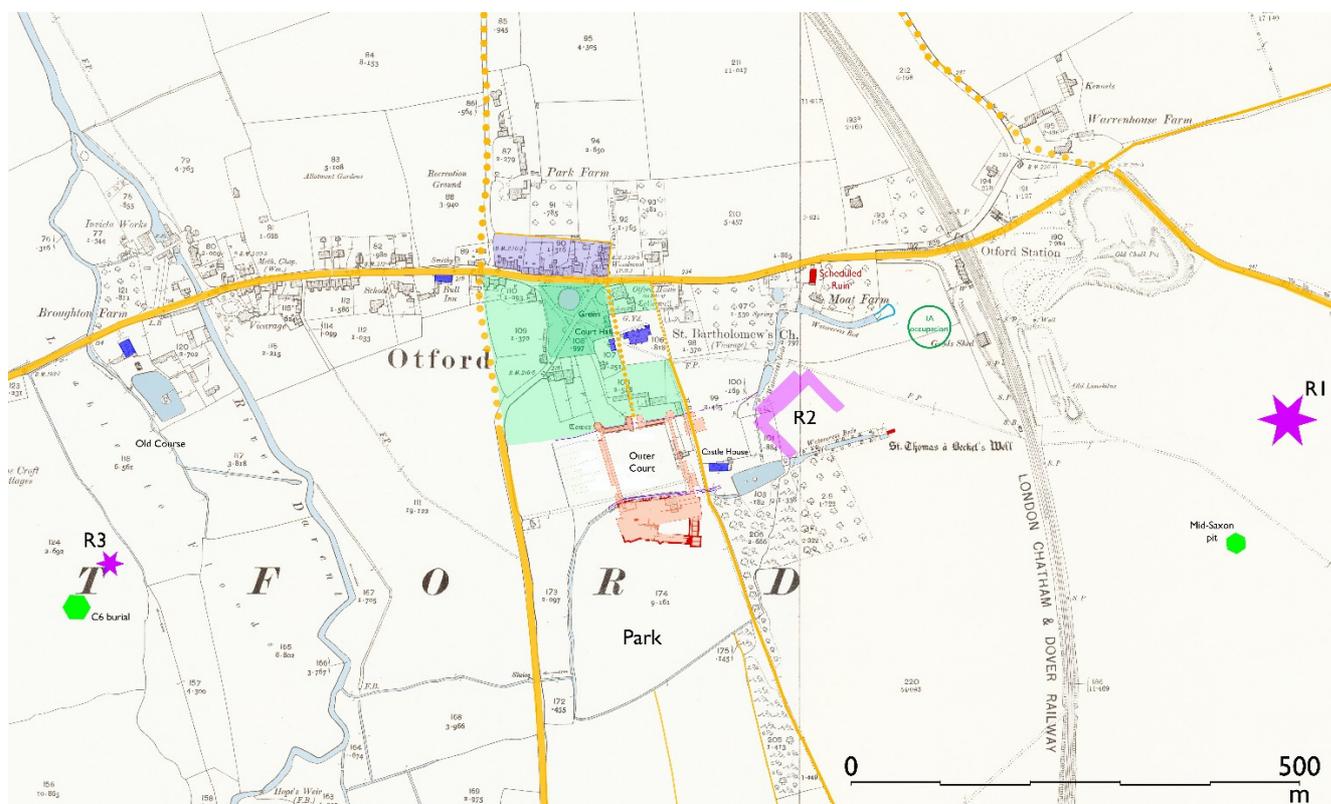
Fig 1 Map of Otford showing the principal features of the historic landscape, superimposed on the second edition 25" Ordnance Survey map, 1907. The outline of the villa (R2) is partly schematic, but allows its approximate scale to be compared with the medieval palace

2.2.2. Traces of an Iron Age occupation site have been found near Otford Station (Fig 1).⁴ This is also close to the second of two large Romano-British buildings located about 500m apart, east of the Darent and south of the 'Pilgrim's Way' (Fig 1, R1, R2). Current understanding is that the eastern one⁵ was occupied primarily in the later first to second centuries, succeeding the iron age settlement, while the western one belongs to the third and fourth centuries. This implies that one succeeded the other as the main house ('villa') at the centre of an extensive agricultural estate, although some estate activity probably continued at the earlier site.⁶ West of the Darent, agricultural buildings (but still in part of masonry) may be part of another working estate centre (Fig 1, R3). The Darent valley is notable for its distribution of villas, including Lullingstone, about 6km north, and Darenth, about 12km north.⁷

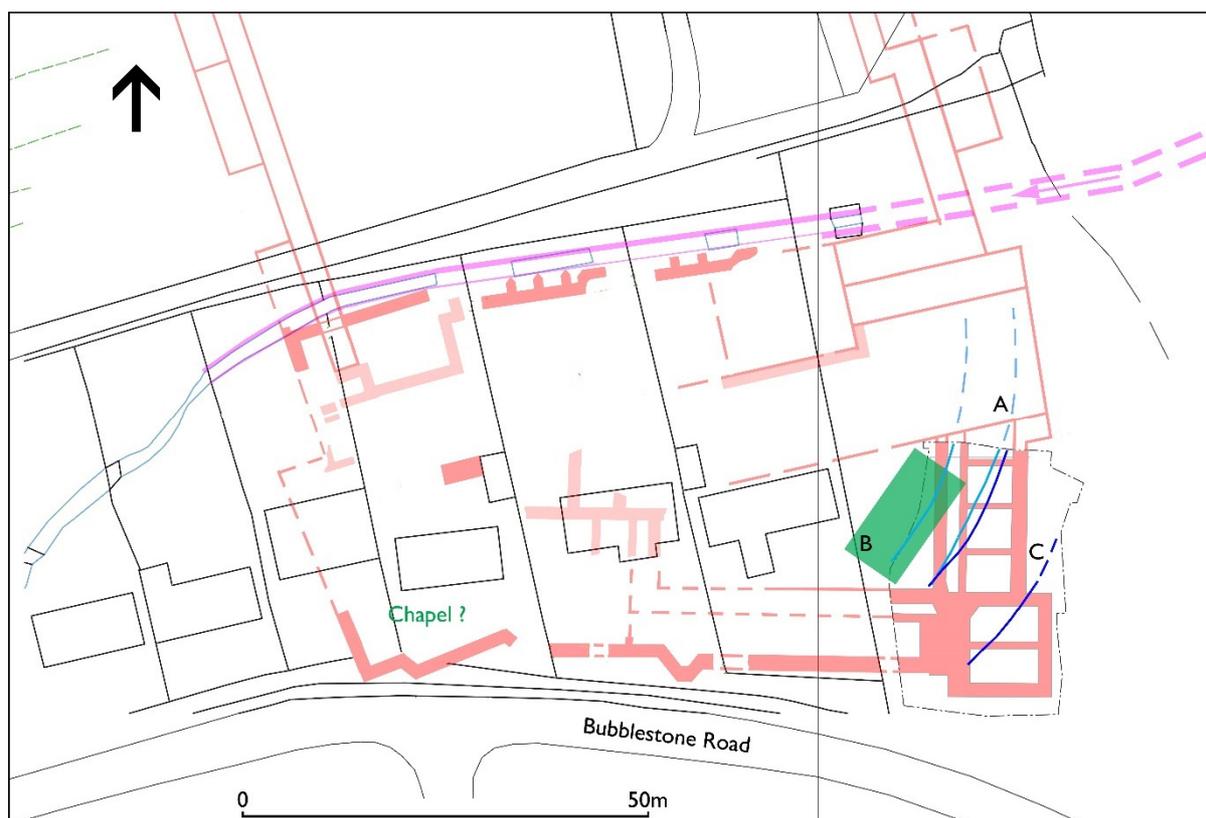
Fig 2 Elements of the earlier medieval house, in relation to modern development and (in red tone) known elements of the early 16th century palace. A, earliest moat; B, mid-14th century lodging range; and C, its associated moat, superseded by Warham's new south-eastern extension to the moated island

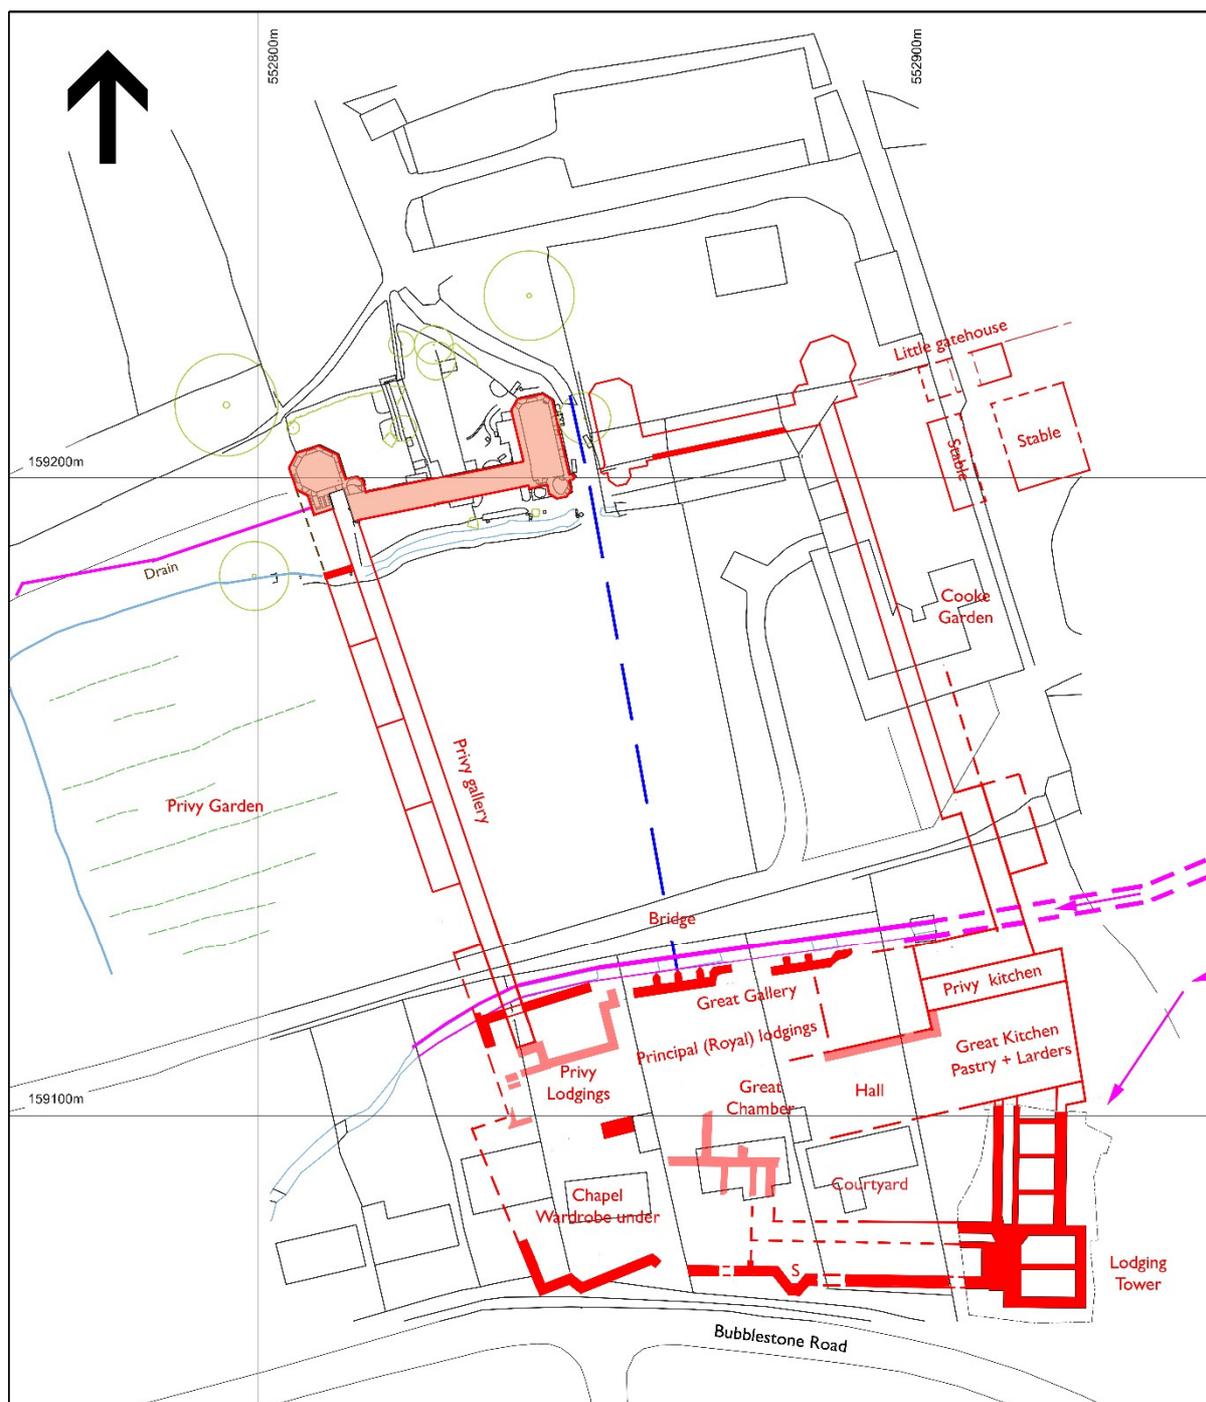
Fig 4 Overall plan of the Tudor palace against a background of modern topography; 100 m grid superimposed. Standing buildings shaded orange; excavated or standing walls shown solid red; walls suggested by geophysical survey by thin red lines; recorded but unverified walls shown in red tone; culverts in purple. The dashed blue line joins the entrance gatehouse to the moat bridge

2.5.14. Although long post-dating alterations to structure or room use made by Henry VIII for royal use, the 1573 survey best illustrates the general layout of the main house, the surveyor arriving via the east outer court gallery and generally working anti-clockwise around the parts that needed repair. The sequence, which can be followed on the outline plan of the inner court, reconstructed from the surviving and recorded walls³⁷ (Fig 4), runs as follows:

2.5.20. The outer court was trapezoidal in plan (Fig 4). The north range was symmetrical around the central 'great gatehouse',⁴⁰ of which the west block survives to just above first floor level. The approximate width of the gate passage is given by dimensions on John Thorpe's partial plan of the gatehouse from the early 17th century (Fig 6). The walls are thicker than those of the north-west tower, probably because of the need to accommodate fireplaces in the main walls. The towers were placed forward of the north range and the gatehouse projected yet further, to create an impressive entrance façade to what was a courtyard defined essentially by narrow galleries.

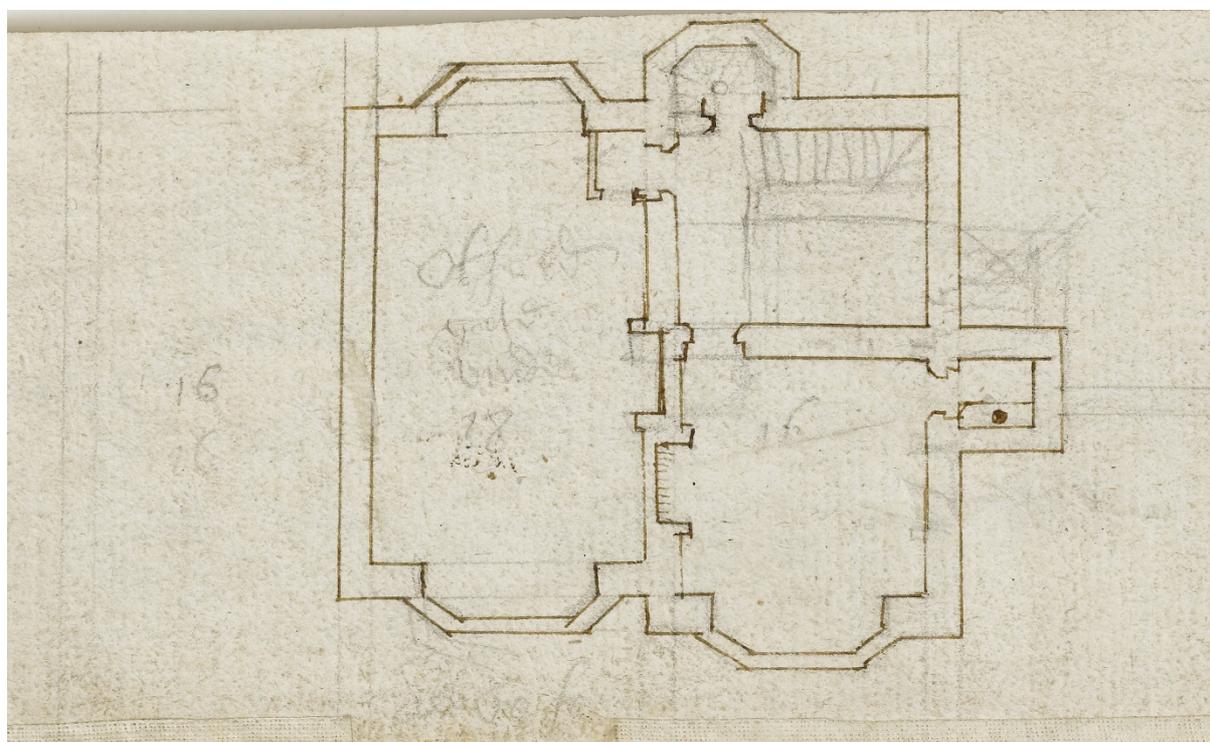
Fig 5 Sketch plan of the western part of the gatehouse at first floor level by John Thorpe, soon after 1605-6; north is at the bottom and the east block is shown only in pencil outline (© Sir John Soane's Museum, vol 181/182)

2.5.27. Thorpe's plan at first floor level (Fig 5) shows a single large chamber over the gate passage, with an oriel window at either end, accessed by an internal porch from the southern of two compartments in the west block. The north compartment had a fireplace and (secondary) garderobe. His sketch plan shows a masonry wall between the two compartments, but the evidence from the fabric at ground floor level suggests that the divisions were of timber and not necessarily corresponding on each floor.⁴⁹

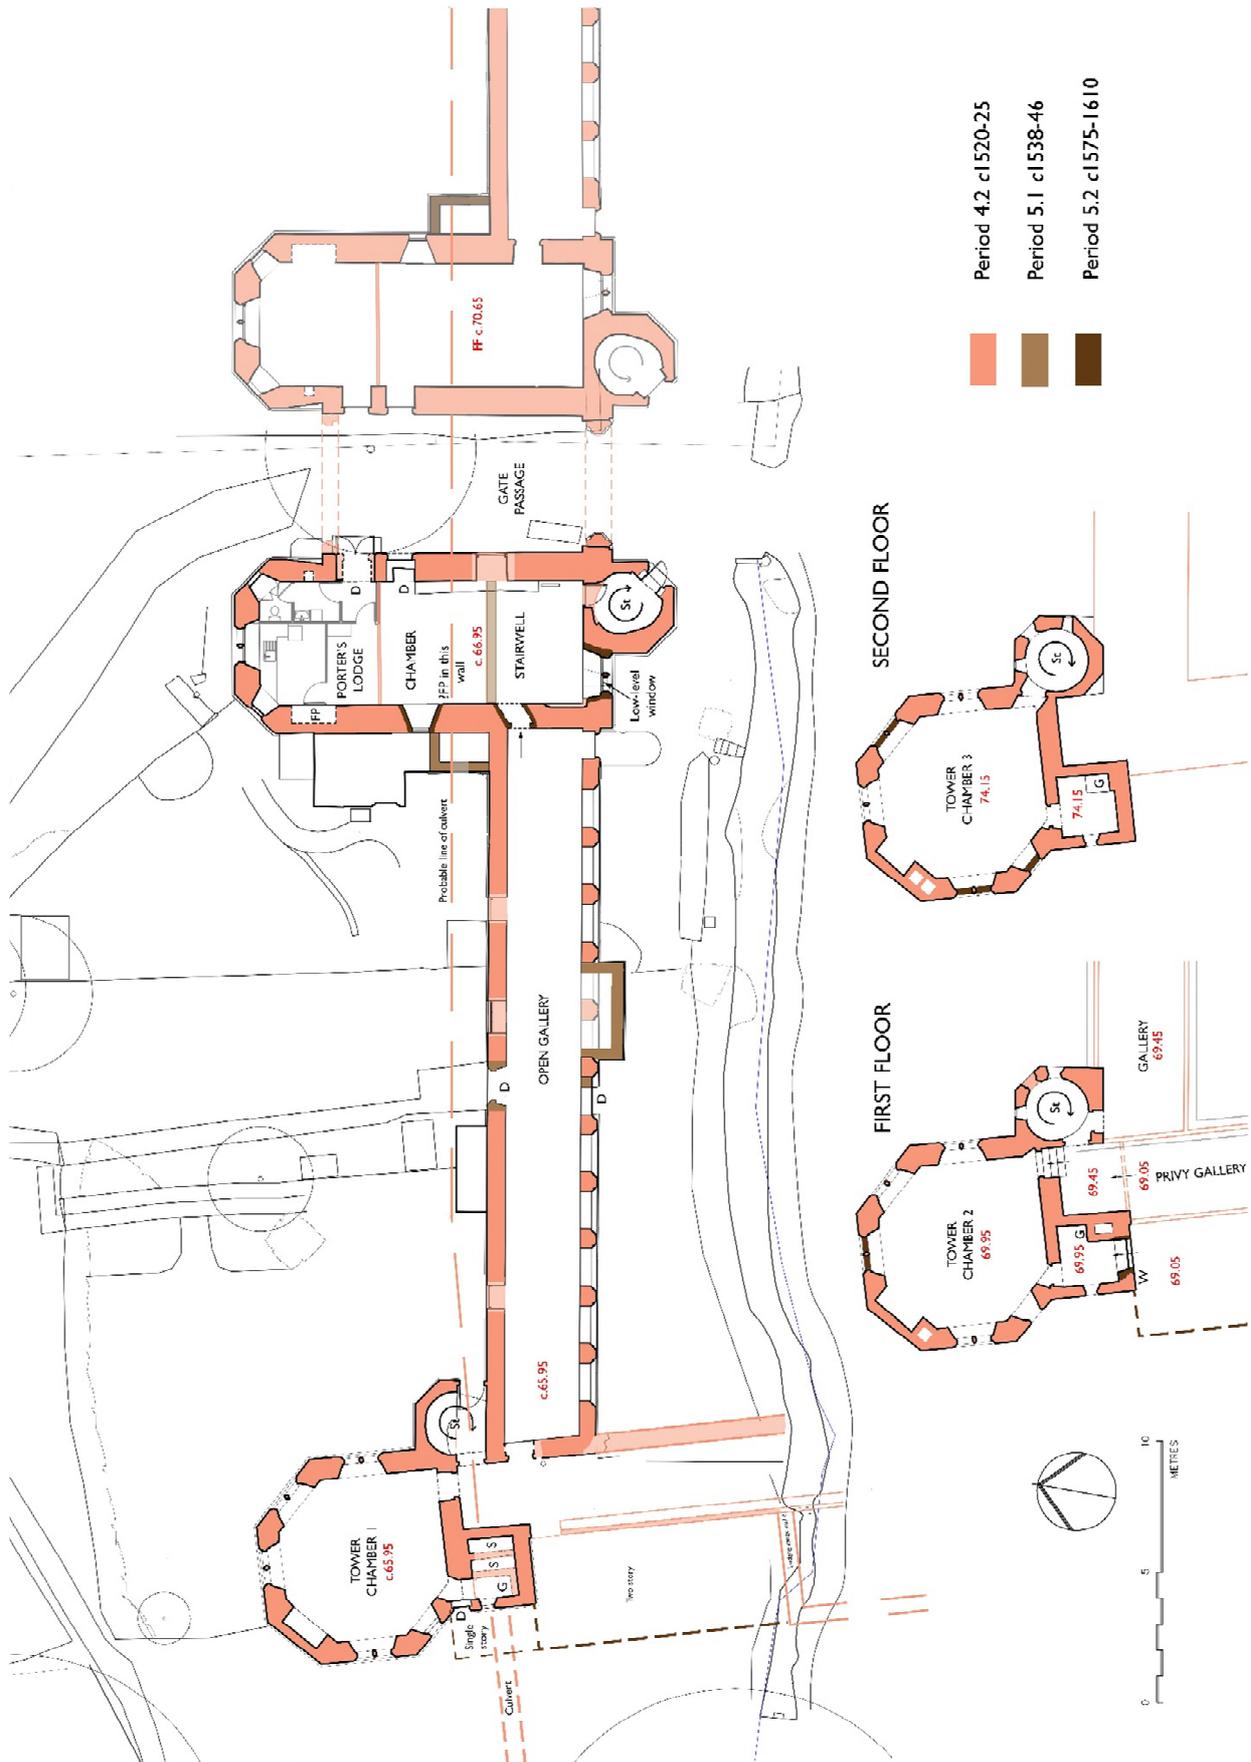
Fig 6 Phased and partly reconstructed ground plan of the surviving elements of the north outer courtyard range (base plan: TFP). Figures in red are historic floor levels in metres above Ordnance Datum Newlyn

2.5.24. The gatehouse had canted bays projecting to the north, flanking the gateway of which only a rebuilt scar survives on the existing structure (Fig 6). Immediately within what was the gate passage, the rere-arch of a doorway survives, later widened and the exterior destroyed; a very awkward position if, as one must assume, the outer arch of the passage was fitted with gates, one of which would open over the doorway. Adjacent to this is another doorway, the rere-arch identical, blocked but intact, with a three-centred head (Fig 10). Outside the gate the flanking walls are splayed inwards from just above plinth level, as if better to display the gateway but primarily connected with accommodating an oriel over it.⁴⁴ The moulded base of the south, inner arch of the passage survives *in situ*; its plan, with a rebate formed between the stone and brick jambs of the archway, indicates former gates,⁴⁵ as does the remains of plaster on the west wall of the gate passage, redolent of an internal space. On the courtyard side the passage was flanked by stair turrets, of engaged octagon plan, the survivor entered from the south-east. Internally it is much damaged, but it rose directly to the upper floors,⁴⁶ with the stair probably built solid to door head height, with stone treads above, like that serving the tower.

- 2.7.9. The projection on the south side of the cloister (Figs 6, 8), was also done with some care and placed neatly to encompass two of the cloister bays. It is similar in construction to the garderobe projection, sharing the distinctive feature of stonework continuing above the main plinth; which suggests that they are broadly contemporary. The plinth adjacent to the west has been raised in brick, and a doorway cut through the central arcade opening, with a chamfered brick jamb, both coursing with but not bonded to the main wall. The rough filling above the doorway is late and suggests that it replaced a timber window (Fig 17), and thus that this short cloister had been glazed in at or by at the time of the intervention. The projection appears to be a substantial hearth,⁸⁴ suggesting the likelihood that another served the enclosed gallery above.

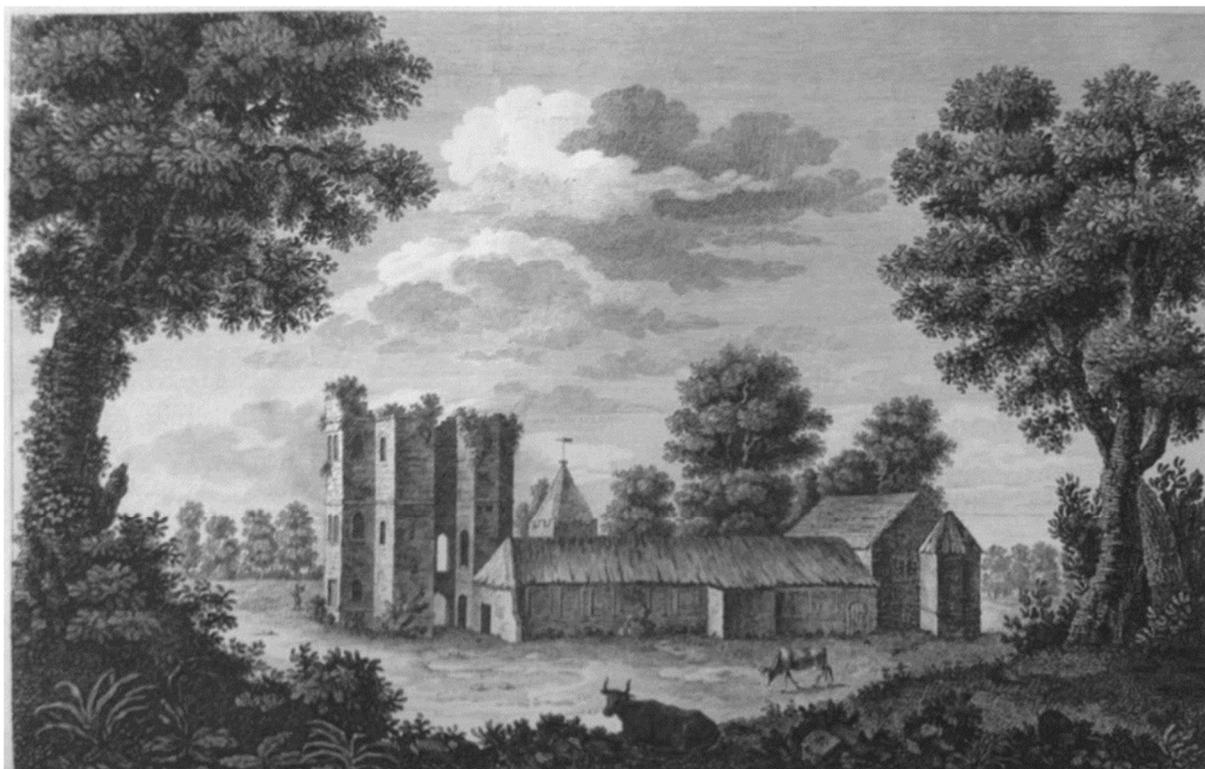
Fig 7 The north-west range of the outer court c1775, as illustrated in Hasted's History of Kent (1778)

- 2.8.4. By the time of the first surviving illustration in Hasted's *History of Kent* (1778 Fig 7),⁹³ the north-west tower was roofless, its parapet largely decayed and mostly lost. The north range was in agricultural use, under a thatched roof over the brick lower storey, as was the surviving ground floor of the western part of the gatehouse. Hasted noted that *'There are now only a wall and two towers, part of the outer court remaining of it. These towers some years ago were two stories high[er],⁹⁴ but the largest of them, which was covered in lead, falling in, the Chief Baron took down the upper story of each.*

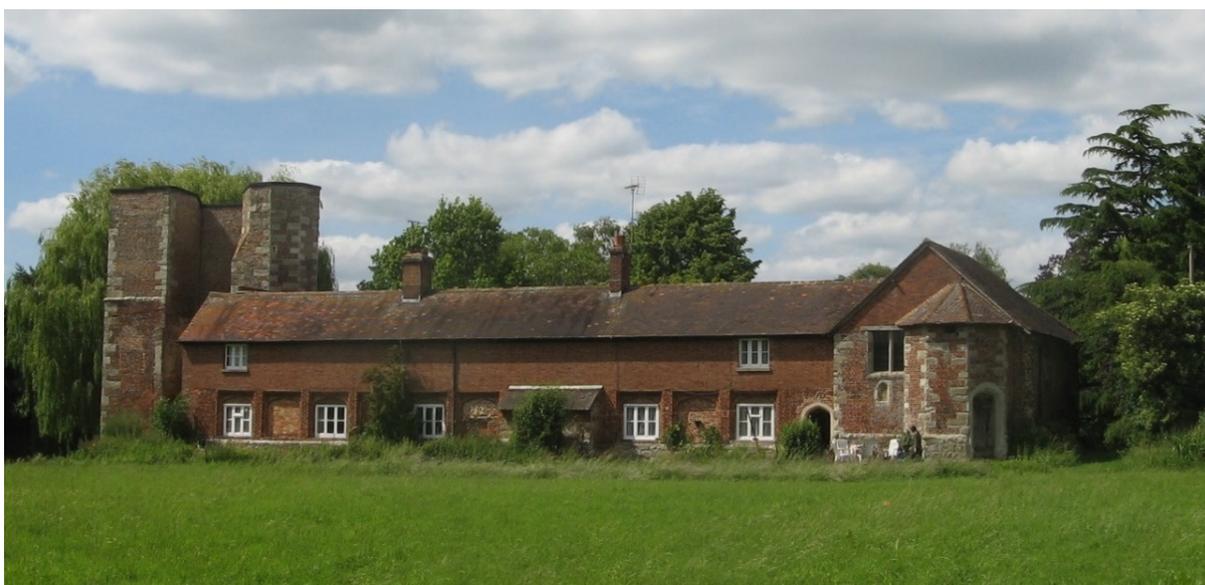
Fig 8: The north-west range of the outer court as it currently exists

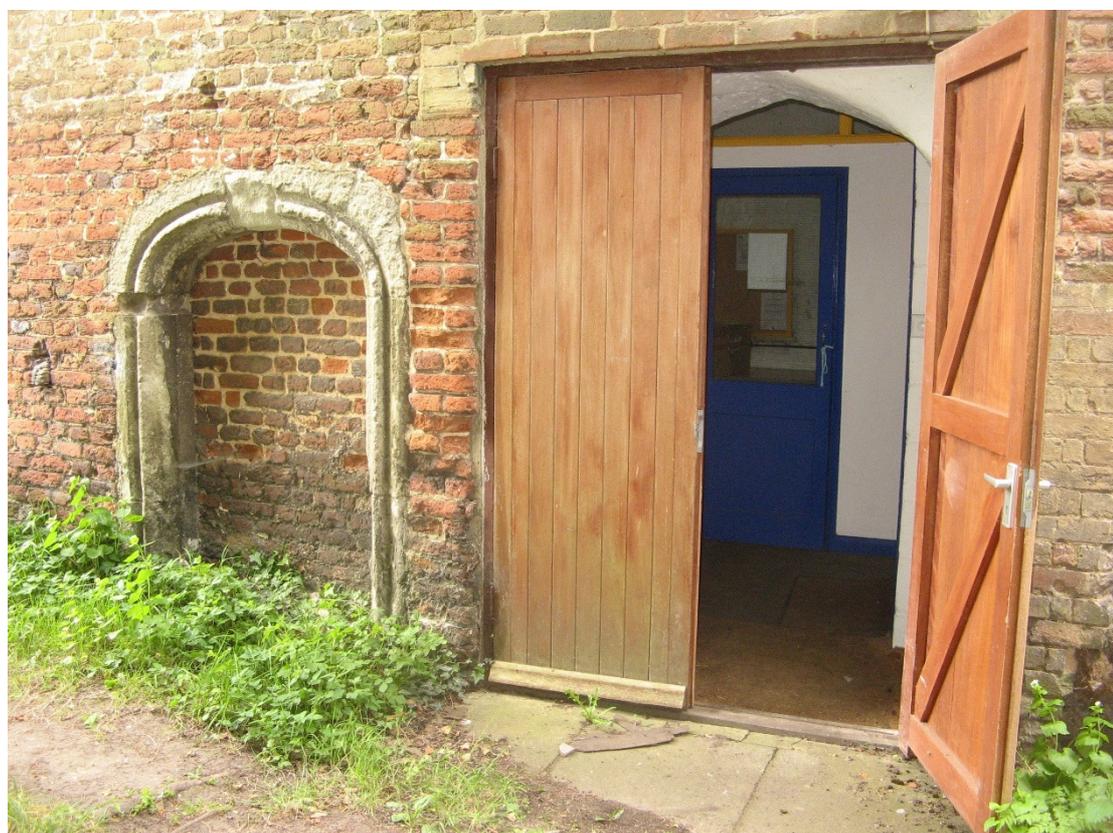
Fig 10 Gatehouse: Blocked doorway and remains of a second doorway, much altered and enlarged, alongside; floor level was originally lower

2.5.25. The pair of adjacent doors in the side of the gate passage indicate an internal partition between them; there are suggestive shadows of a timber-framed one on the walls. The north chamber is likely to be a porter's lodge, generously lit through three windows in the north wall.⁴⁷ Surviving primary plaster and a refaced zone place the first-floor structure directly above the higher (side) primary window lintels, with first floor level being about 3.7m above estimated original ground floor level (3.5m above existing).⁴⁸ There was a fireplace on the west wall, indicated by part of its relieving arch, and a lamp recess or cupboard, now blocked, adjacent to the door.

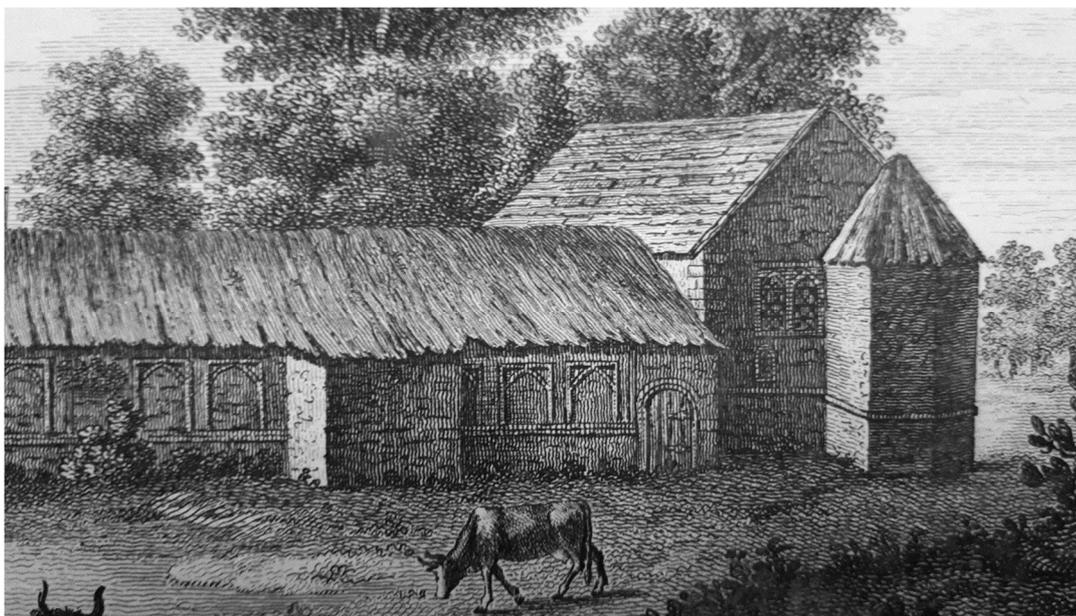
Fig 11 Enlarged extract of Fig 7, c1775, showing detail of east end of gallery and gatehouse

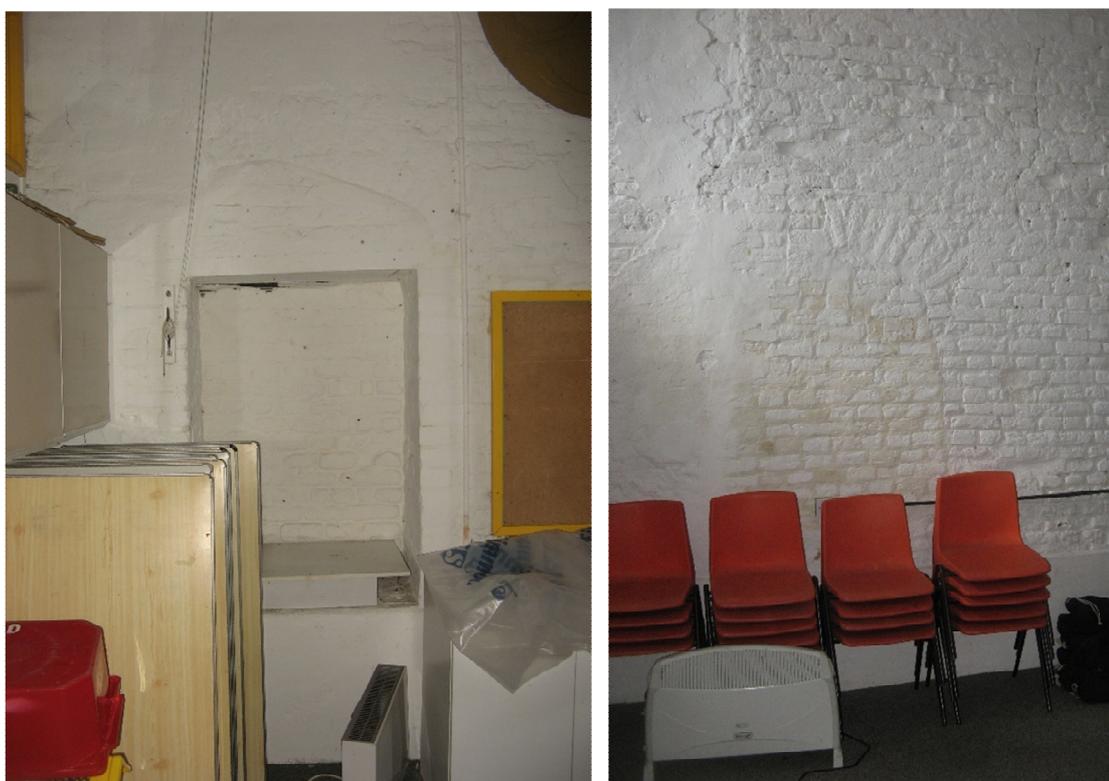
Fig 12: Gatehouse: Blocked doors from gate passage (left; for outside see fig 10) and west cloister (which appears to be secondary)

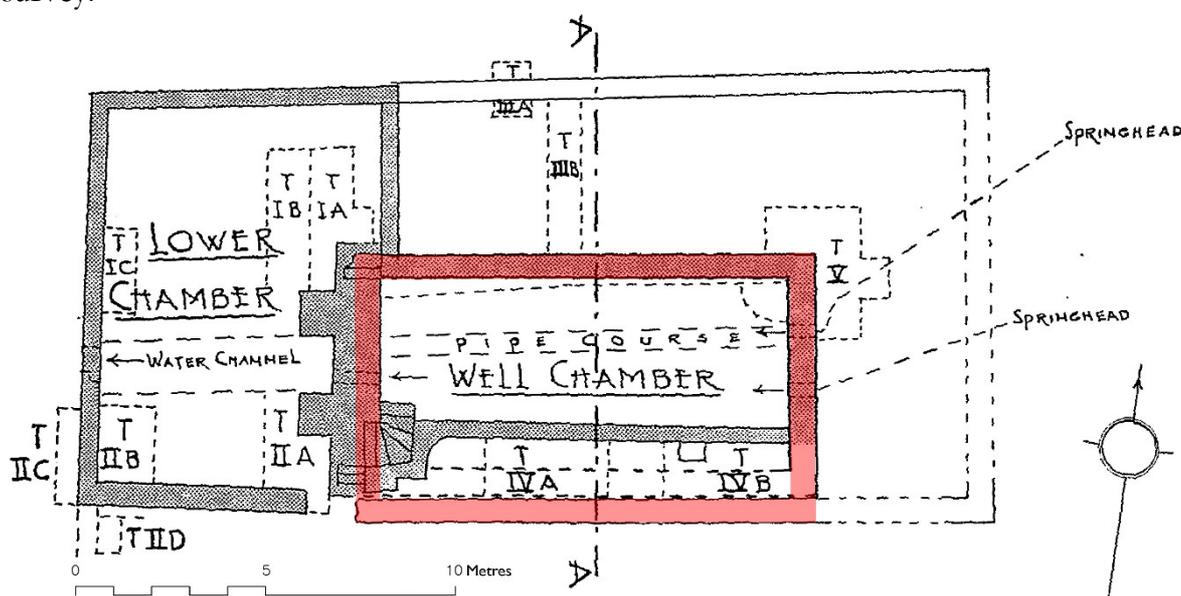
Fig 14 St Thomas a Becket's well, from *Archaeologia Cantiana* 70 (1956), 173; approximate scale added. The earliest surviving chamber is outlined in red

2.6.4. The earliest surviving stone reservoir walls, and its floor of chalk blocks set in a layer of gault clay, probably date from the 14th century primarily on the evidence of the earliest finds from the site generally.⁶⁷ The reservoir was *c* 10.7m long, and originally 5.8m wide, with two pointed-arch inlets in the base of the east wall, connected to springheads at least 6.1m distant by chalk-lined conduits. The northern was, probably secondarily, connected to a lead pipe⁶⁸ presumably for drinking water, while the other fed the cistern from which a channel, controlled by a sluice, flowed westwards. Since the internal dimensions essentially agree, this should be the base of *'the conduyte house or well conteyning in length xxxvi foote and in breadth xix fote to be taken downe and newe sett upp'*, estimated to cost £30 in the 1573 survey.⁶⁹

2.6.5. The lower chamber seems, from the brick used its construction, to have been added in Warham's time, and an enclosure wall constructed around the primary chamber. The whole structure was maintained, with piecemeal rebuilding, into the 19th century, with the south wall of the well chamber being rebuilt further north around the end of the 18th century.

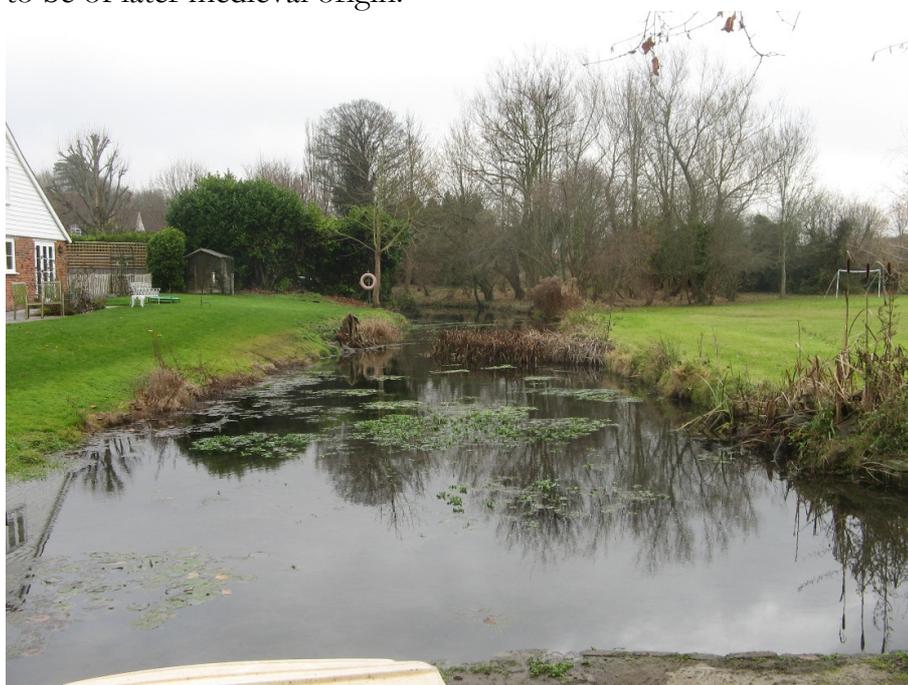
Fig 15 The reservoir of the northern system of water management, looking east, from the dam

- 2.6.8. The northern system now begins with a deep spring-fed reservoir (perhaps also serving as a fish pond) almost following the contour at Moat Farm, north-east of the palace. It originally extended further east, where the terminal of the deep cut has been located (Fig 13);⁷³ above it the banks were cut back to a gentler slope, as can still be seen (Fig 15) towards the east end of the surviving section. Although the bottom was not reached in excavation it presumably cuts through the edge of the chalk, into the gault clay beneath. The east end cut through two successive shallow ditches on a similar alignment, the fill of the earliest of which contained a single sherd of late 11th/early 12th century pottery;⁷⁴ the later contained only residual Roman and earlier material. In its ultimate form, at least, the reservoir is thus likely to be of later medieval origin.

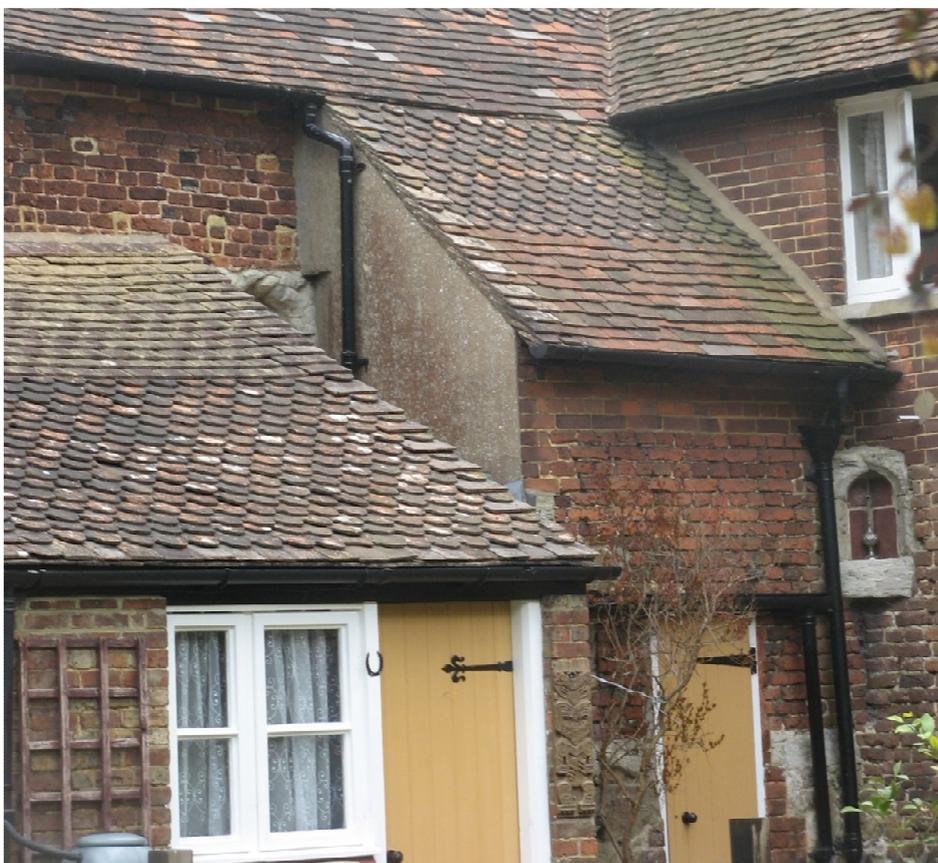
Fig 16 The remains of the added garderobe tower – the doorway is a 20th century insertion

2.7.8. This structure might be thought a late intervention, but in fact its presence and purpose are shown on Thorpe’s first floor gatehouse plan, as containing a garderobe serving the first floor of the gatehouse. The drawings in Thorpe’s *Book* include surveys, designs, and adaptive or inventive developments of plans of buildings seen or illustrated in printed books; the Otford plan might therefore include some ‘improvement’ of what actually existed. But by 1600 garderobes had been superseded in polite society by stool closets, so this was not a proposal or invention by Thorpe but a record of something already existing. It probably stood over and connected to a pre-existing culvert serving the tower garderobes (2.6.10).

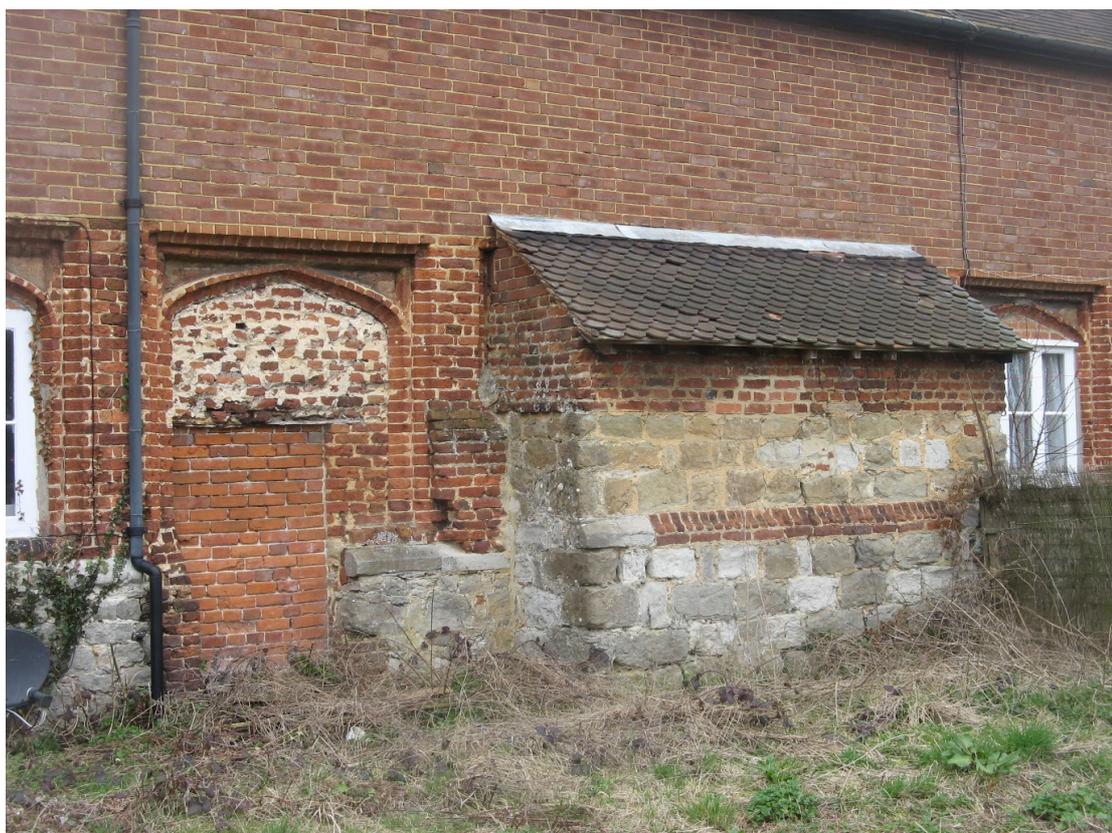
Fig 17 The projection on the south side of the north-west range; note the section of the plinth raised in brick, and the chamfered jamb of a doorway formed through one of the arched openings of the cloister. The rough infill above it is of uncertain date, the infill of the doorway around 1800

⁸⁴ Stoyel (report 7.9.78 on the SPAB file) suggests that it was for the farm smithy, with the adjacent doorway formed to give access to it; it may have served this purpose later, but is too elaborate to have started life as part of a farm smithy. A post-1914 (construction of present cottages) photo shows small chimney rising through the roof. The author has not seen the structure internally.

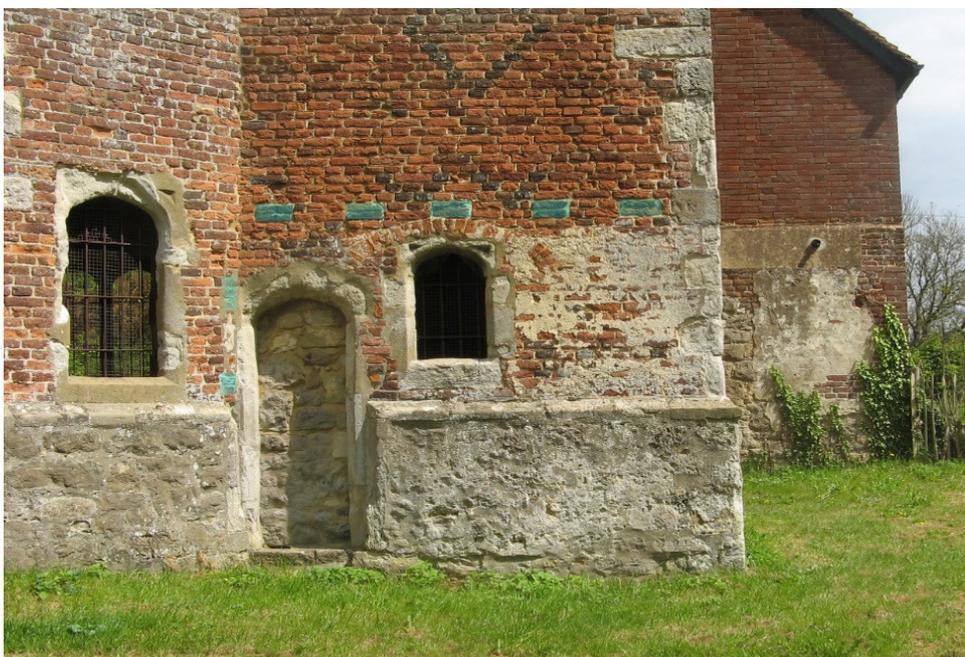
Fig 18 The south side of the garderobe tower showing blocked sockets for rafters, and probably rails of timber-framed wall, and internal plaster on the formerly external wall

- 2.7.16. A lean-to single storey addition on the west of the garderobe tower, whose scar remains (Fig 18) was certainly timber framed and probably part of this scheme. Selective blocking of tower windows, well finished in plaster on both sides, is also likely to be part of this phase. Austin notes⁸⁷ evidence for lime plaster succeeding the primary panelling, and a doorway cut from the ground floor passage through the stair turret into the north range.

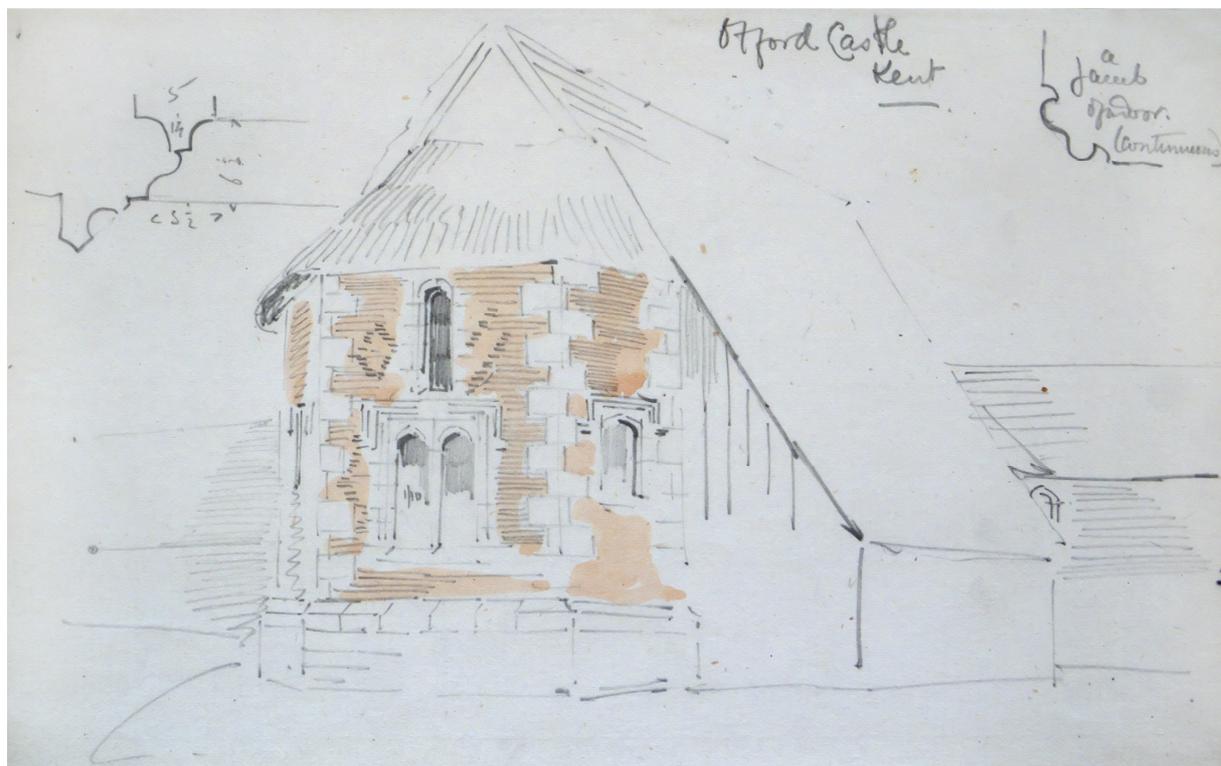
Fig 19: The gatehouse from the north-west before the 1914 fire: Pencil and wash drawing, © Society of Antiquaries of London Roland Paul Collection (Box 6)

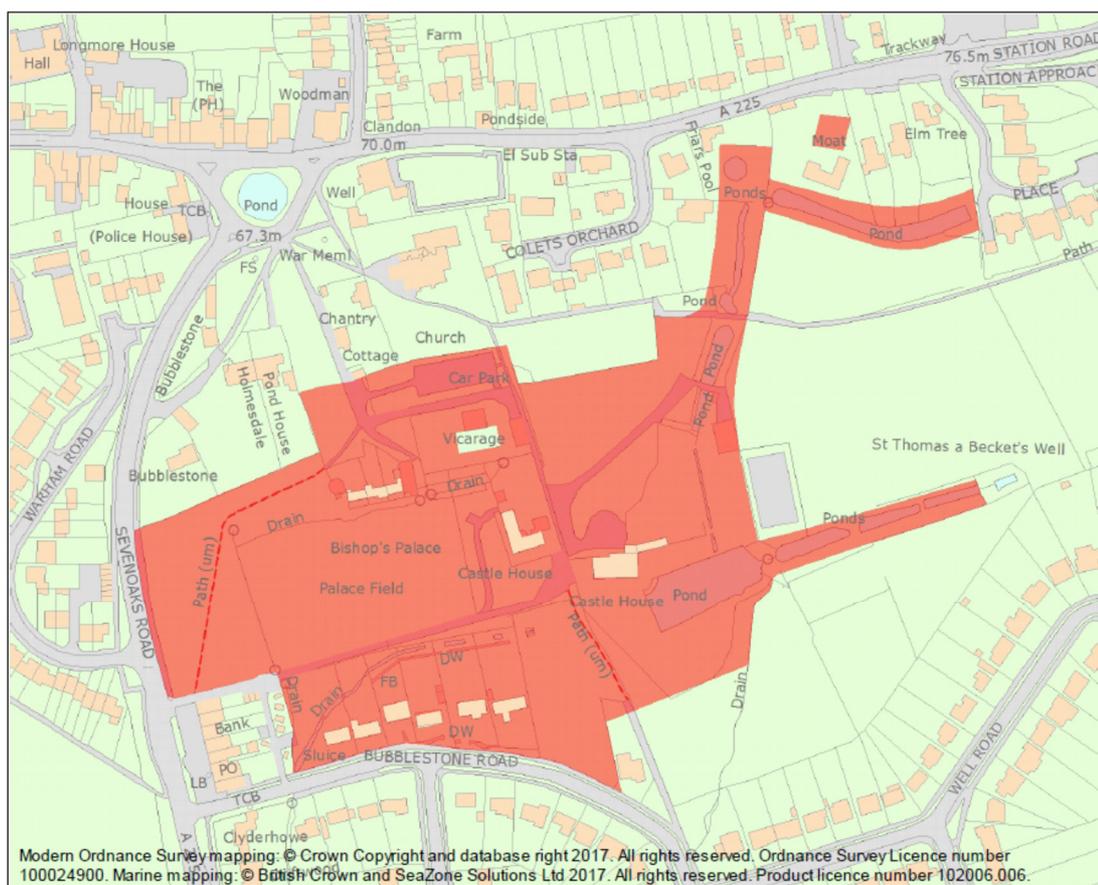
Fig 20 The extent of the scheduled area; dwellings excluded; St Thomas a Becket's well scheduled separately (Historic England)

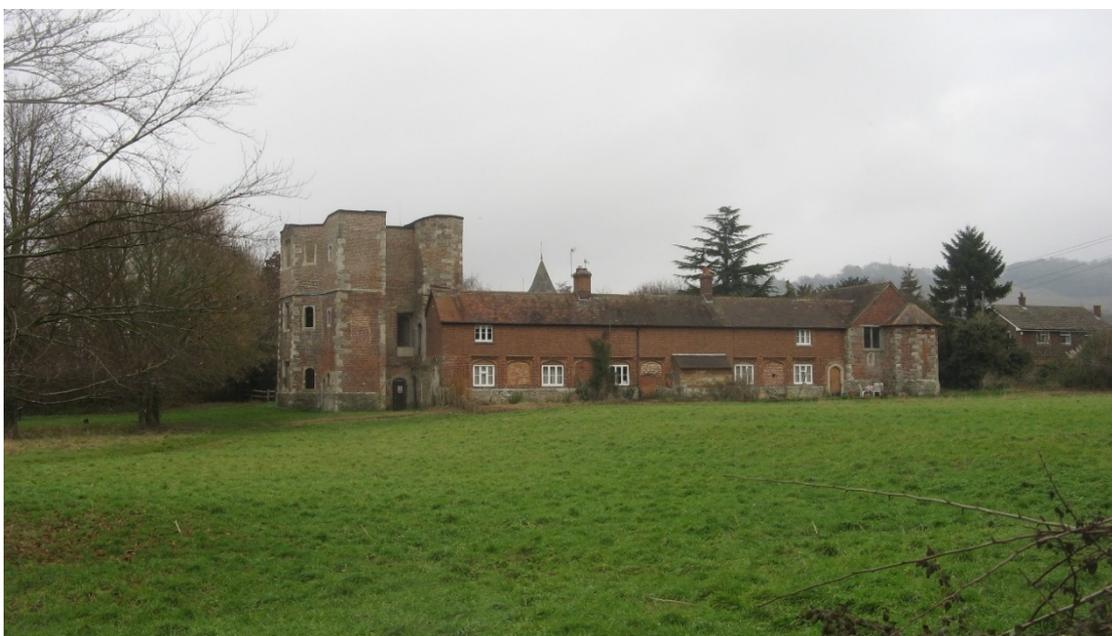
Fig 21 The north-west range seen from the south-west across Old Palace Field; note terrace marking site of former west range of outer court

4.4.22. The problems on the south are greater, where the range is seen both at close quarters (across the stream) and distantly across Old Palace Field (Fig 21). The long view is the best, indeed the only, one of the group as a whole. The Castle Cottages have curtilages defined southwards by a stream whose centre meanders from 5.5m to 8m from the front elevations. The eastern cottage cultivates this space and has created a terrace in front of the gatehouse block, facilitated by an historic doorway being renewed and opened. The others lack direct access, and the spaces are overgrown and unsightly. Proposals to create access doors by re-opening blocked doors caused an outcry in 1978 (before the sale of the cottages) and were dropped.

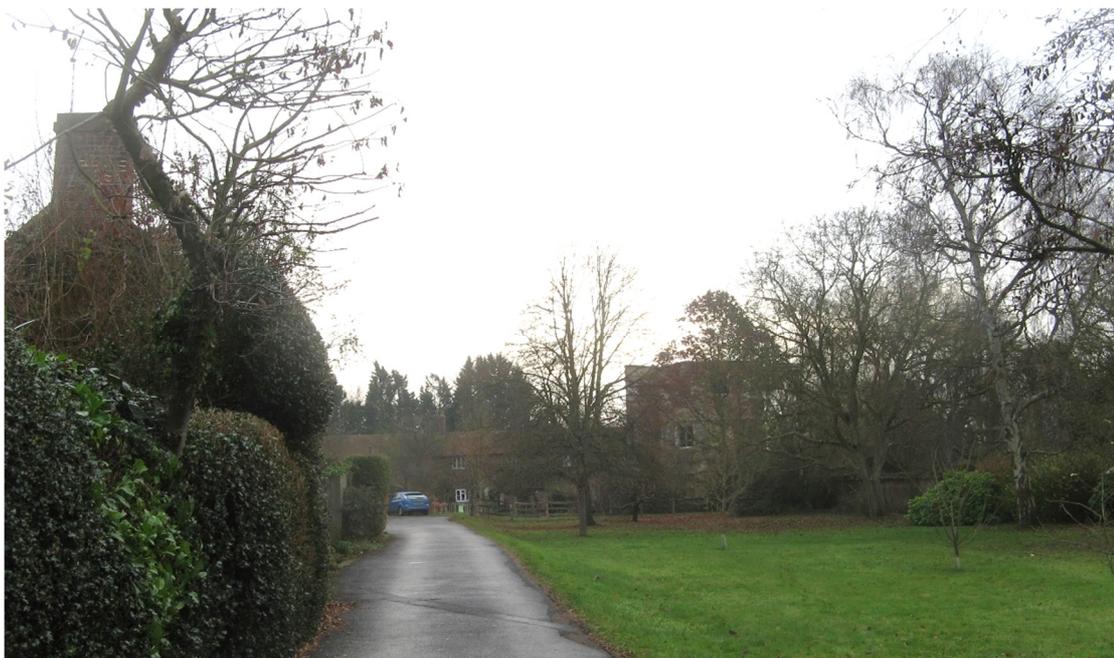
Fig 22 Castle Cottages and the north-west tower from the north; recently-planted trees in the foreground, with trunk protection still in place

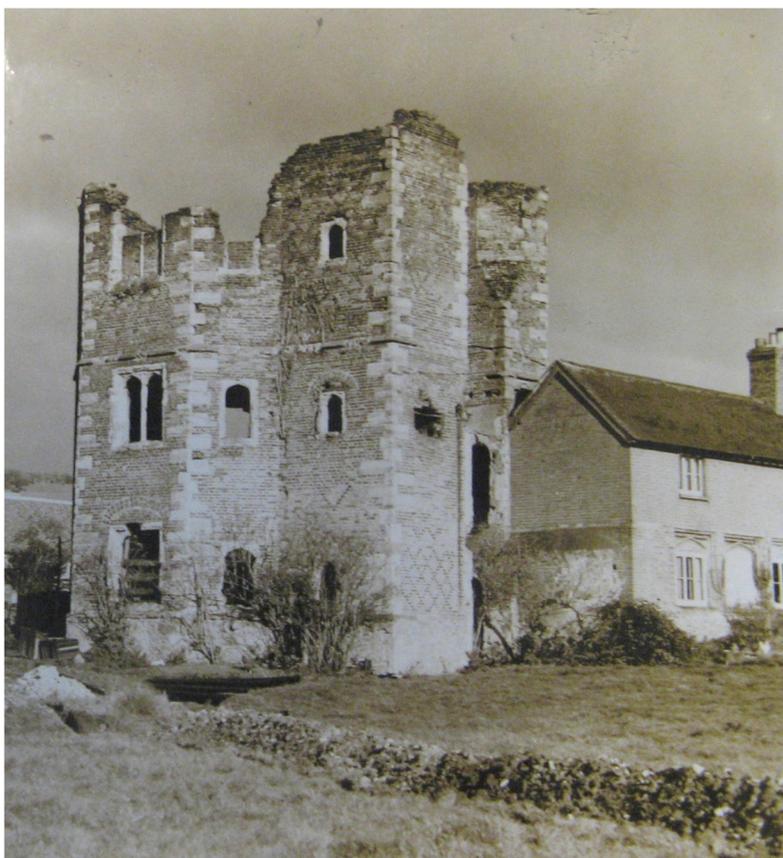
Fig 23 The north-west tower in 1934, after the removal of ivy (SPAB archive)

4.5.1. The condition of the north-west tower was a matter of recurring concern for over a century. After adaptation as a dwelling it was abandoned when the roof failed in the middle of the 18th century (2.8.5 above). The earliest engraving (Fig 7) shows it with part of the parapet still intact (on the west), the rest reduced evenly to roof level (below which the wall was much thicker), and some vegetation growing out of the wall tops. After more than a century of weathering, it was covered from the top almost to ground level with ivy, suggesting that this was well rooted in the wall heads. By 1934, when the ivy had been cleared, the extent of loss at high level, particularly on that same west front, was evident, with collapse reaching down below window head level (Fig 23). Internal timber window lintels, particularly, must have been failing, contributing to the fragility of the structure.
