**OTFORD PALACE
OTFORD, KENT
CONSERVATION STATEMENT**

Drury McPherson Partnership
Historic environment policy and practice

FINAL DRAFT: FEBRUARY 2018

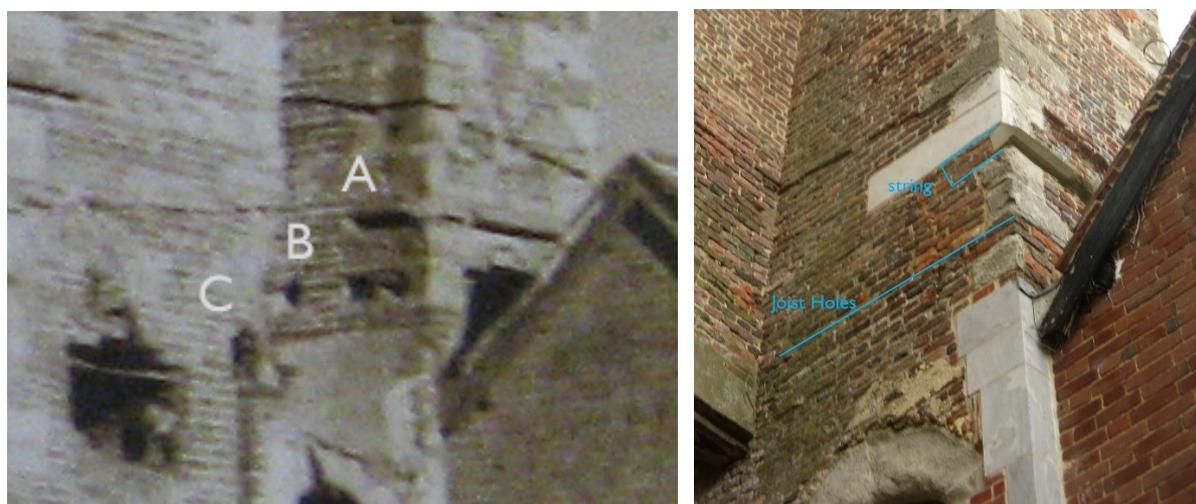
Fig 24 The north-west stair tower at second floor level in 1934 and 2017 showing (A) weathering course returning but now cut off; (B) gallery roof joist sockets now lost; (C – 1934 only) socket for bead of timber frame of west wall of the west gallery. Note extensive survival of internal plasterwork below joists 'B' in 1934; barely a fragment now remains

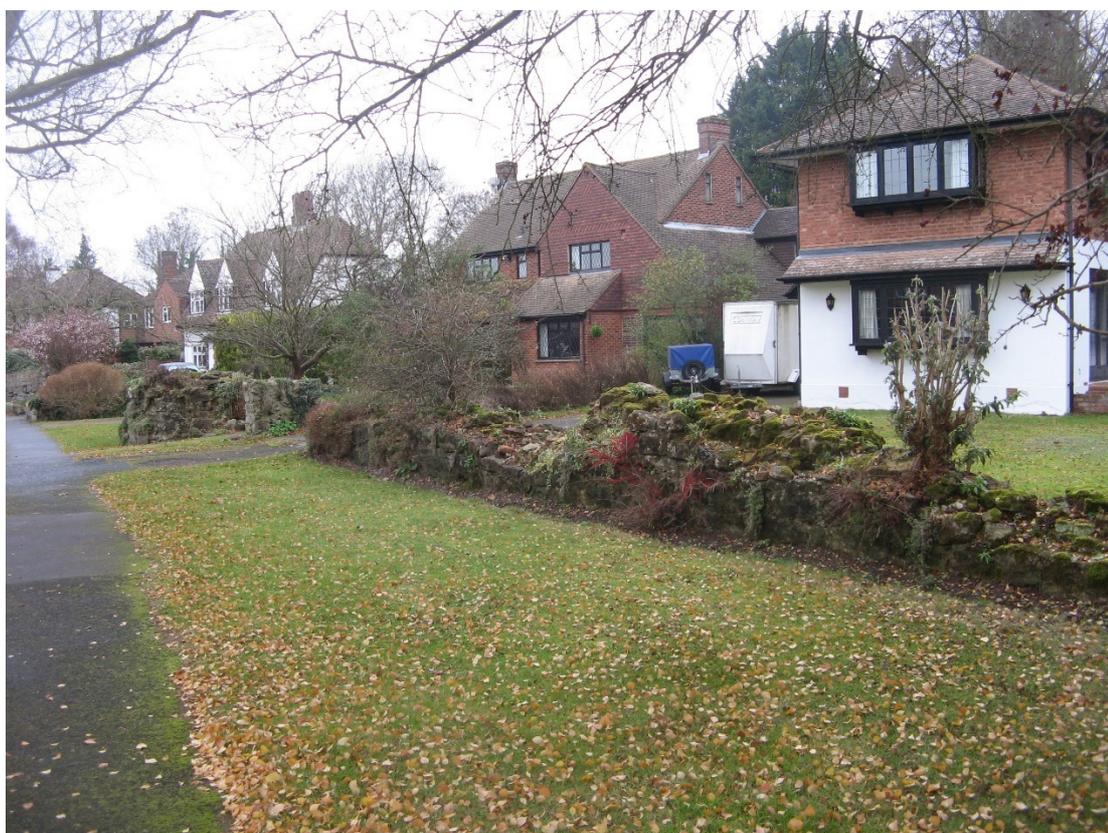
Fig 25 The remains of the south curtain of the palace site, on the north frontage of Bubblestone Road, looking west

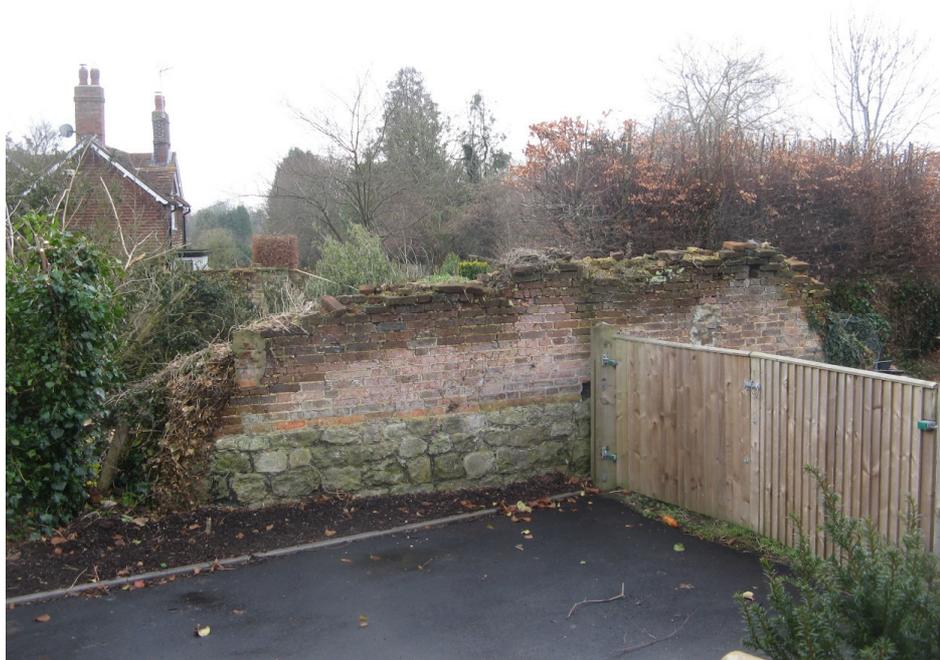
Fig 26 The remains of the north gable of the scheduled structure by the reservoir

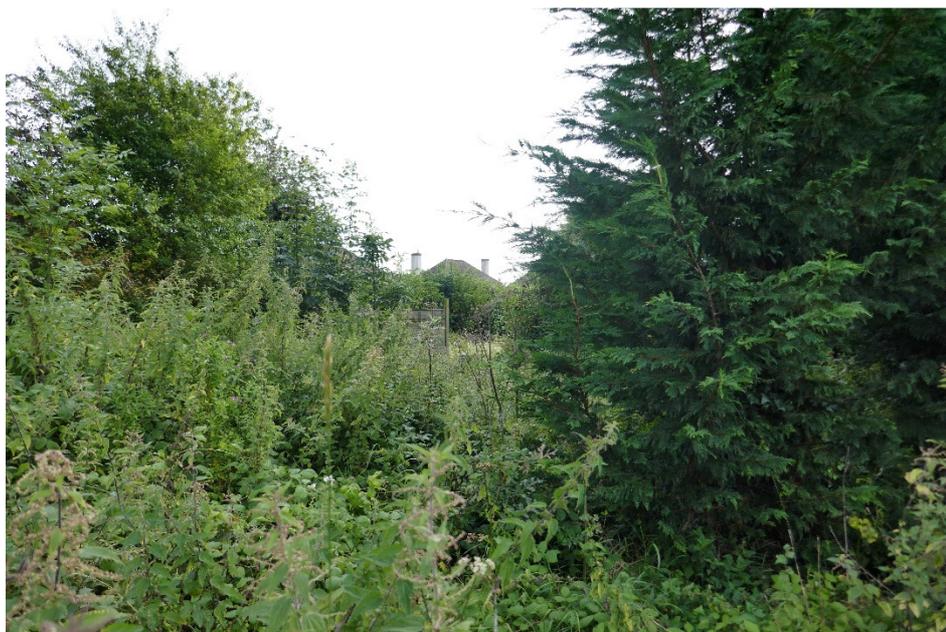
Fig 27: St Thomas à Becket's Well from the north, August 2017

4.5.12. St Thomas à Becket's Well has been reported in the past (1955)¹¹⁸ to be in poor condition, and in 2017 was completely overgrown with vegetation (Fig 27).
