# Kent Pedestrian Guard Railing Assessment

## Sevenoaks – Report for Consultation

Project Number B1555300

Client: Kent Highway Services  
 Project: Kent Guard Railing Assessment Job No: B1555300  
 Document Title: Sevenoaks Guard Railing Assessment

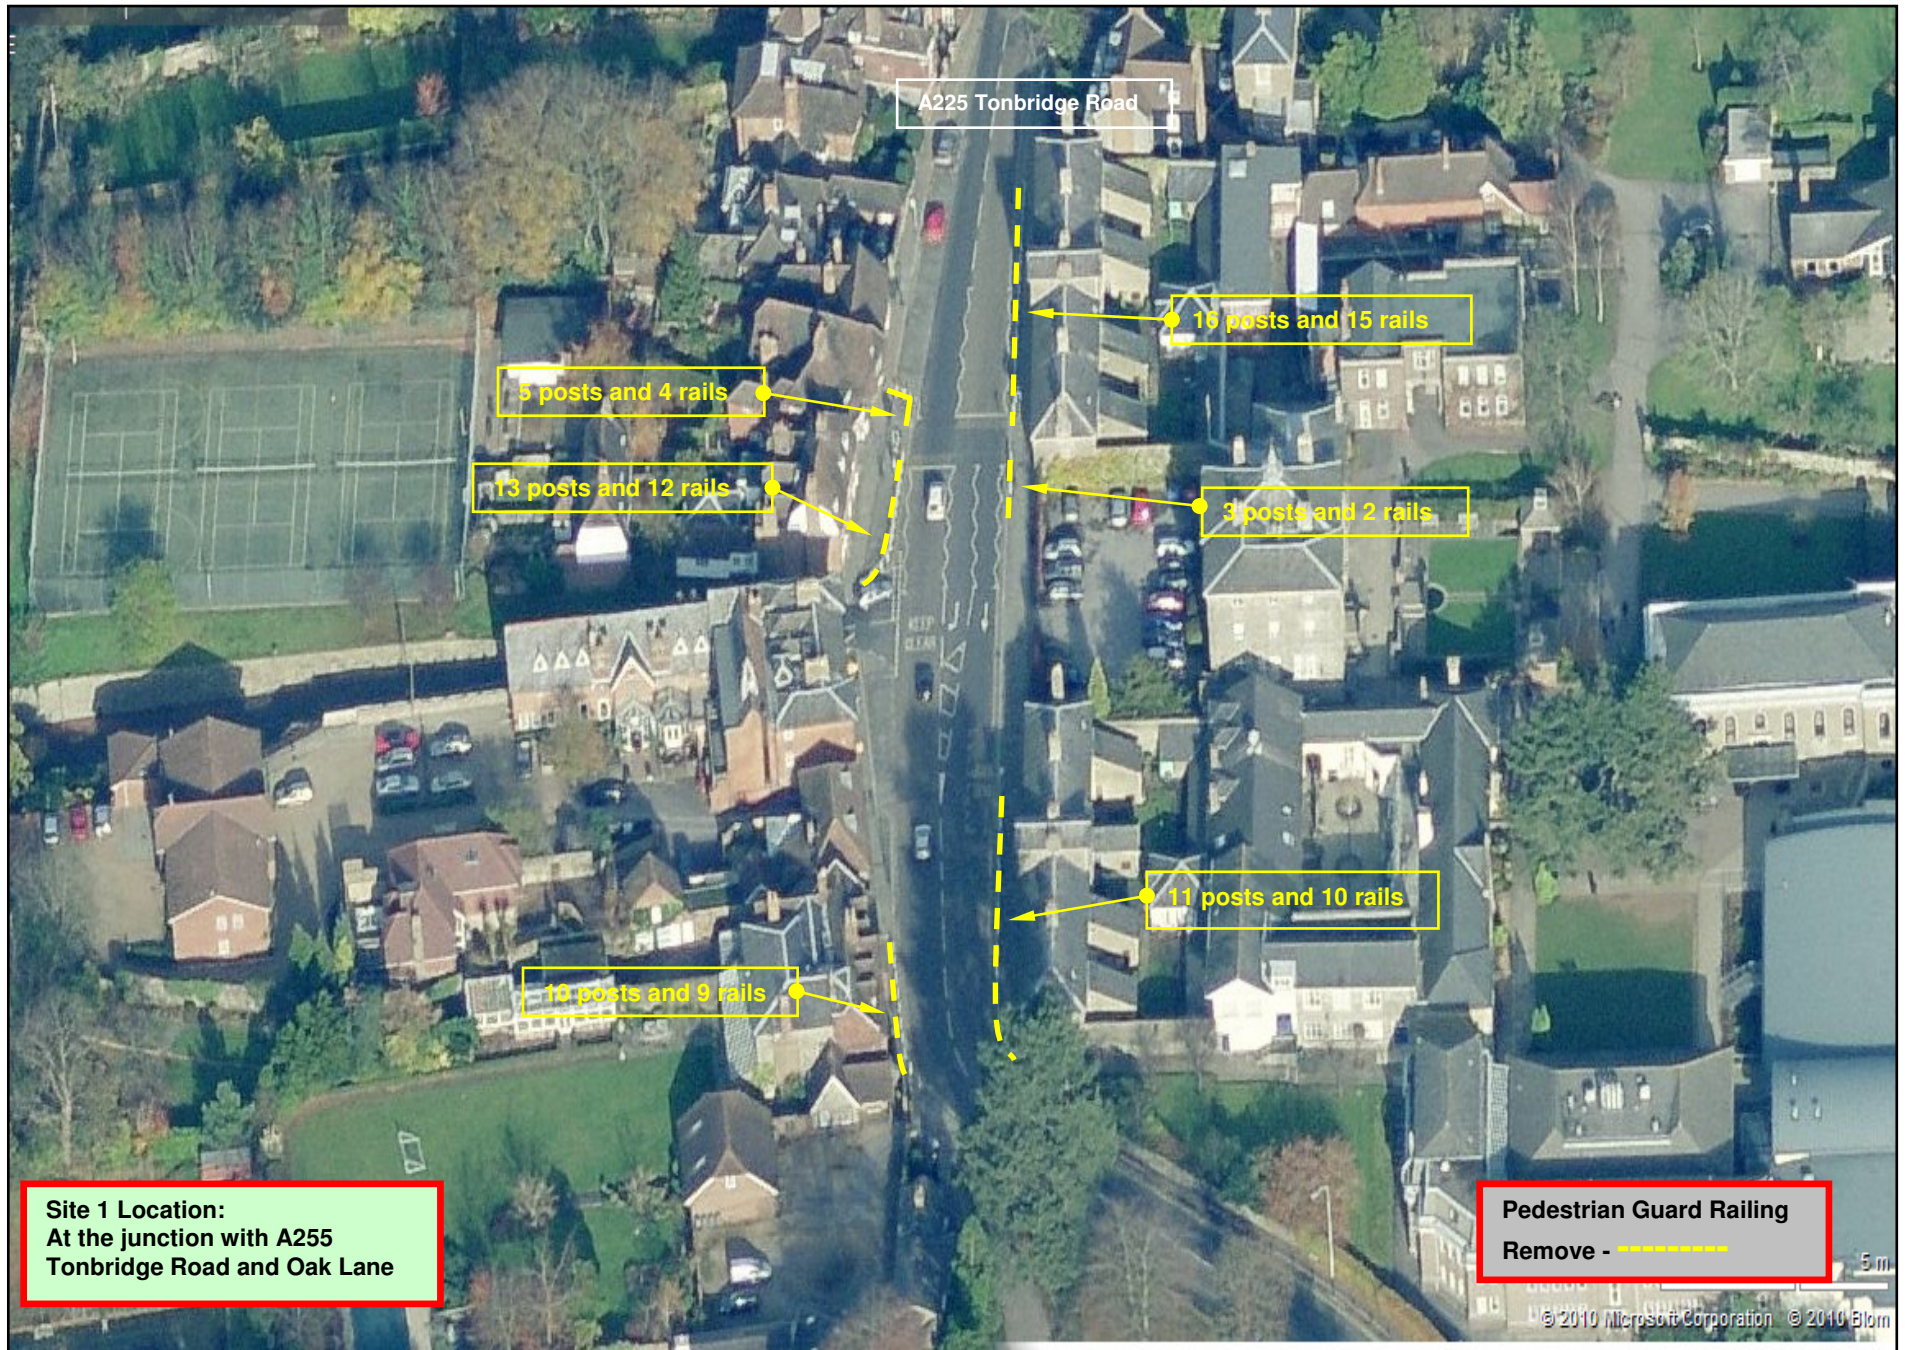
**Illustrated Diagram of site 1**

Site 1 is located on the A225 Tonbridge Road outside the Sevenoaks School and the junction with Oak Lane.

The guard railings are located outside the Sevenoaks School and the junction with Oak Lane. During peak times there is a high volume of vehicular traffic and the Pelican Crossing at the site has a high volume of pedestrian movement, in particular school children.

The post and railing type of panel installed offers little benefit as a guide or protective device for either pedestrians or vehicles.

The general condition of the post and railings are fair.

- **It is recommended to remove the post and railing at site 1.**

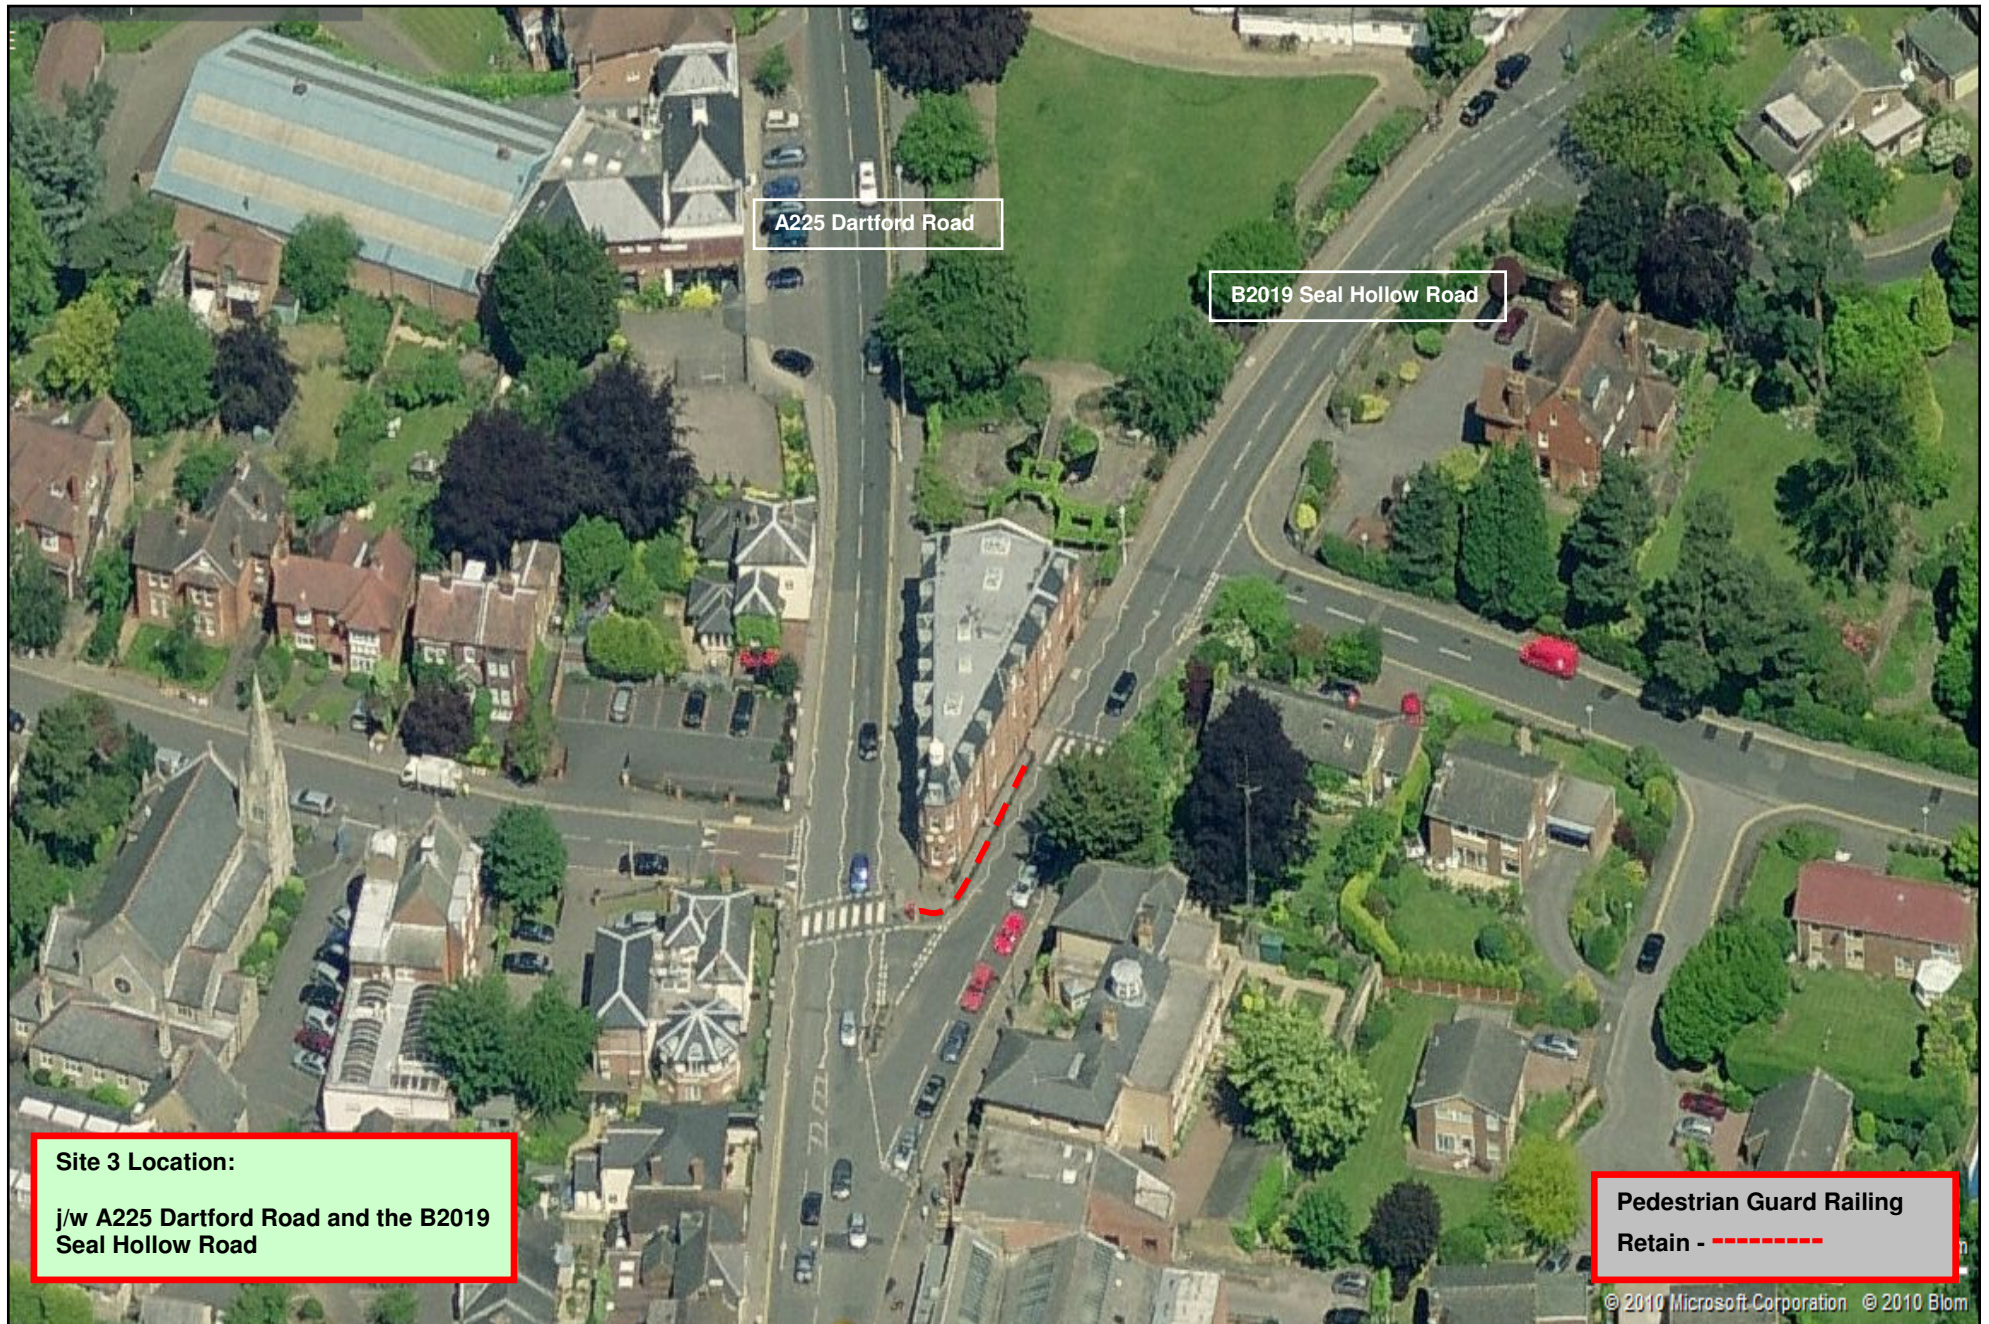
**Illustrated Diagram of site 3**

The pedestrian guard railing is located at a complex junction and links two Zebra Crossings, one located at the junction with A225 Dartford Road and the other approximately 15metres away on the B2019 Seal Hollow Road.

The guard railings guide pedestrians from the A225 Dartford Road footway away from the northern and southern exit and entry points of Seal Hollow Road to a safe point at the Zebra Crossing on Seal Hollow Road and visa versa.

The site has a high volume of vehicular traffic and a moderate volume of pedestrian movement.

- **It is recommended to retain the pedestrian guard railing at site 3.**

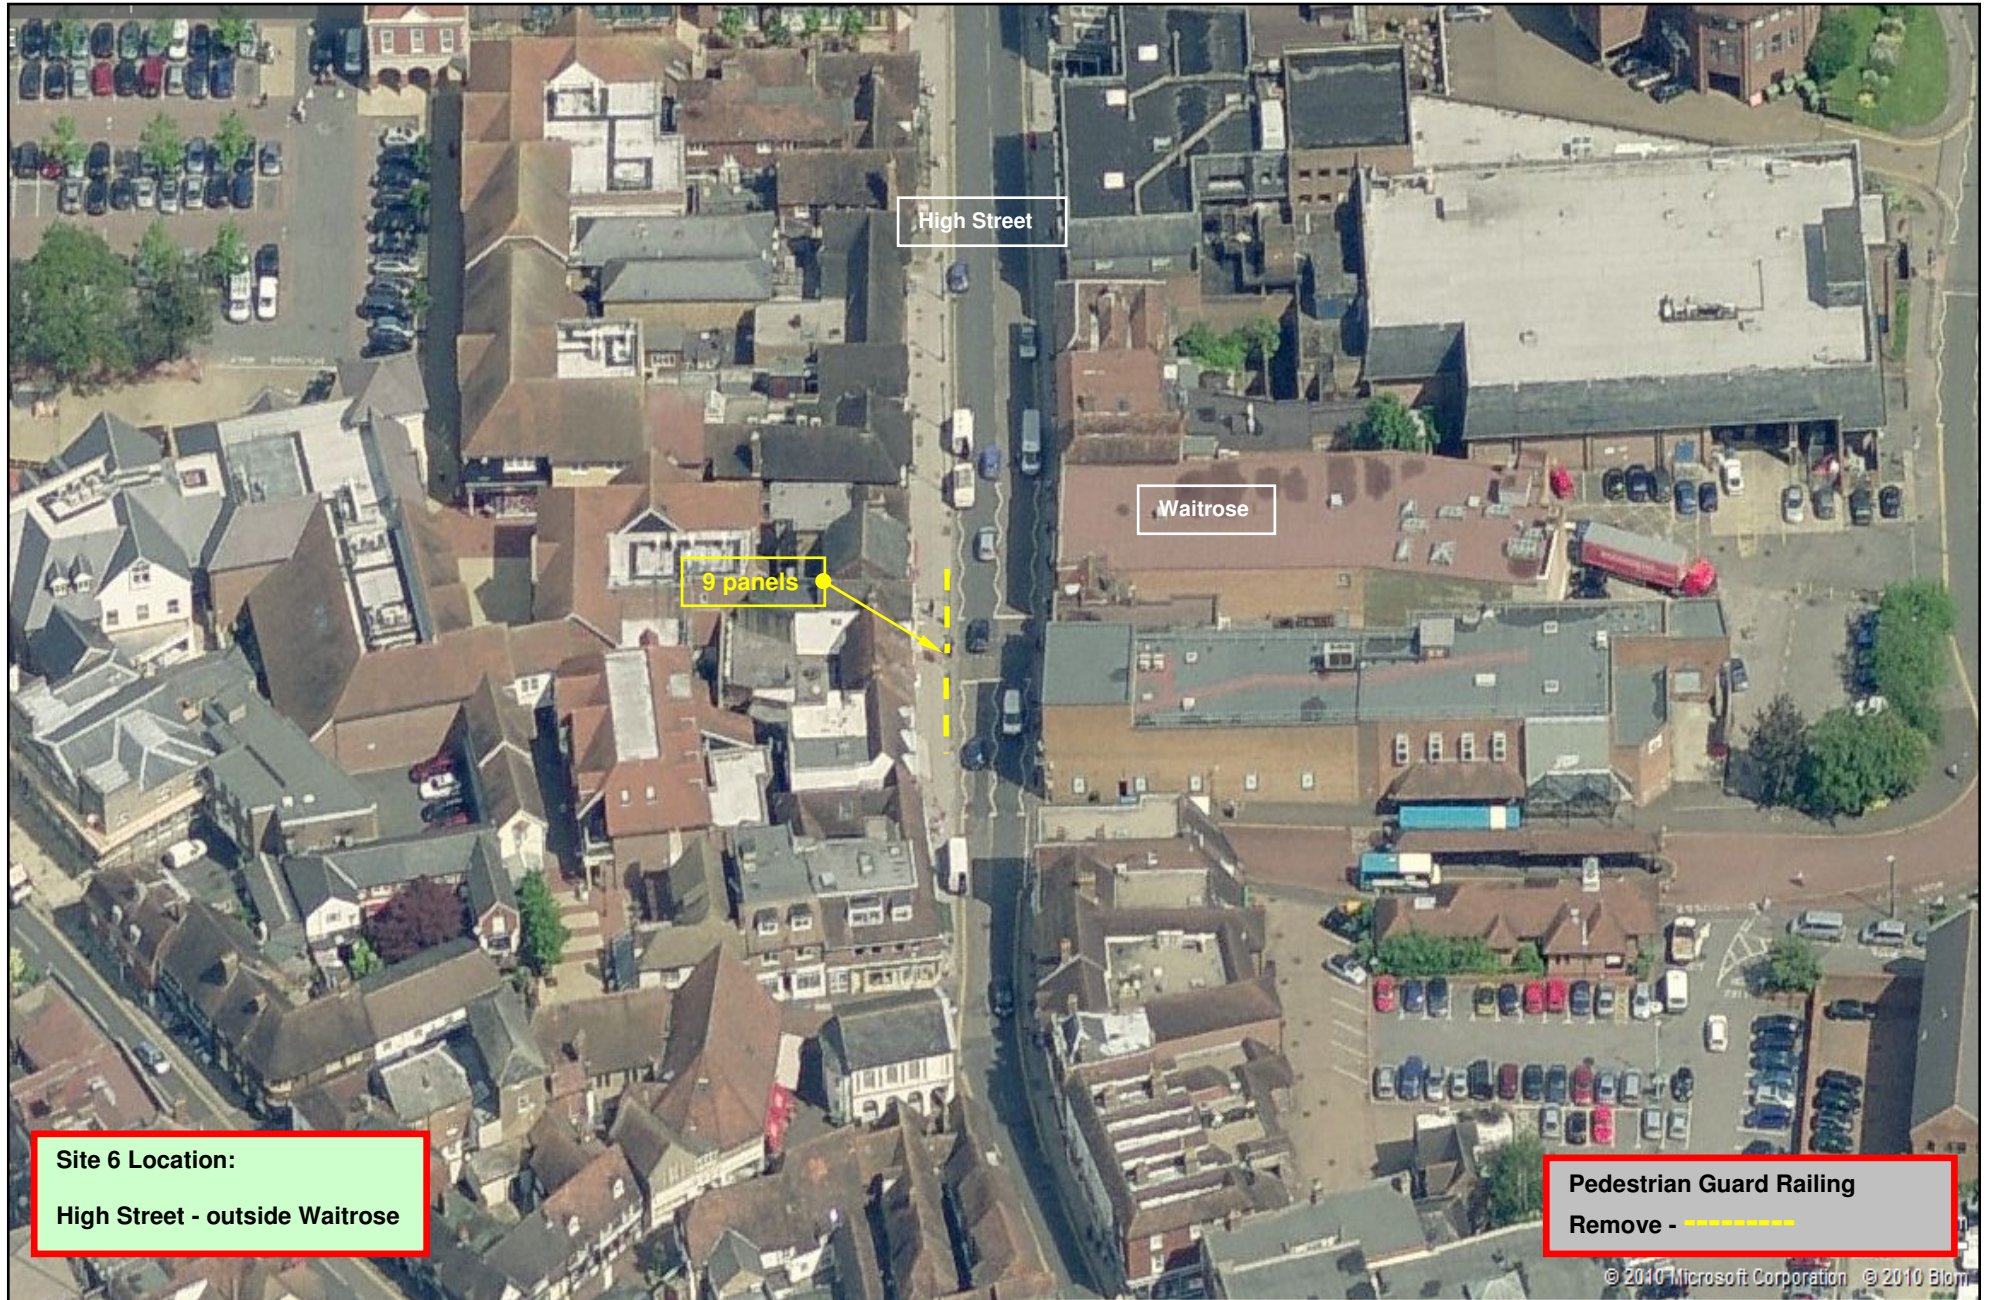
**Illustrated Diagram of site 6**

There are 9 pedestrian guard railing panels located on the western side footway at the Pelican Crossing and no guard railings on the eastern side, the 9 railings offer no benefit as a guide or protective device, as pedestrians were observed crossing the road all along the High Street.

The site has a high volume of vehicular traffic and a high volume of pedestrian movement.

- **It is recommended to remove the pedestrian guard railing at site 6.**
