**A25 (Dryhill Lane to the Surrey Border)
Route Study**

Client: Kent Highway Services, West Kent Division

April 2008

Project Number B0820600
Jacobs, Miller House, Lower Stone Street, Maidstone, Kent, ME 15 6GB

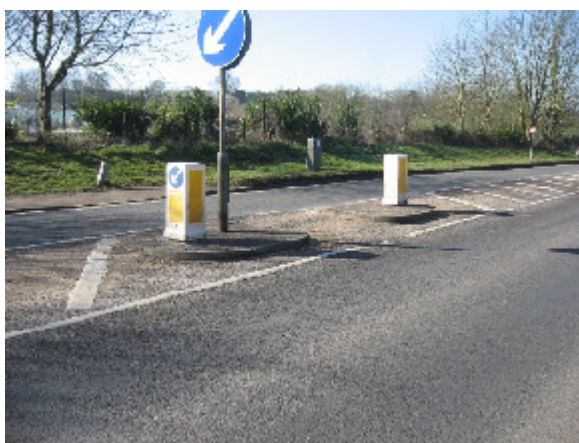
Opposite house numbers 8 -14 - 16 Main Road

A feeder pillar supplying the central island of the pedestrian crossing opposite house number 10 and approximately 50metres west from Dryhill Lane on the south side of the main carriageway has been dislodged.

The illuminated bollards at the pedestrian crossing are coated in grime.

Photo 3 - A feeder pillar is dislodged and the illuminated bollards coated in grime

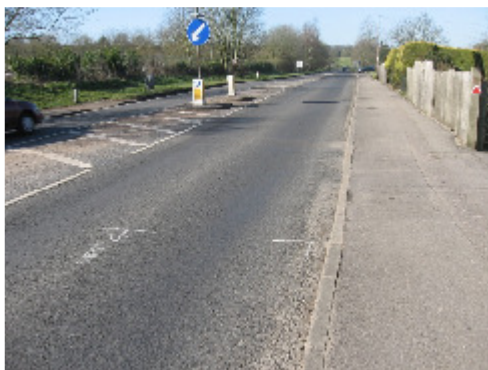
Photo 4 -Sunken carriageway

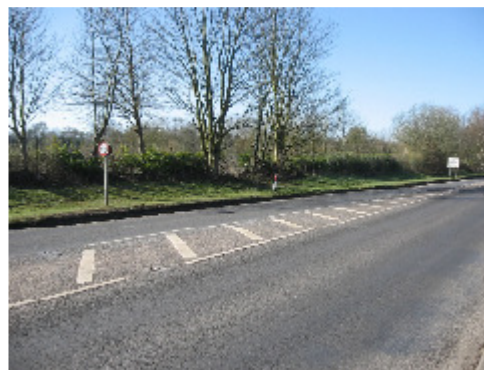
Road marker posts on the southern verge of the west bound carriageway opposite house number 16 have been struck.

Photo 5 - Road marker posts have been dislodged and the repeater sign is coated with grime

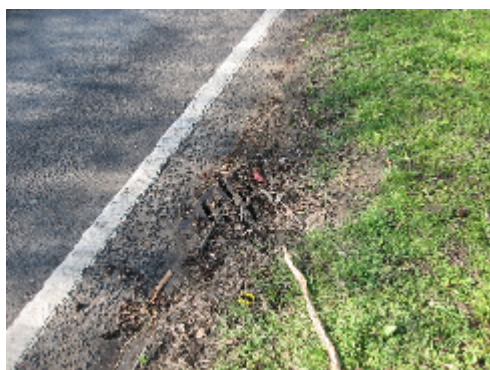
Photo 8 - Gullies are blocked

The gullies outside and opposite house numbers 48 -54- 56 -58 are blocked with debris and outside house number 52 a section of the footpath is deteriorating with previous remedial work breaking away. There is rutting on the edge of carriageway outside house number 58.

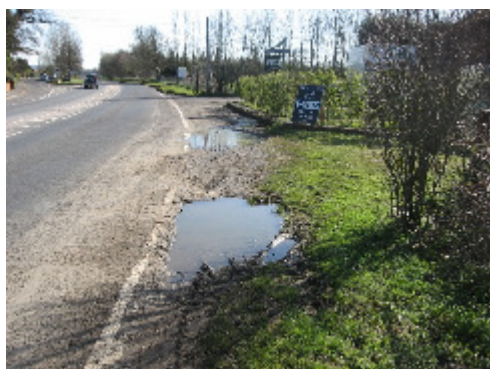
The lay-by outside ‘Green Oak Barn’ is in a poor condition with evidence of ponding and the road surface is cracking and breaking up with potholes forming at the edge of the carriageway.

Photo 10 - Lay-by is in a poor

The repairs to the carriageway outside house number 58 and the lay-by outside Green Oak Barn should be carried out.

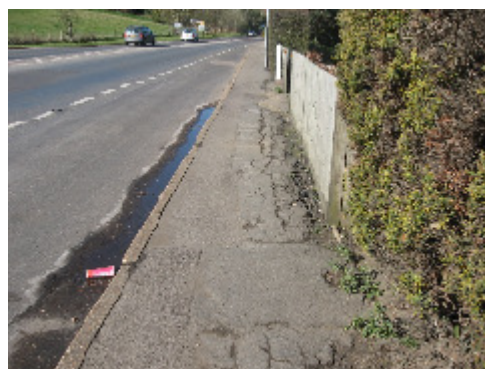
The carriageway edge adjacent to the kerb outside house numbers 66 and 70 is breaking away and sunk where ponding is evident.

Photo 11 - Edge of carriageway

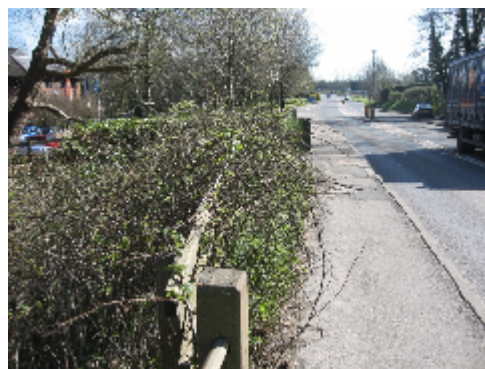
Photo 14 - Thorny vegetation encroaching onto footpath

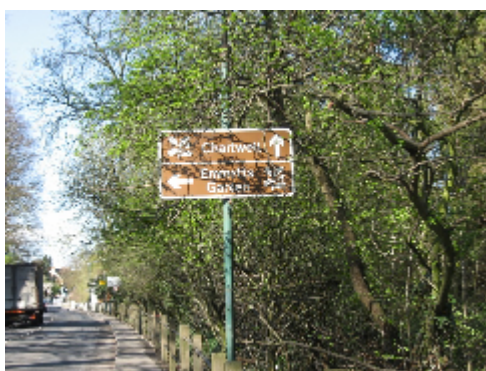
Photo 15 - Tourist sign partly obscured by vegetation

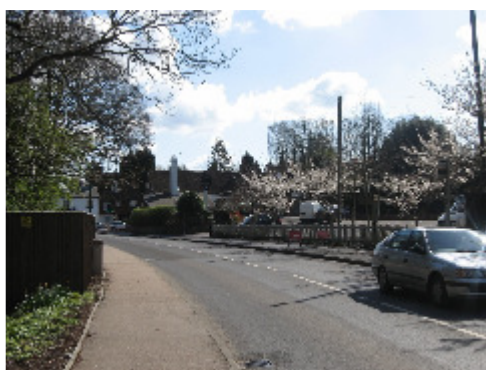
The 30mph repeater sign outside the 'White Horse Public House' car park is inconspicuous due to its size, current location on the footpath and is hidden by bordering fruit trees and not in the line of sight for drivers.

Photo 18 - Inconspicuous 30mph speed sign

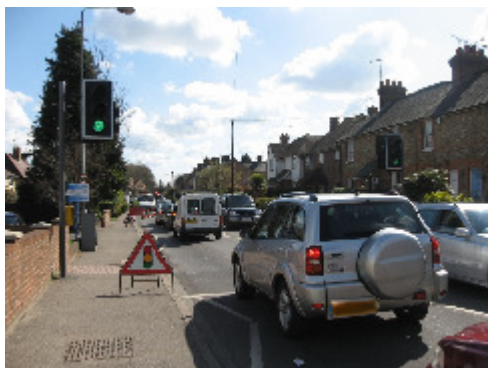
The 30mph speed limit repeater sign on the east bound carriageway opposite house number 154 Main Road is partly obscured by a 'House for Sale' sign.

Photo 19 - Partly obscured
30mph speed limit sign

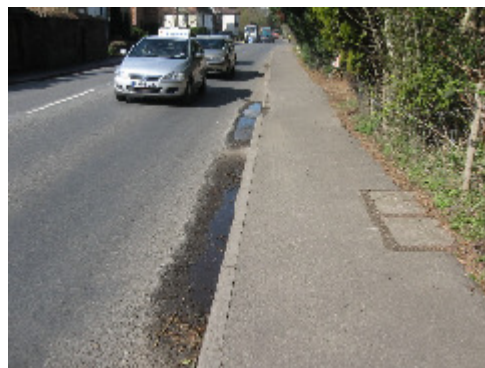
Photo 20 - Ponding on carriageway

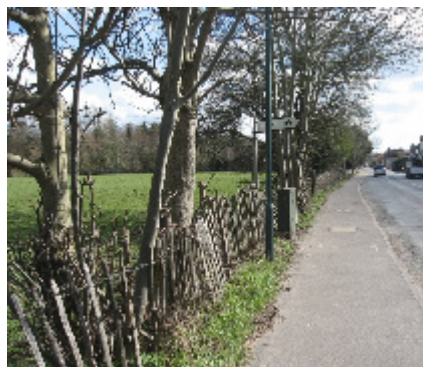
Photo 22 - Partly obscured directional signs

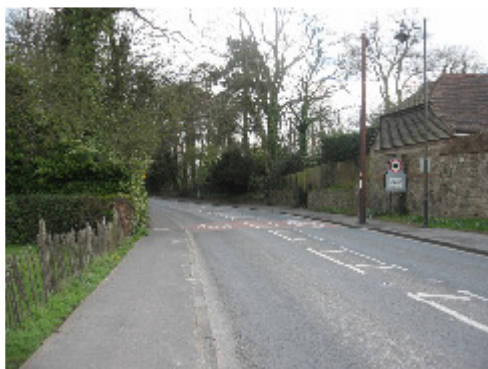
There is a 'Neighbourhood Watch' sign located on a lamp column which is incorrectly positioned obscuring a traffic calming sign.

Photo 27 - Obscured 30mph speed limit sign

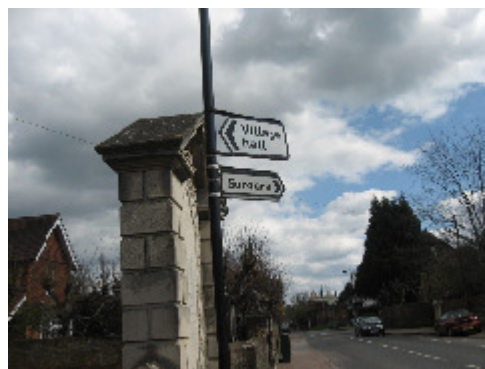
Photo 35 - Misaligned signs

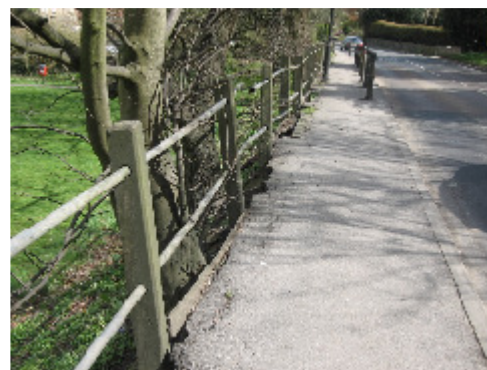
Photo 41 - Footpath subsiding

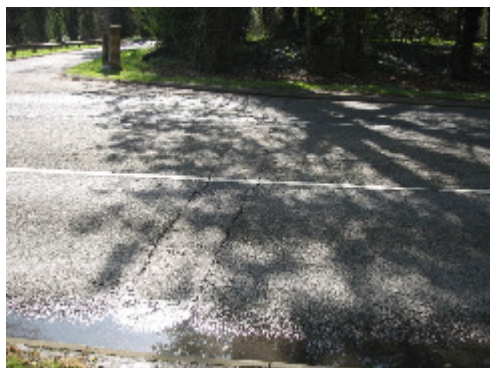
Photo 49 - Rutting in the carriageway

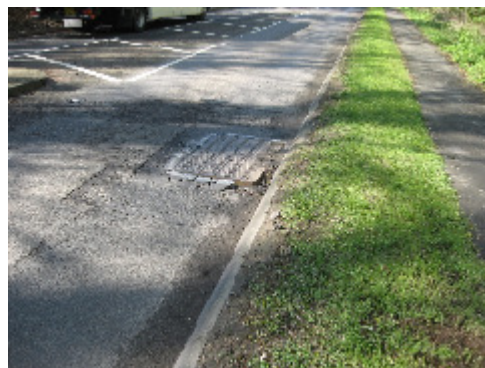
Photo 50 - Manhole cover surrounds breaking up

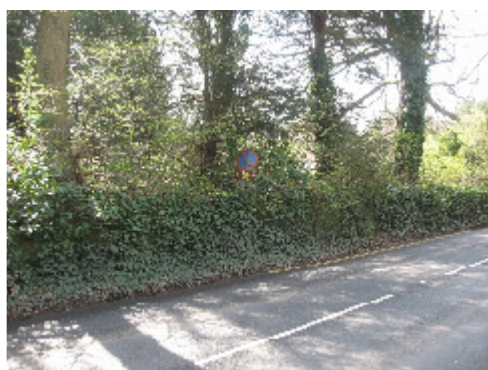
Photo 60 - Partly obscured sign and AAT sign

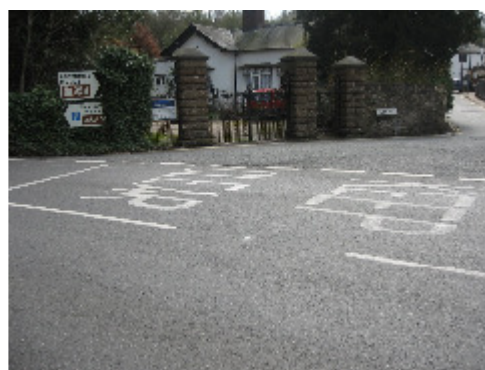
There is a pothole forming at the junction interface with 'Hosity Hill' and the main carriageway.

Photo 61 - Pothole in junction interface and partly obscured sign

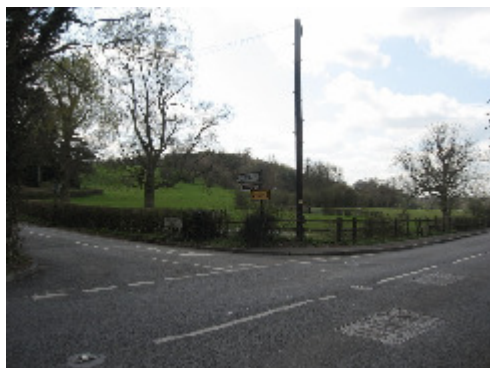
The 'Housing Development' sign located on the directional and tourist signpost adjacent to the junction mouth of Goodley Stock Lane is positioned to low and constitutes a hazard.

Photo 74 - 'Housing Development' sign is positioned to low

The 'Housing Development' sign located on the directional and tourism signpost at the junction mouth of Goodley Stock Lane should be removed and the footpath from Goodley Stock Lane to Farley Lane should be repaired.

- The 'Junction Ahead' and tourist sign which is partly obscured by vegetation should be cut back (7.5.1).
- The 'Housing Development' sign should be removed (7.5.2).
- Repair southern footpath from 'Goodley Stock' Lane to 30/60mph speed limit gateway (7.5.3).

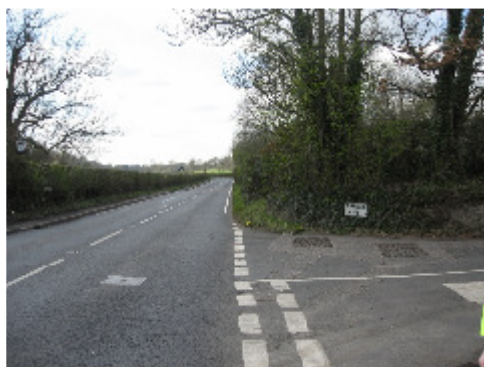
The view to exit Farley Lane is severely restricted by a hedge and a bank to the west.

Photo 76 - The view to exit Farley Lane is severely restricted

- The view to exit Farley Lane is severely restricted by a hedge and should be cut back (7.5.4).
- The Farley Lane western junction interface adjacent to the wall should be repaired and to improve visibility a portion of the bank should be removed (7.5.5).
- The Farley Lane junction mouth road markings should be reinstated and aligned with the existing carriageway edge line (7.5.6).
